## HISTORIC STRUCTURAL ASSESSMENT 741 JEFFERSON AVENUE, LOUISVILLE, COLORADO

October 16, 2024

Andy Johnson, AIA  
DAJ Design  
922A Main Street, Louisville, CO 80027  
303-527-1100; [andy@dajdesign.com](mailto:andy@dajdesign.com)

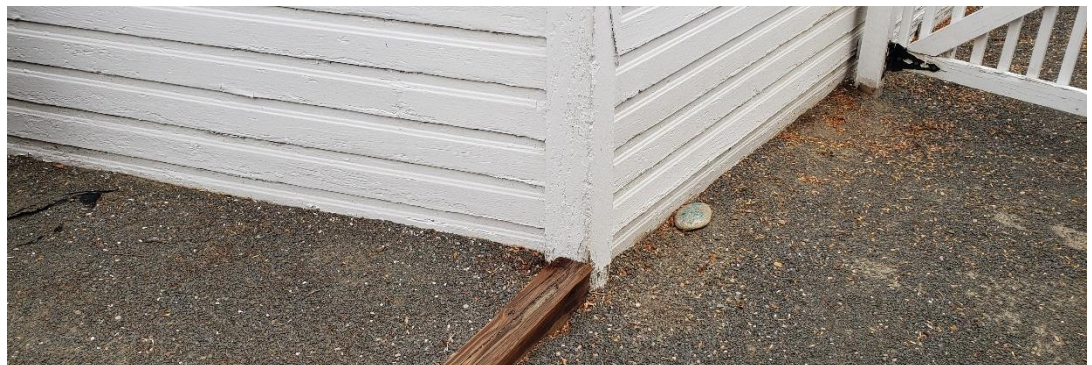
*Finish materials run beneath grade all around the south altar bay.*

The overall site grading is in poor condition. It is important that the grading around the church should be a minimum of 6 inches below the top of the foundation and slope away from the foundation for at least the first 5 feet. Due to the nature of the lot, it is difficult to meet these requirements without a large amount of regrading in addition to significant foundation repairs or replacement as outlined below.

3. Finished grade around the church perimeter should be re-graded to create positive drainage away from the foundation. The top of finished grade should be a minimum of 6 inches below the top of the foundation and slope away from the foundation for at least the first 5 feet. Coordinate slope with a licensed architect or geotechnical engineer.

4. The foundation may need to be replaced in some locations to bring the top of foundation at least six inches above finished grade, mainly at the south bay where the foundation could not be observed. Coordinate with a licensed structural engineer and a licensed geotechnical engineer.

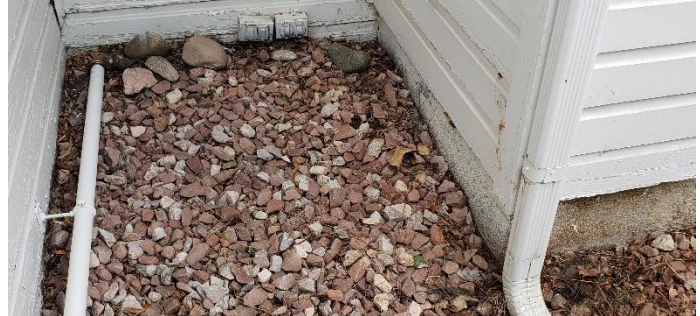
*Foundation of the 2000 addition is exposed above grade while the older foundations are not.*

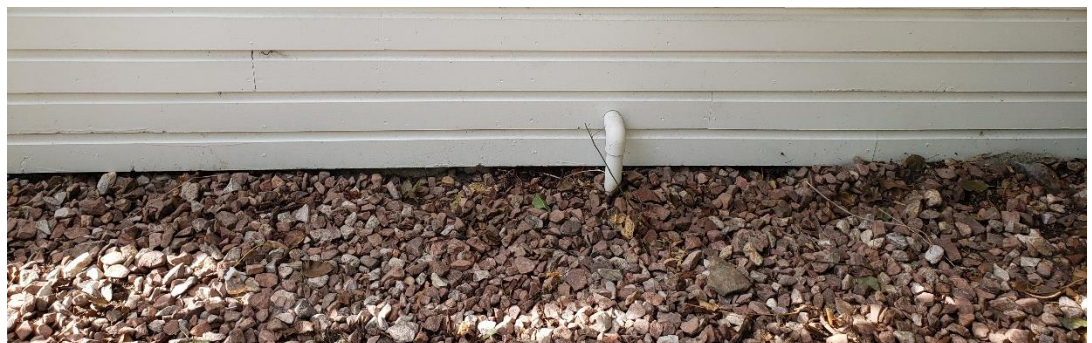
*Finish materials sit at grade making it difficult to determine the top of foundation relative to grade.*

2. The top of the foundation relative to the top of grade should be determined around the entire perimeter of the building. If the top of the foundation is determined to be at or below the existing grade, new grading should occur to bring the grade down below the top of the foundation, as prescribed by a licensed architect or structural engineer.

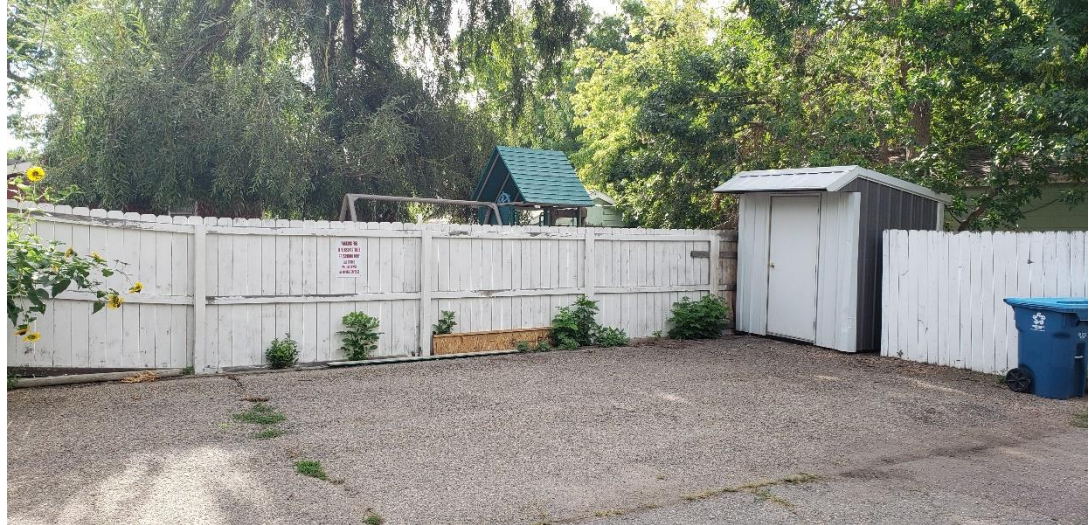
*Asphalt parking area along the west alley behind the preschool.*

Overall, the parking area along the alley appears to be in fair condition with some cracks in the asphalt paving but with adequate space to park several vehicles with turnaround clearance in the alley. Drainage in this area appears to slope minimally away from the property and towards the alley.

No recommendations at this time.

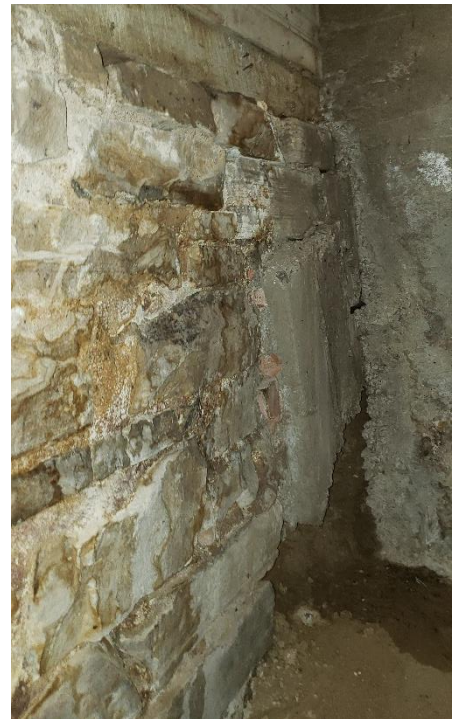
*Original stone foundation at basement access area. Water was observed in the basement during a rainstorm.*

The stacked stone foundations of the original construction and the north addition are in fair to poor condition and a large portion of the construction was not visible or discoverable without destructive testing or the removal of soil along the perimeter of the building. The top of the foundation relative to the top of grade is good on the east side of the church but diminishes as grade slopes upward going west. Additionally, it is unclear as to the size or depth of foundation footings in these areas, if any exist. The wood and 6-inch cmu walls that retain the soil between the crawlspace and basement areas are in poor condition as they do not show signs of failure or damage, but it is unlikely that the crawl space retaining walls were built to any model building codes of the time. There are also soil cut areas where there are no retaining walls present and these areas are in poor condition as the soil is not properly supported which could lead to undermining other structural elements.

1. The basement and crawlspace foundation walls showed various signs of damage that require further evaluation. No additional load should be added to the existing foundation system without a full analysis of the current foundation walls/footings. In addition, a licensed Structural Engineer and Contractor should be contracted to evaluate and repair the existing stone foundation walls. This work could include re-tuck pointing of existing stone and/or the removal and replacement with a modern concrete wall, etc.

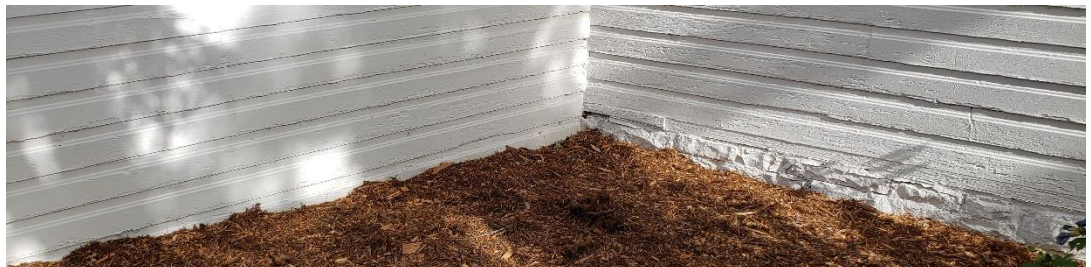
*The original stone foundation is seen from the exterior on the right. The south addition on the left does not have an exposed foundation above grade.*

The foundation of the south addition could not be determined. Based on site observations, it appears that this area has a wood foundation. The entire south bay appears to be sinking away from the main church structure, indicating a different foundation type than the stacked stone. A condition evaluation of this area cannot be performed without further intrusive investigation to determine the type of foundation. It is assumed to be in poor condition, and it is strongly encouraged to further investigate this area and remediate any failing structural elements.

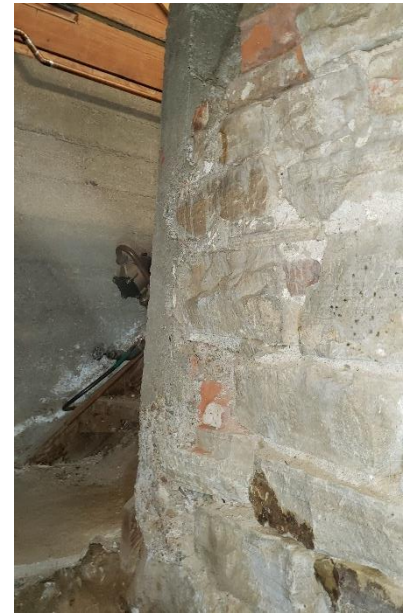
*1941 concrete foundation where it ties into the original stone foundation.*

The poured concrete foundation of the 1941 addition appears to be in good condition, though assessment of this foundation was minimal due to limited access. There is minimal crawlspace access to this area and the foundation could not be viewed from the exterior as there is an attached deck on the south side and an attached accessibility ramp on the north side obscuring the view of the foundation. Further deconstructive investigation is required to fully analyze the concrete foundation of the 1941 addition.

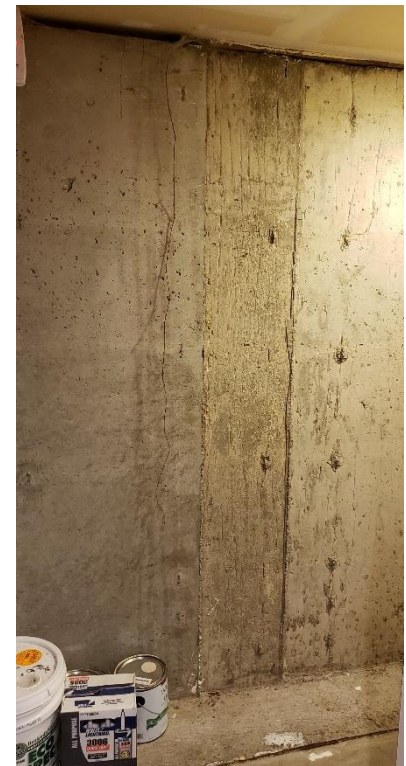
*2000 addition concrete foundation and footing that is flush with the concrete slab floor.*

The poured concrete foundation of the 2000 west addition appears to be in good condition. Assessment of this foundation is primarily from the interior of the basement as the finish siding materials run to grade on the exterior. Building records indicate that this foundation was built to local codes at the time of construction and that proper waterproofing measures were taken to reduce the risk of the top of foundation appearing to not be adequately above the top of grade. There was one area at the top of this foundation, near the bottom of the access stairs, where plant roots or vines were seen growing into the basement. This could indicate poor drainage near the north side entrance. However, the remainder of the basement was unfinished, and no areas of water infiltration were observed even though one of the site visits occurred during a significant rain event.

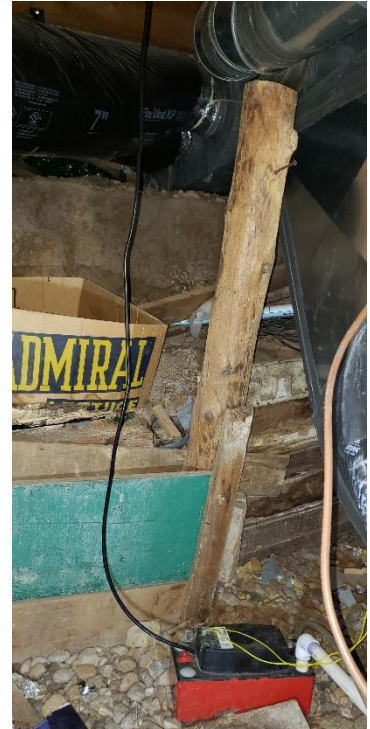
*Various materials have been used to brace the cut soil.*

4. The transition from shallow crawl space to deeper crawl space should be evaluated by a structural engineer. Repair could be necessary to replace the existing retaining systems with new poured concrete retaining walls. The soil cut portion should be temporarily braced until a retaining wall can be designed and built.

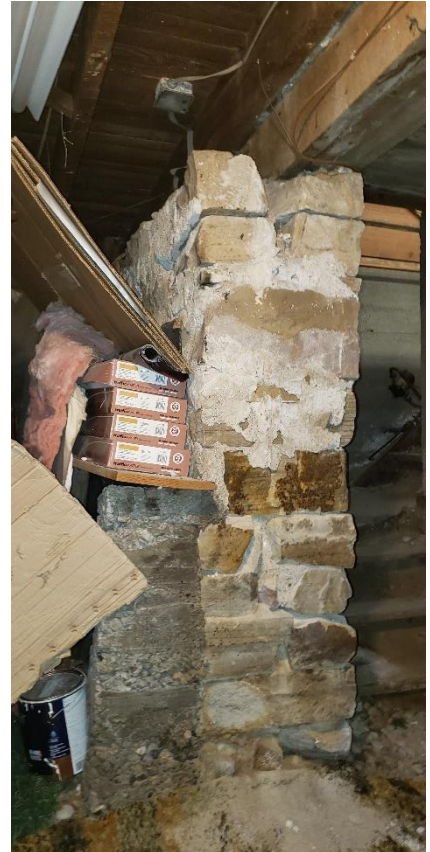
*Stacked stone beam support in basement.*

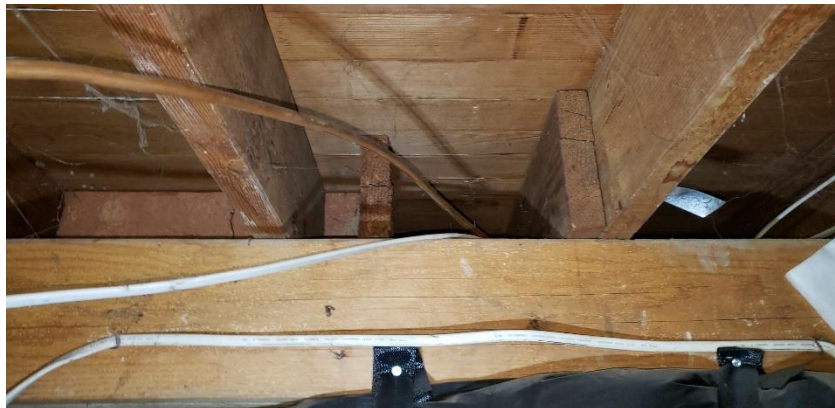
*Spliced floor joists on a support beam in the 1941 addition.*

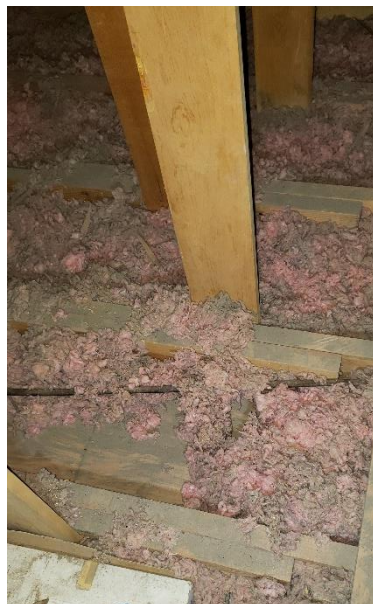
*Ceiling joists of the 1941 addition are spliced mid-span and unsupported.*

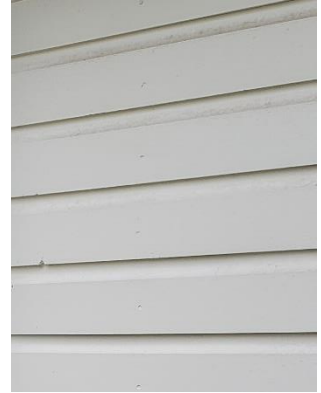
The wood or composite siding on the 2000 addition is generally in good condition. However, the siding is at or near grade at most locations exposing it to potential water damage. Additionally, where exterior walls meet lower roof pitches, the siding was installed too close to the finish roofing and therefore water damage to the cut ends of the siding was observed.

*Dutch cove profile siding used in the 2000 addition.*

1. The siding on the entire structure except for the 2000 addition should be scraped, repaired, refinished, or replaced as necessary.
2. The siding of the 2000 addition should be further evaluated for water damage at the base of the siding where it is near or at grade. Replace any damaged boards.
3. The siding of the 2000 addition, where the exterior walls meet lower roof aspects, should be replaced. The siding should be held off the top of the roof shingles by 4 inches. The step flashing beneath may need to be replaced or modified and painted to match the siding.

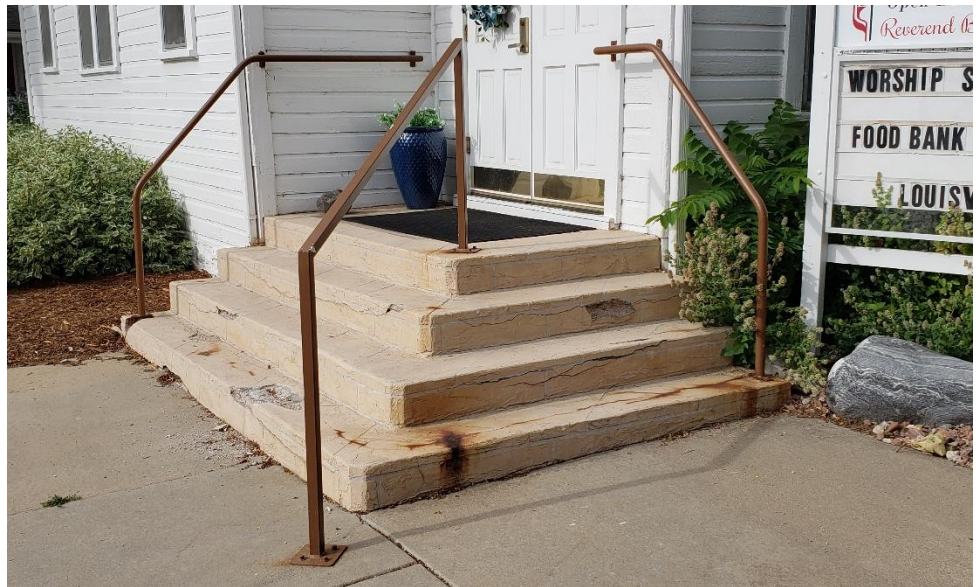
*Stairs to the front entrance are cracked throughout and beyond their expected lifespan.*

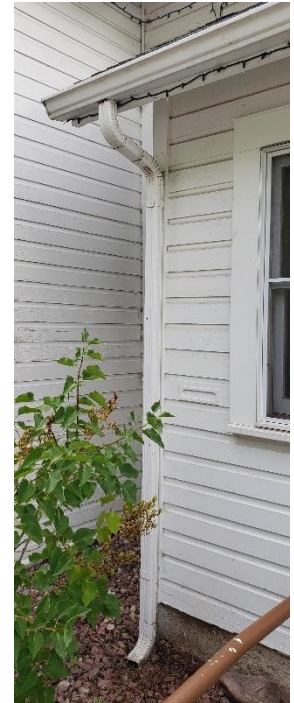
*K-style gutter and 2x3 downspout typical of entire building. Not all downspouts have extensions.*

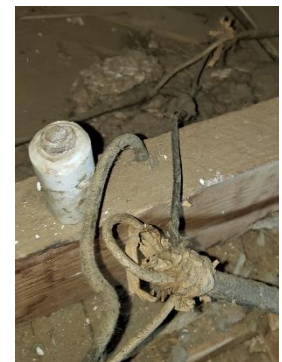
*Knob-and-tube wiring seen in the bell tower.*
