***Historic Preservation Commission
Agenda***

November 21, 2016

Historic Preservation Commission Meeting Minutes

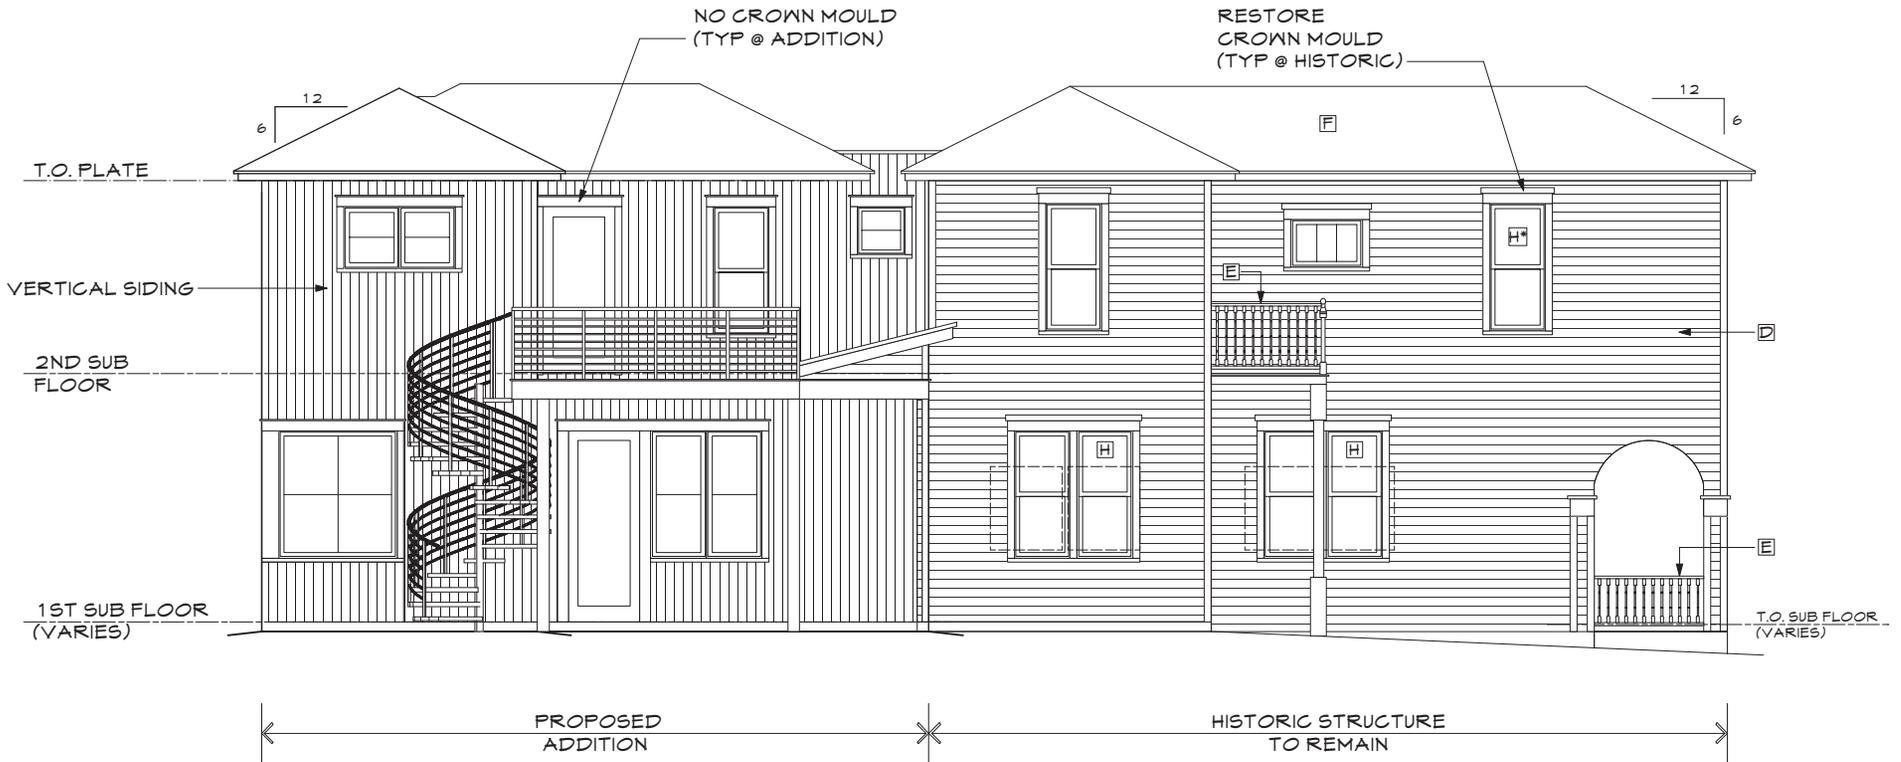
PROPOSED SOUTH ELEVATION
1/8"=1'-0"

- REMOVE ALUMN SIDING. REPAIR HISTORIC WOOD SIDING & TRIM.
- REMOVE NON-HISTORIC RAILING-NEW RAILING TO MATCH HISTORIC PHOTOS.
- NEW ASPHALT SHINGLE ROOFING.
- REMOVE NON-HISTORIC WINDOWS, NEW WINDOWS OF PROPER PORPORTION.
- NEW WINDOW IN ORIGINAL OPENING.

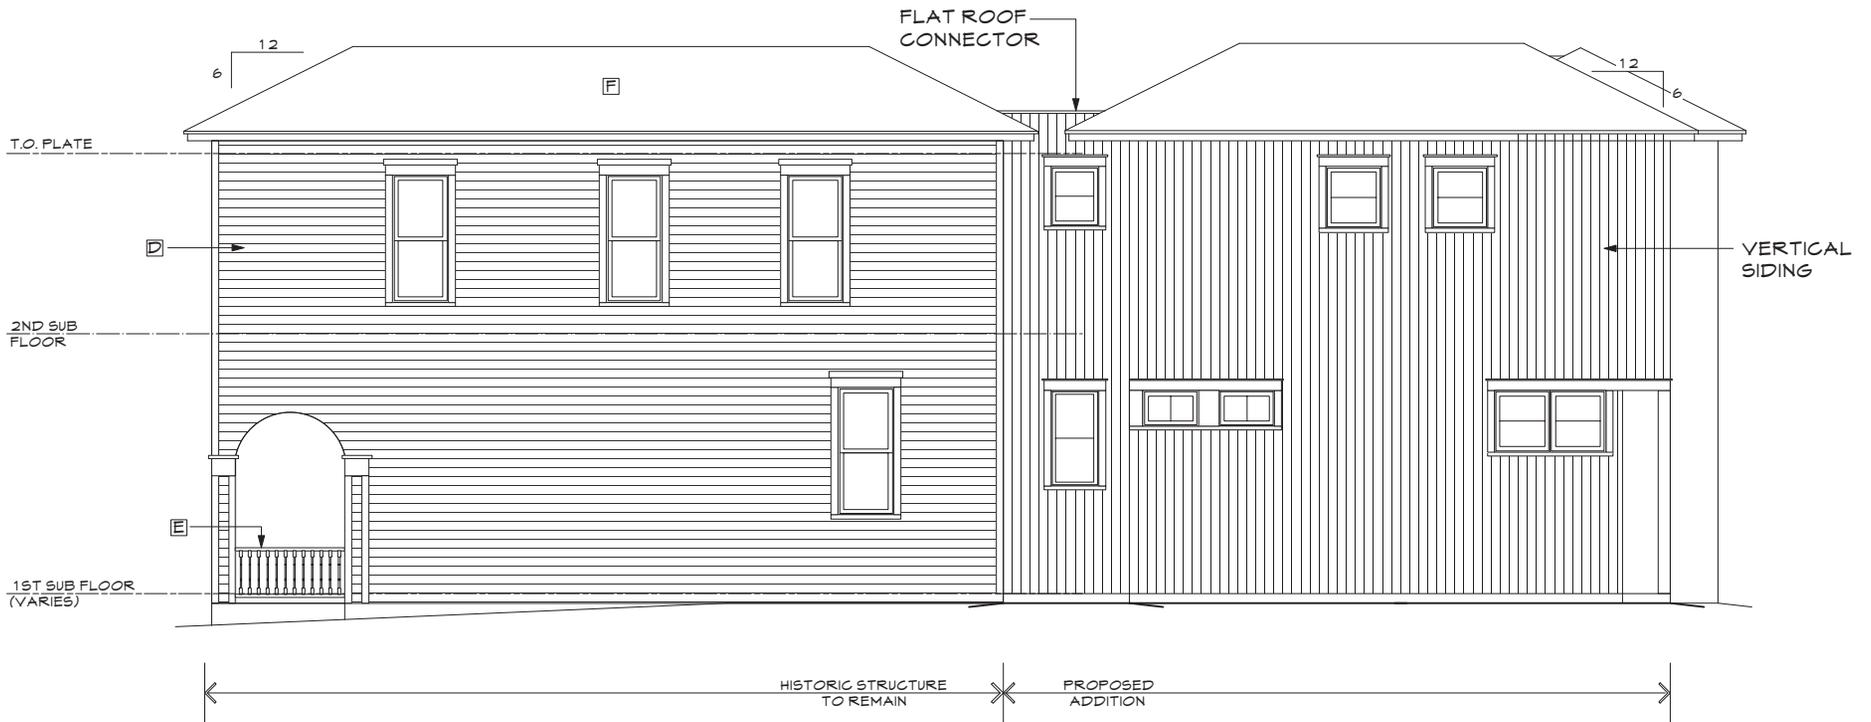
PROPOSED NORTH ELEVATION
1/8"=1'-0"

- REMOVE ALUMN SIDING. REPAIR HISTORIC WOOD SIDING & TRIM.
- REMOVE NON-HISTORIC RAILING-NEW RAILING TO MATCH HISTORIC PHOTOS.
- NEW ASPHALT SHINGLE ROOFING.

HISTORIC STRUCTURE
 [E] EXCAVATION AND NEW FOUNDATION WORK.

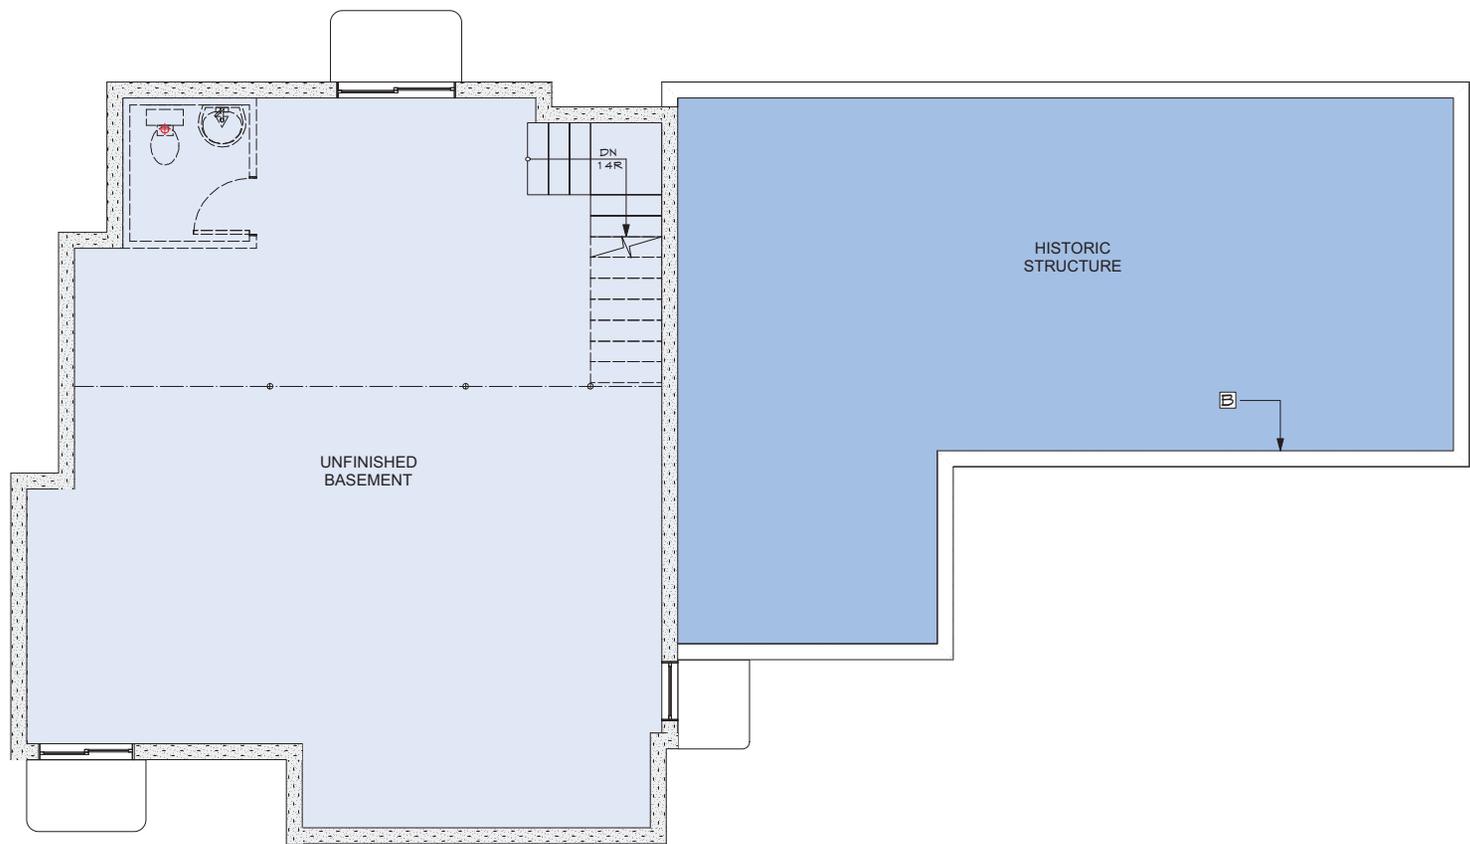
PROPOSED BASEMENT FLOOR PLAN
 1/8" = 1'-0"

← PROPOSED ADDITION | HISTORIC STRUCTURE TO REMAIN →

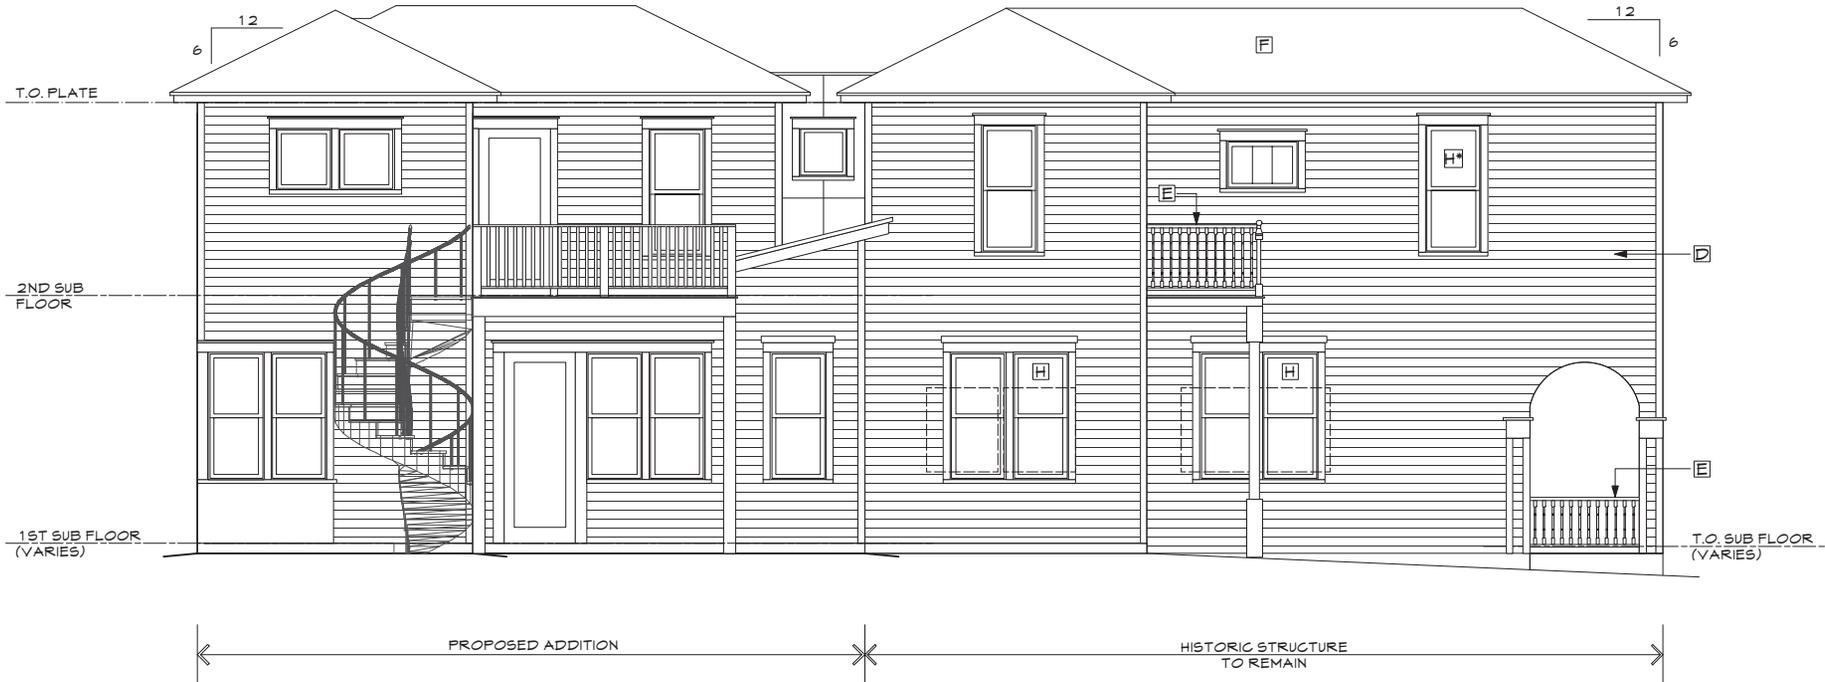
PROPOSED SOUTH ELEVATION
1/8" = 1'-0"

- REMOVE ALUMN SIDING. REPAIR HISTORIC WOOD SIDING & TRIM.
- REMOVE NON-HISTORIC RAILING-NEW RAILING TO MATCH HISTORIC PHOTOS.
- NEW ASPHALT SHINGLE ROOFING.
- REMOVE NON-HISTORIC WINDOWS, NEW WINDOWS OF PROPER PROPORTION.
- NEW WINDOW IN ORIGINAL OPENING.

ADDITION
ASPHALT SHINGLE ROOF.
FIBER CEMENT SIDING & PANELS.
PROPORTIONAL WINDOWS.

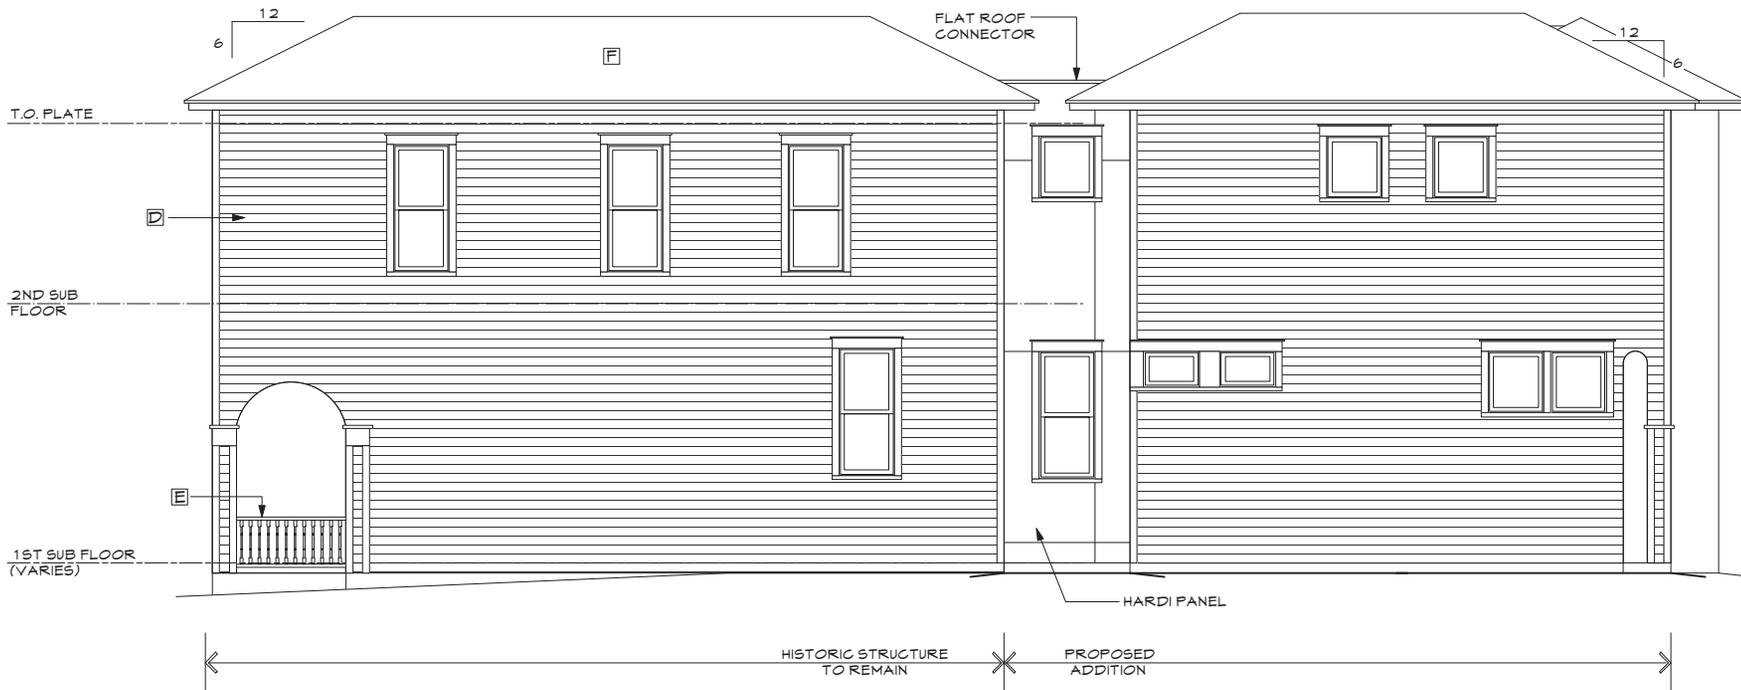
PROPOSED NORTH ELEVATION
1/8" = 1'-0"

- ASPHALT SHINGLE ROOF.
- FIBER CEMENT SIDING & PANELS.
- PROPORTIONAL WINDOWS.

HISTORIC STRUCTURE
[B] EXCAVATION AND NEW FOUNDATION WORK.

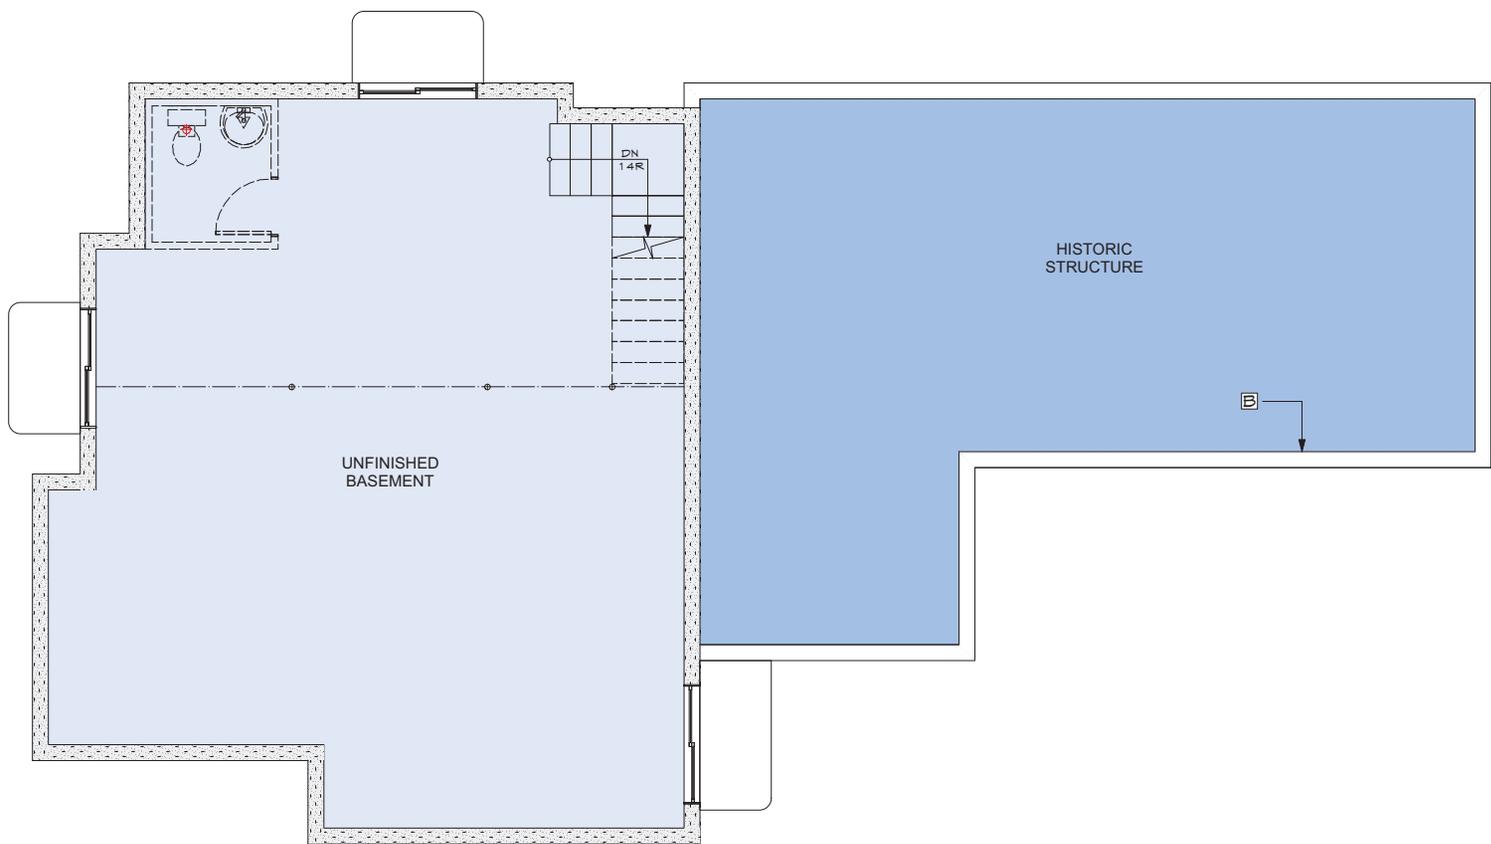
PROPOSED BASEMENT FLOOR PLAN
1/8" = 1'-0"

← PROPOSED ADDITION | HISTORIC STRUCTURE TO REMAIN →

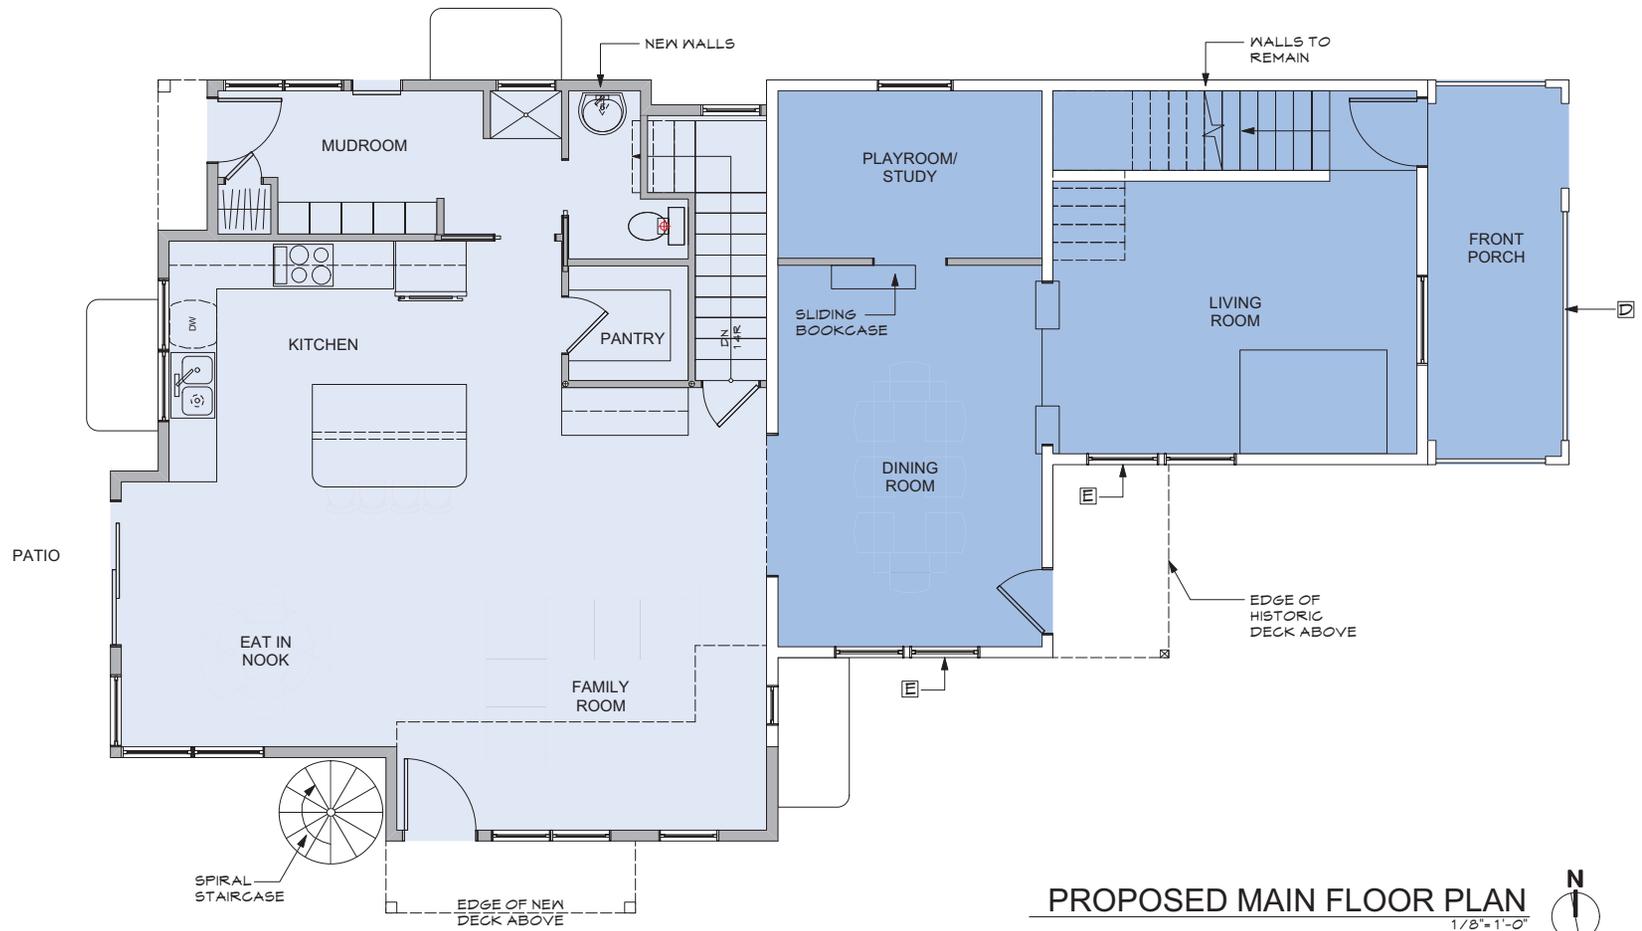
PROPOSED MAIN FLOOR PLAN
1/8" = 1'-0"

← HISTORIC STRUCTURE TO REMAIN PROPOSED ADDITION →

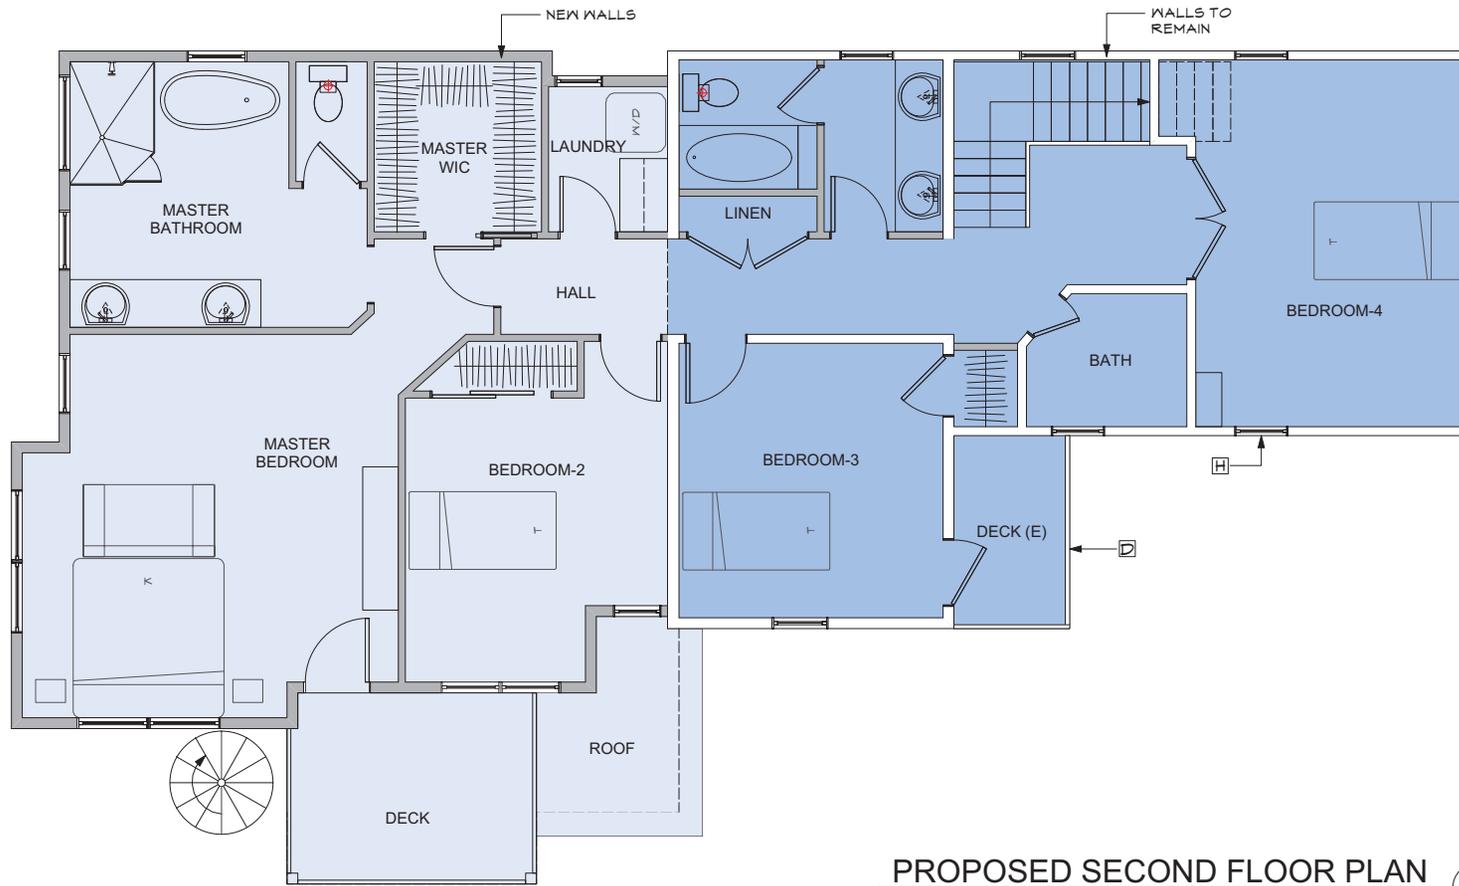
PROPOSED SECOND FLOOR PLAN
1/8" = 1'-0"

- REMOVE NON-HISTORIC RAILING-NEW RAILING TO MATCH HISTORIC PHOTOS.
- NEW WINDOW IN ORIGINAL OPENING.

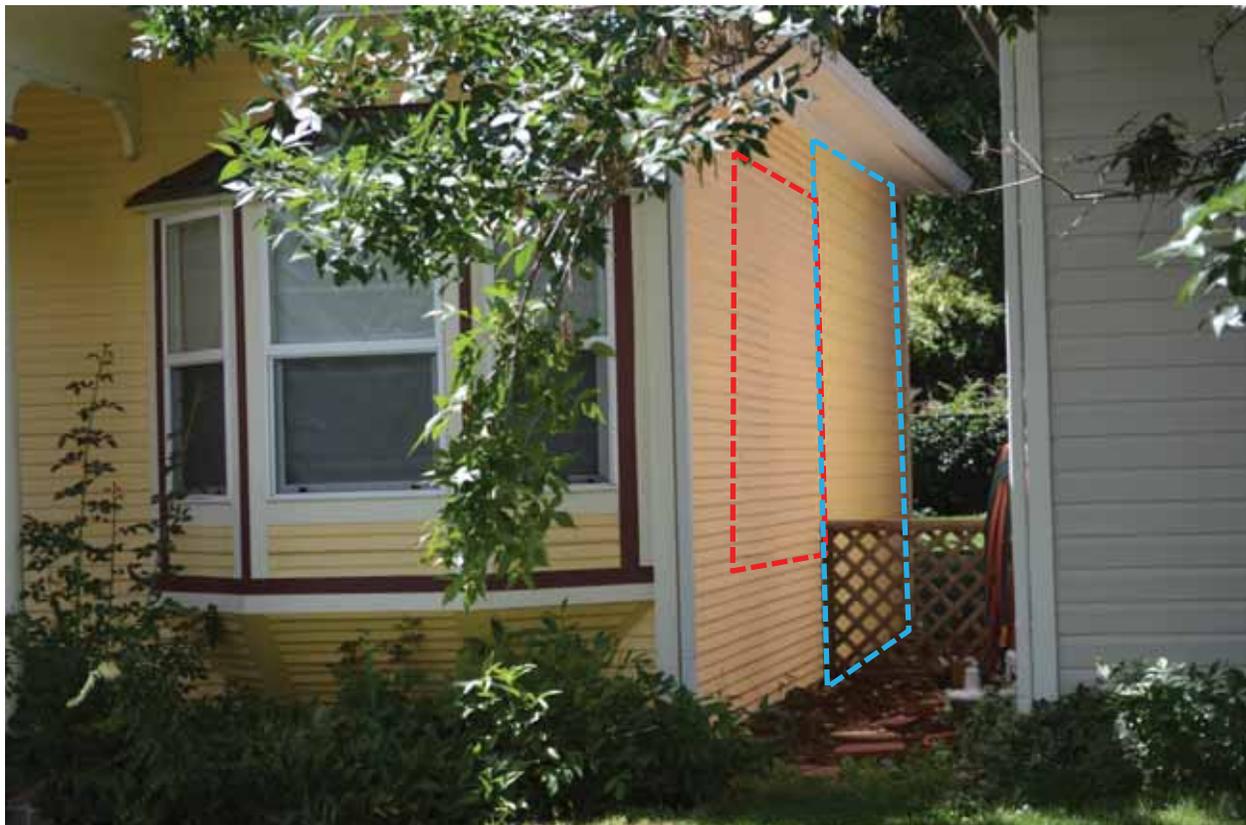
625 Lincoln Avenue – Ghost Window and Passageway on North Elevation

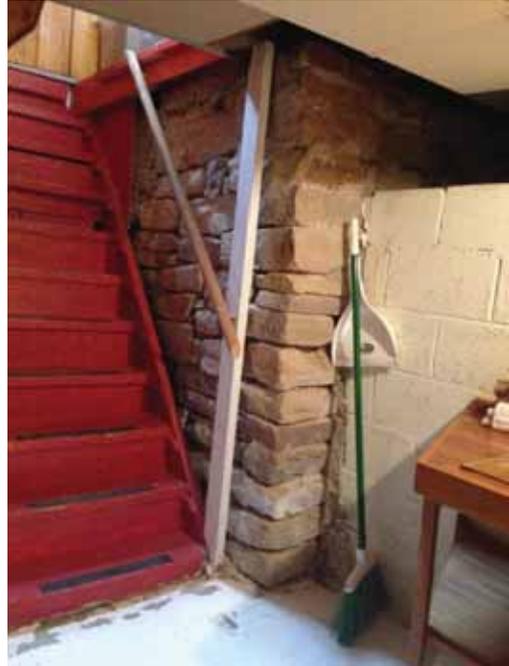
Original stone foundation from crawlspace.

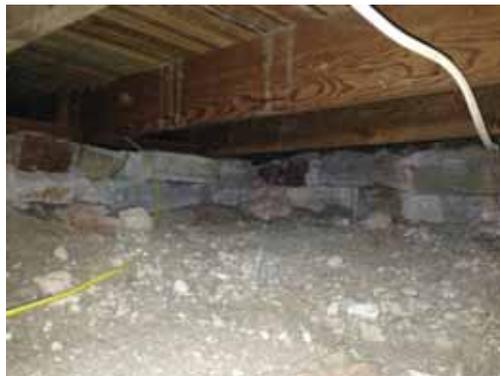
Detail of floor framing in crawlspace showing original stone foundation at mid-span support.

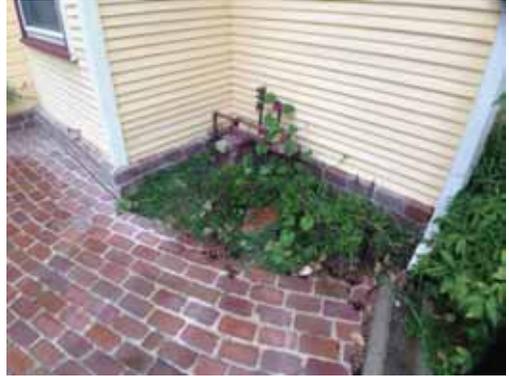
Detail of brick-clad foundation on the south elevation.

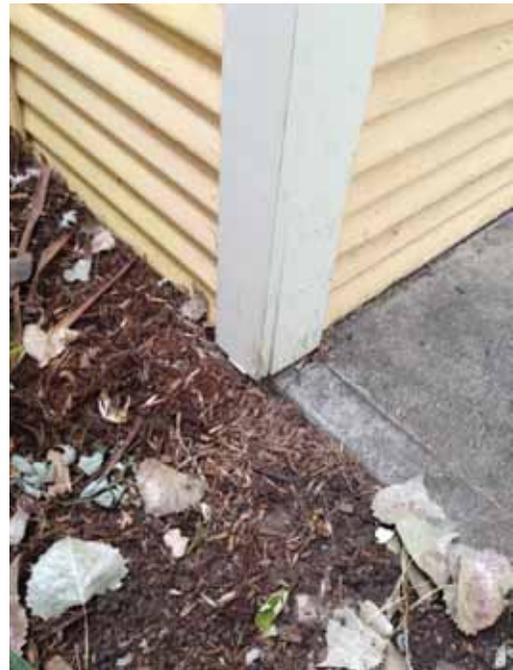
Detail of grading at the southwest corner of the house.

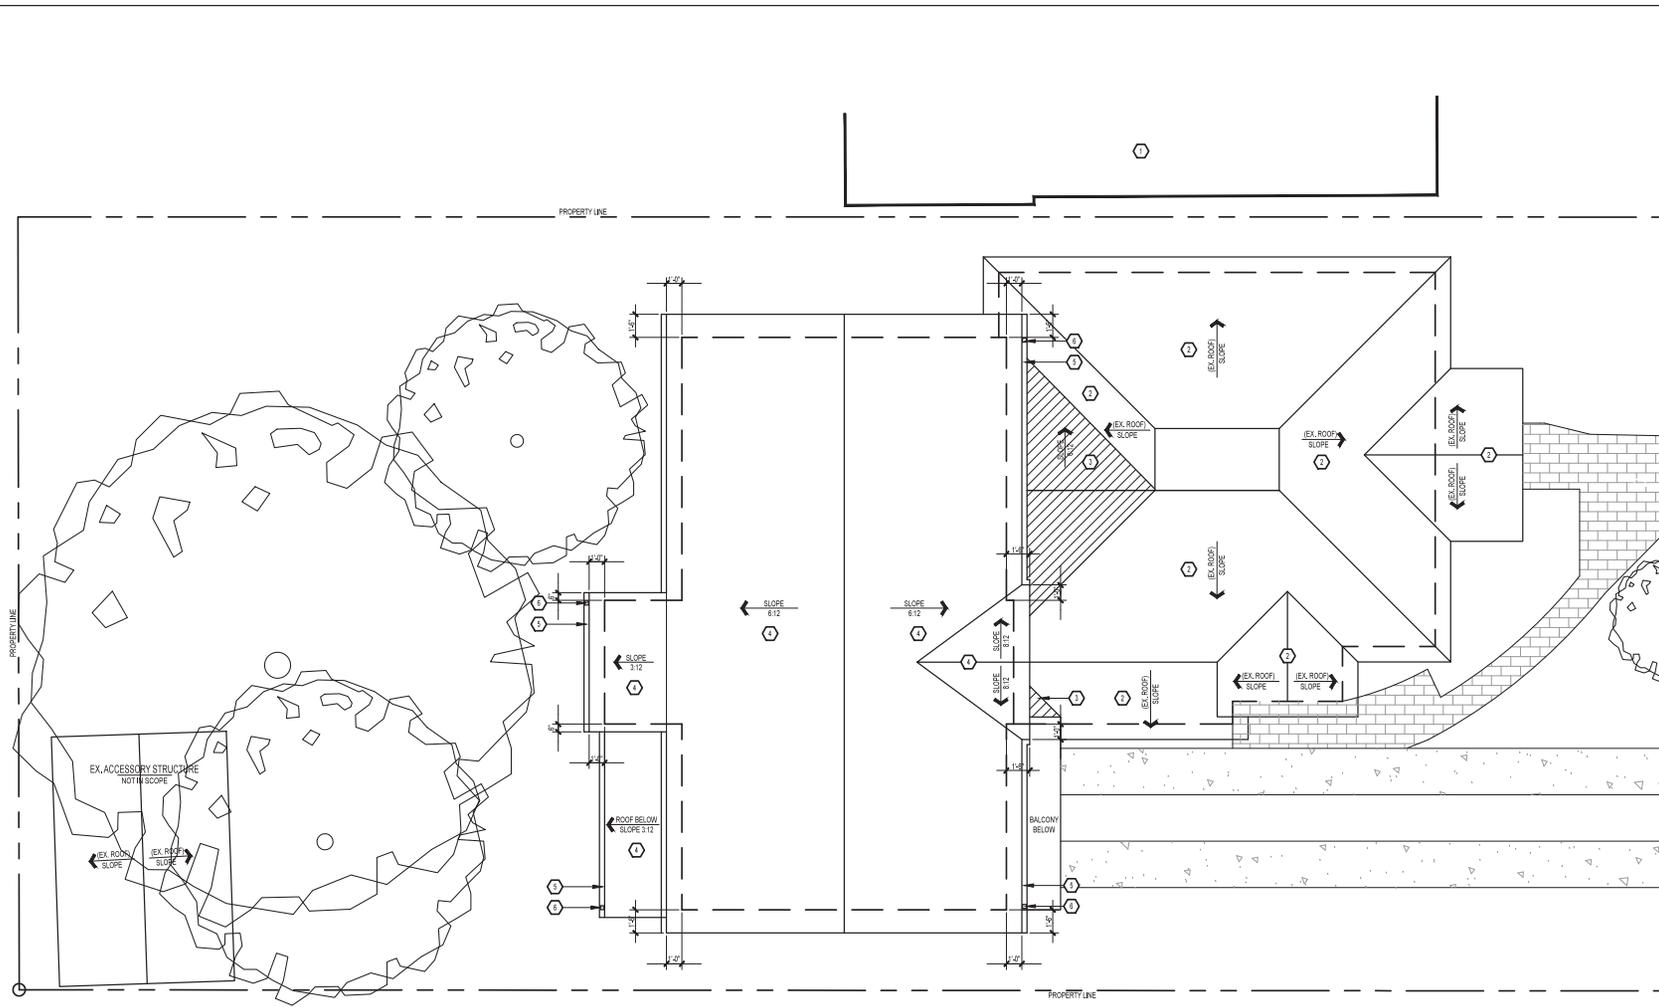
- ### KEY NOTES
1. EXISTING NEIGHBORING STRUCTURE
 2. EXISTING ROOF STRUCTURE, NEW ASPHALT SHINGLES, TO MATCH EXISTING
 3. NEW OVER FRAMED ROOF STRUCTURE, ASPHALT SHINGLES TO MATCH EXISTING
 4. NEW ROOF STRUCTURE, ASPHALT SHINGLES TO MATCH EXISTING
 5. NEW GUTTER, TO MATCH EXISTING
 6. NEW DOWNSPOUT, TO MATCH EXISTING

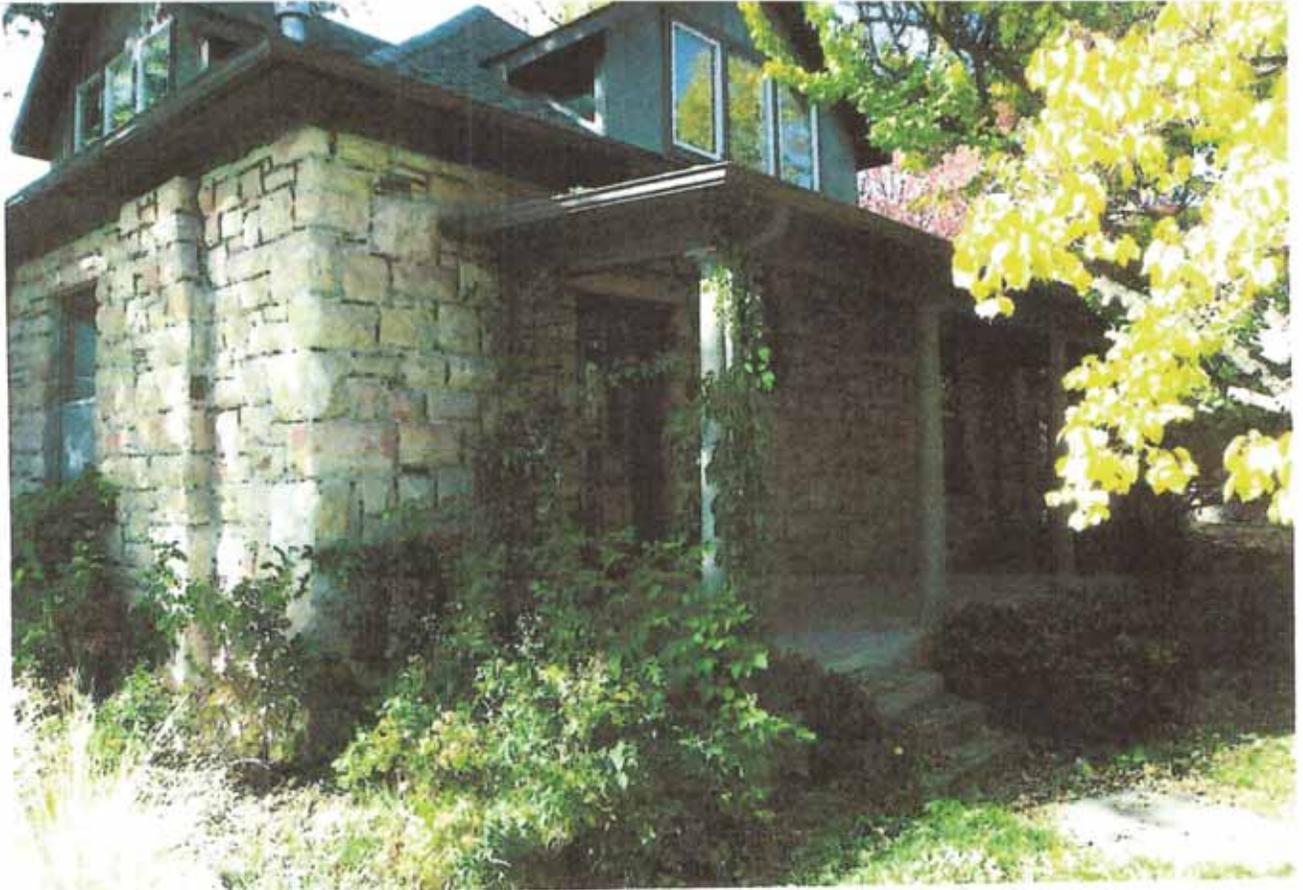
STONE REPAIR - S.E. CORNER

STONE REPAIR - N.W. CORNER

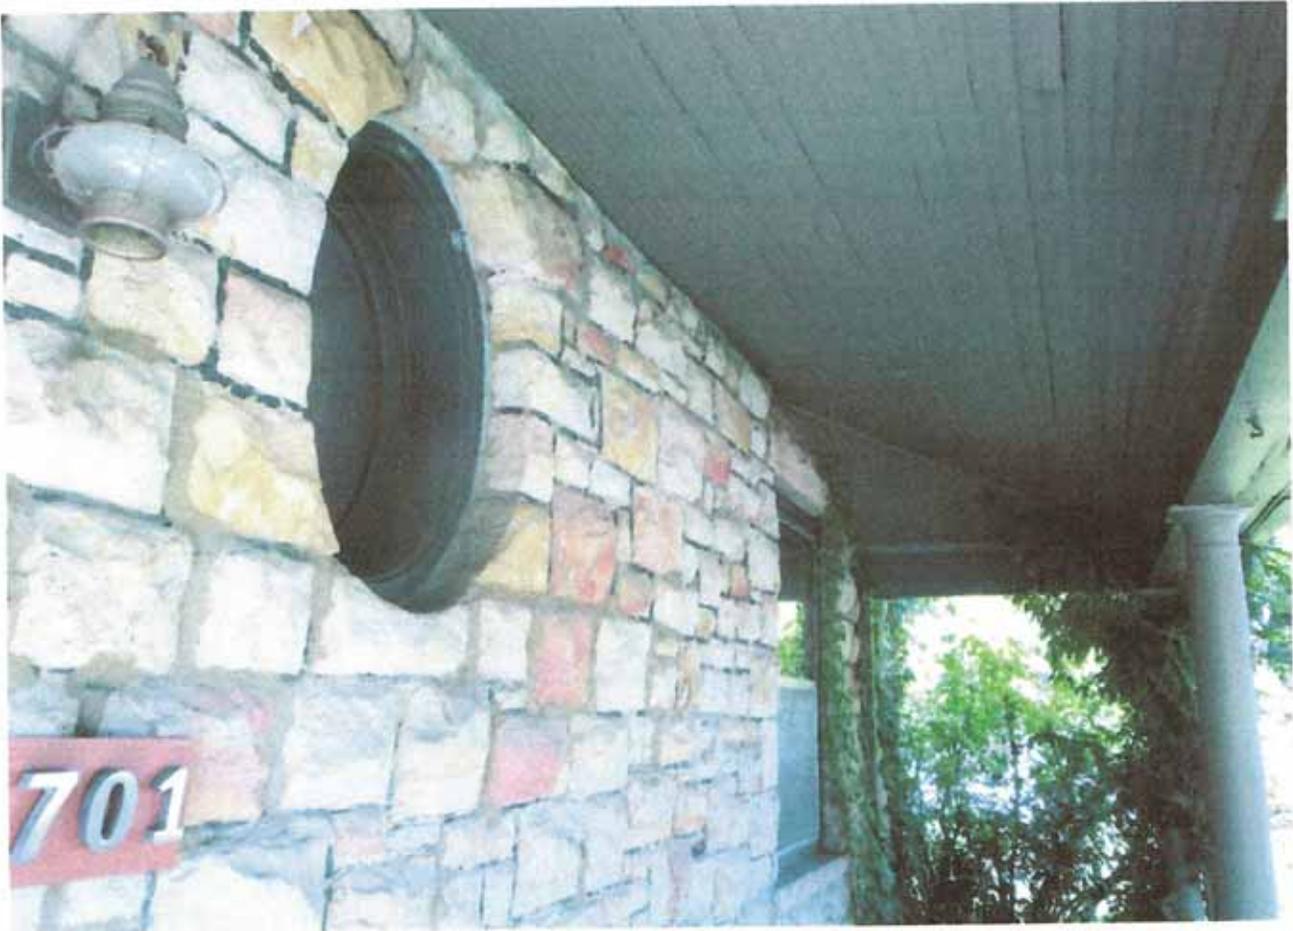
STONE REPAIR - EAST WALL & ENTRY

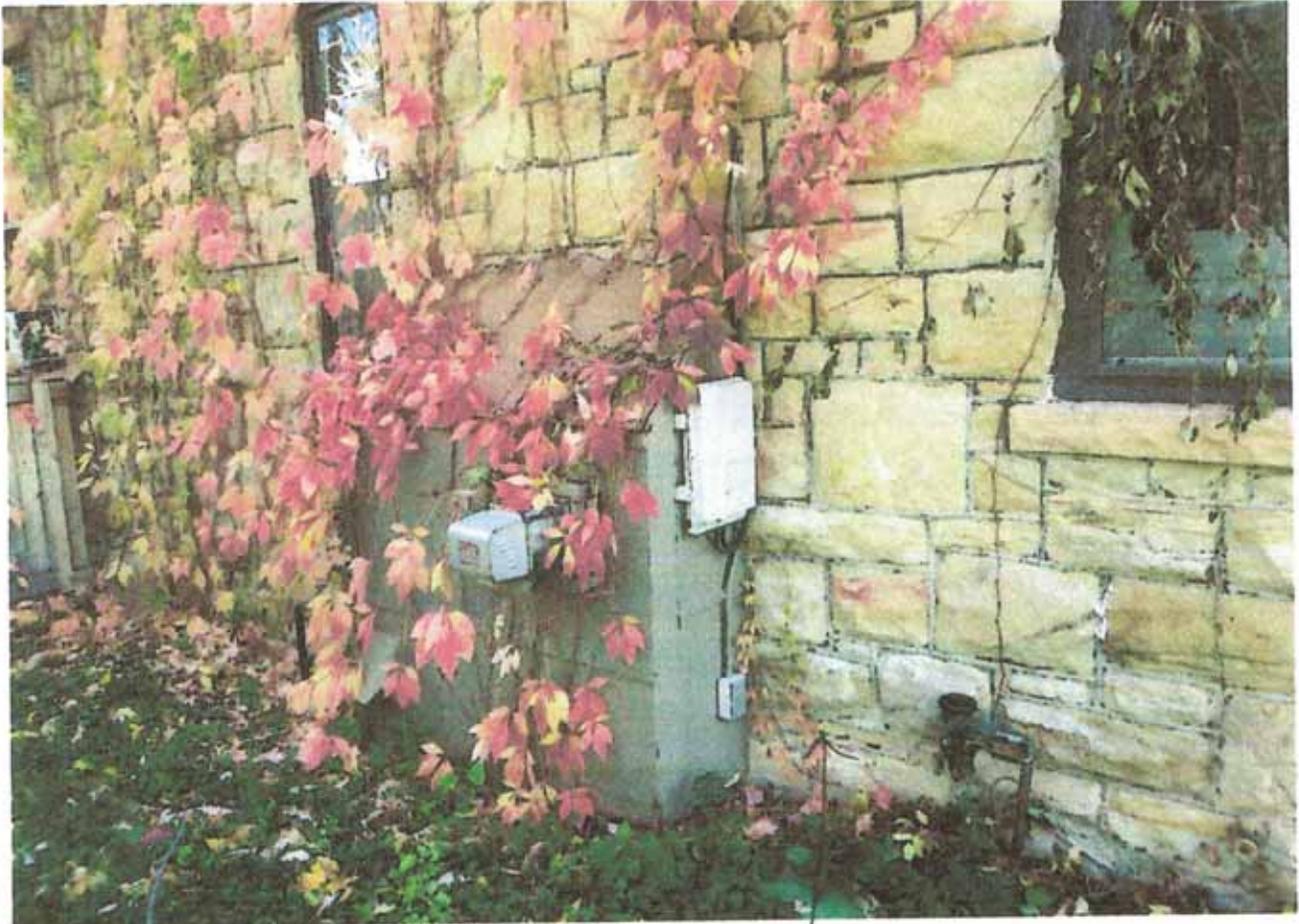
STONE REPAIR - NORTH WALL

STONE REPAIR - SOUTH BASEMENT WINDOW
