## ***Historic Preservation Commission***

### ***Agenda***

**July 18, 2016**

HISTORIC BUILDING CONDITION ASSESSMENT  
OF  
725 LINCOLN AVENUE, LOUISVILLE, COLORADO

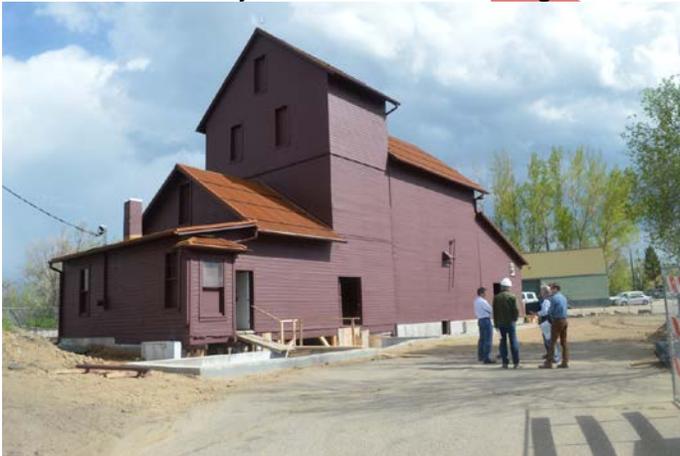
Looking at it today, it is not quite the same vision. We can all agree that after getting this far with the structure stabilization, repairing the envelope, the roof, the walls, and the siding, it is really important to protect the structure from damage in the future. We need to make sure we have a safe electrical system, a fire sprinkler system, and a fire alarm system. If this does remain a vacant shell, those would be the minimum things to protect the structure in the future. We feel they are important.

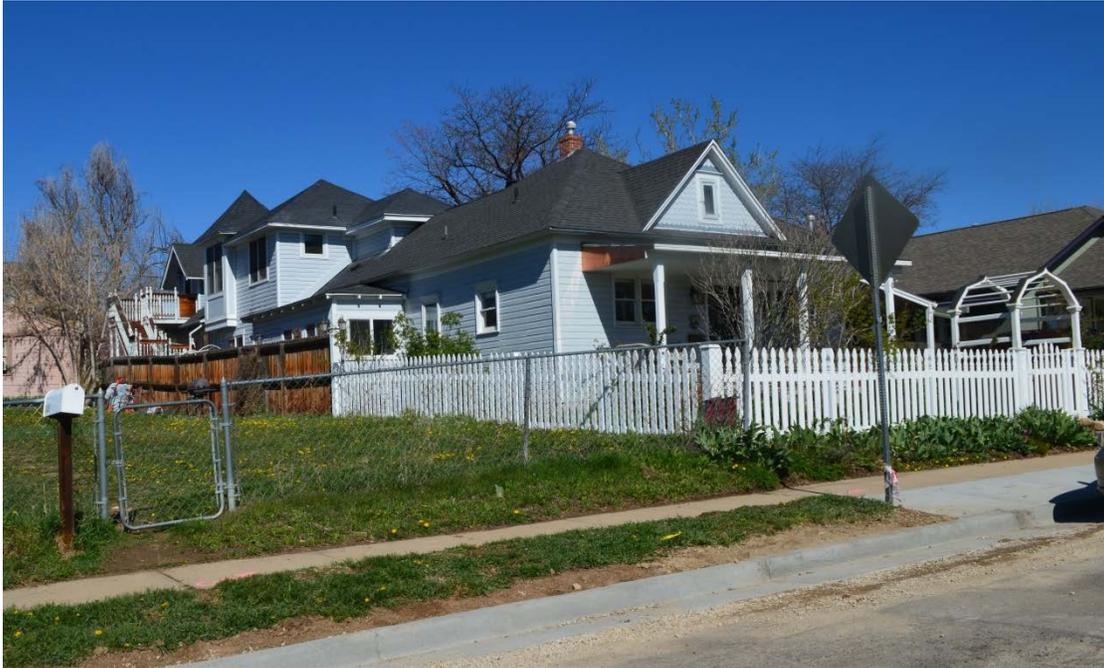
*1129 Jefferson Avenue Southeast Corner - Current Photo*

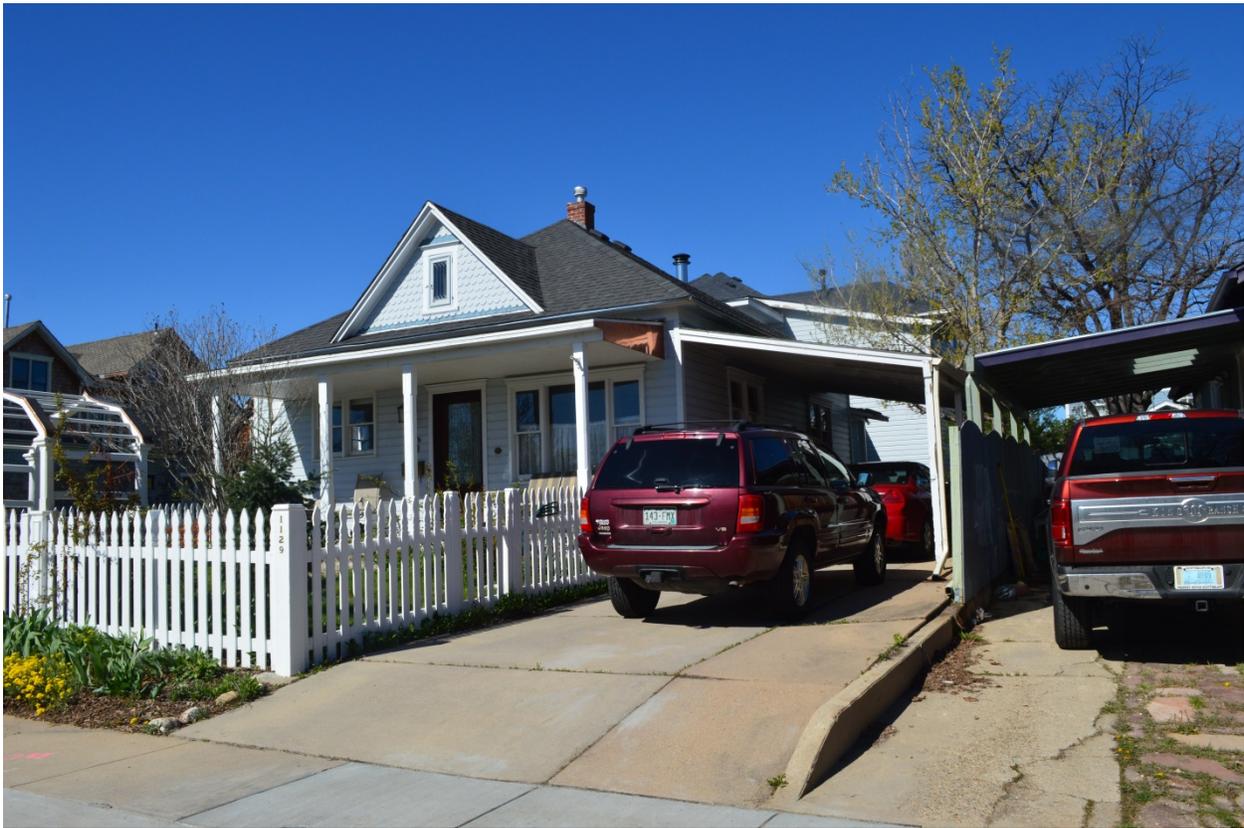
*1129 Jefferson Avenue Northeast Corner - Current Photo*

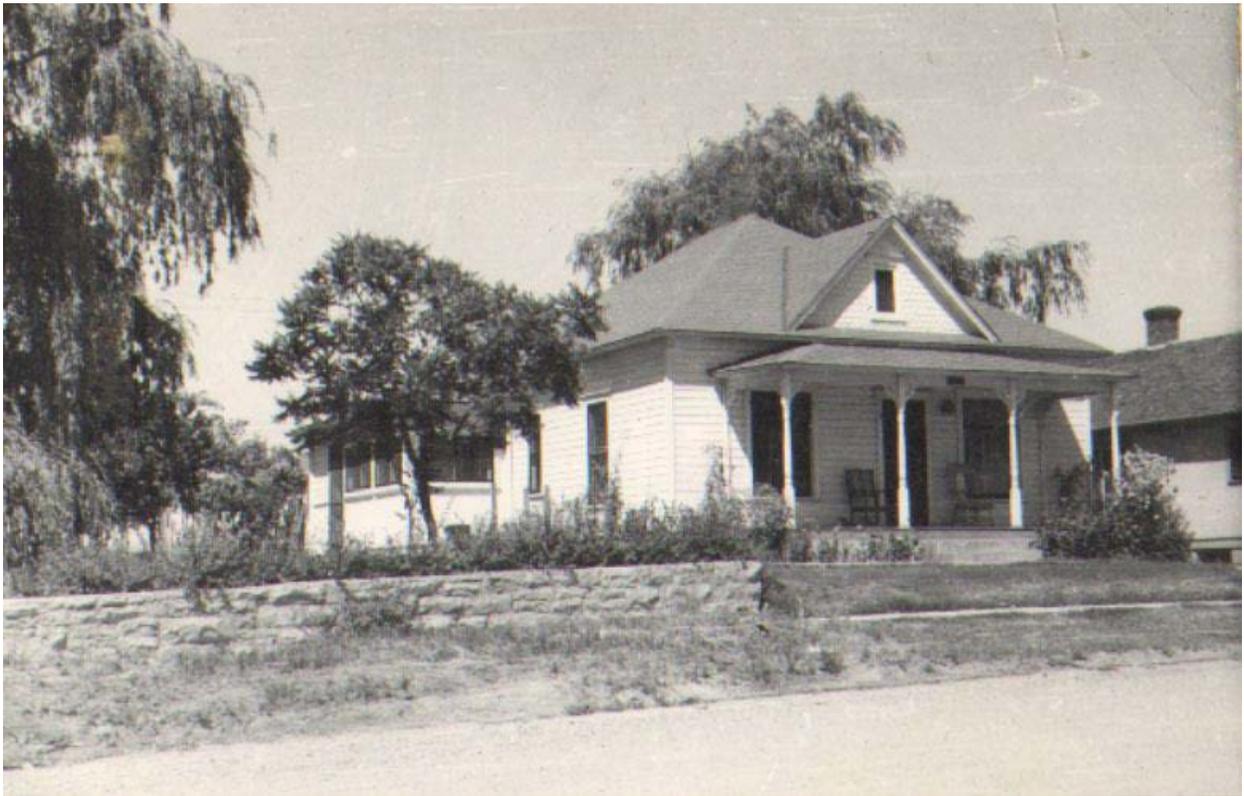
*1129 Jefferson Avenue – 1948 Assessor Photo*

The rectangular vernacular structure has elements of the Victorian style. The hipped-roof structure is clad in wood siding. The full front porch has a shed roof and chamfered porch supports. In 1948 the structure also had a full front porch, however, the porch roof was hipped and the supports were turned with decorative, Victorian style bracketing. According to the current owners, the front porch was replaced in the 1960s and they constructed the current porch after they bought the house in 1999. A gabled dormer is centered on the roof. The gable end holds a small casement window and is filled with wooden, fish scale shingles. The dormer, window and shingles appear in the 1948 photo. There is an enclosed side porch on the south elevation which also appears in the 1948 photo. A notation that a County Assessor representative made on the Assessor card in 1956 stated that the house was quite improved inside, with some new windows and door. The ghost of one of the larger original windows is evident on the south elevation. A carport is located on the north elevation.

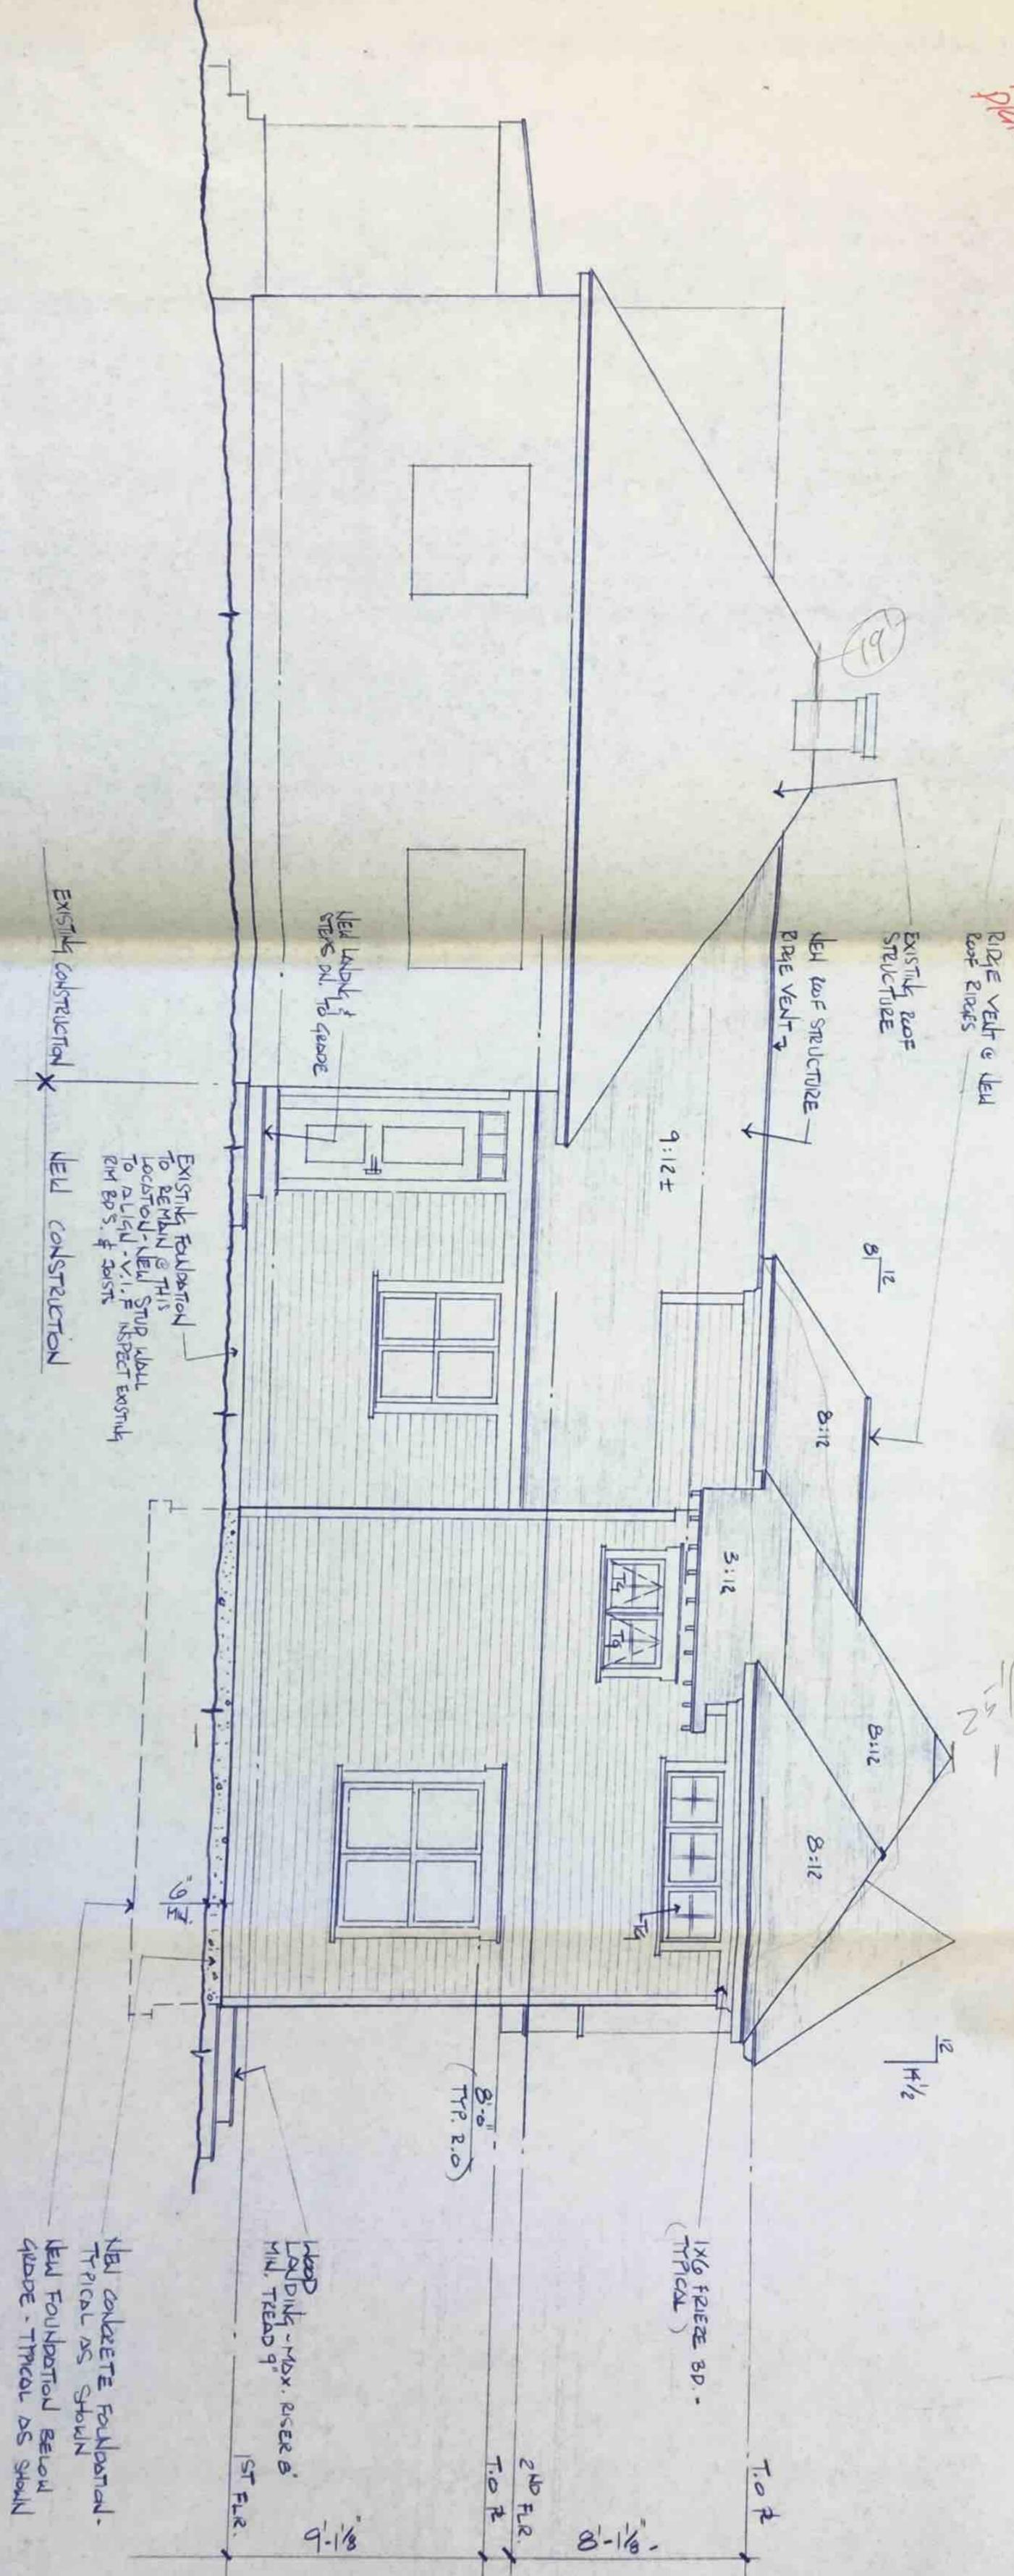
**NORTH ELEVATION**

NEW CONCRETE FOUNDATION - TYPICAL AS SHOWN  
NEW FOUNDATION BELOW GRADE - TYPICAL AS SHOWN

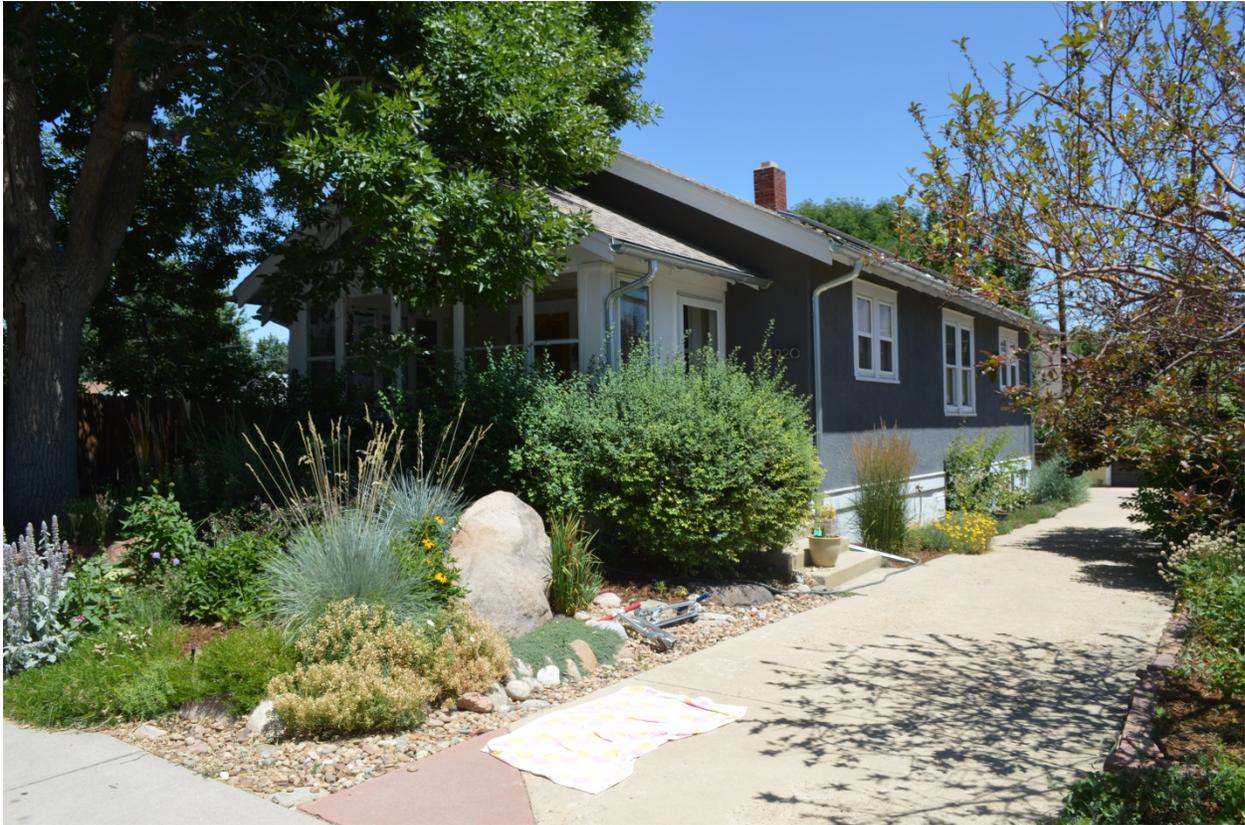
*920 Lincoln Avenue Southwest Corner - Current Photo*

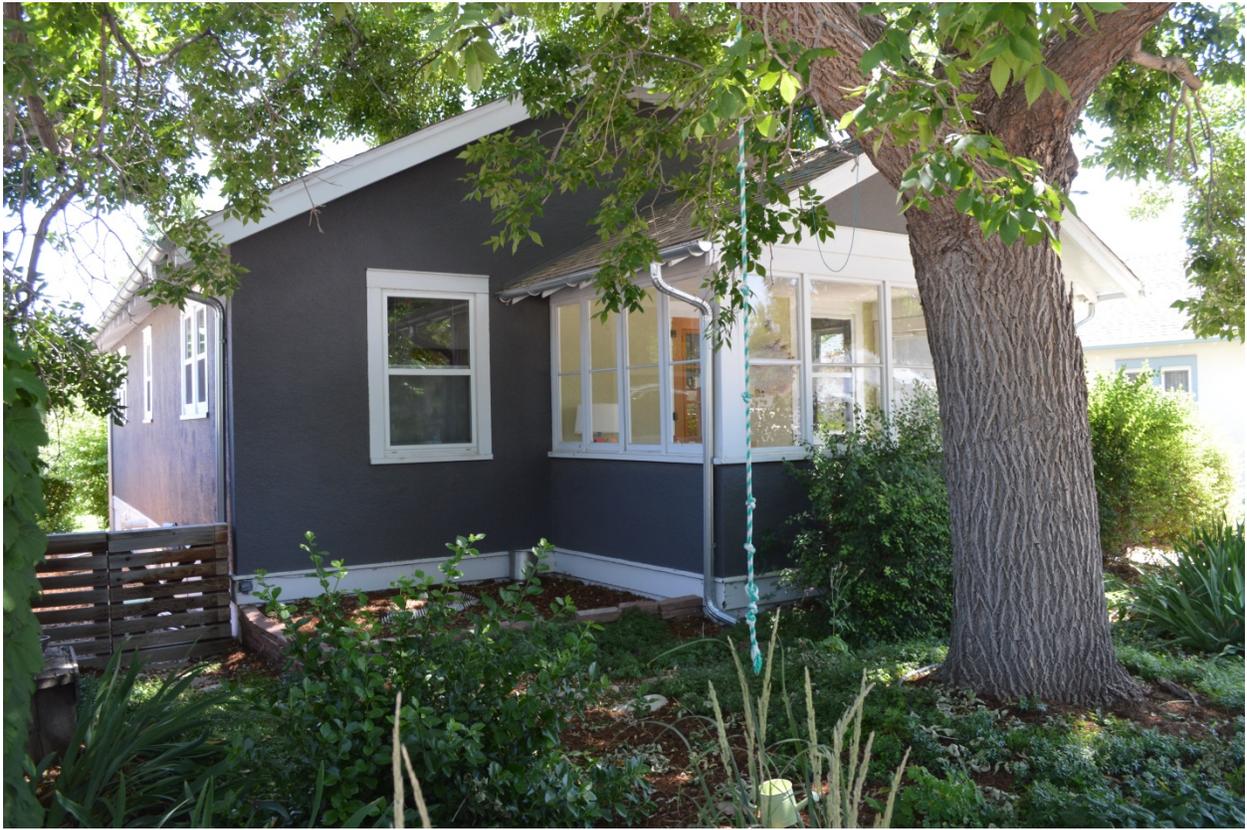
*920 Lincoln Avenue Northwest Corner - Current Photo*

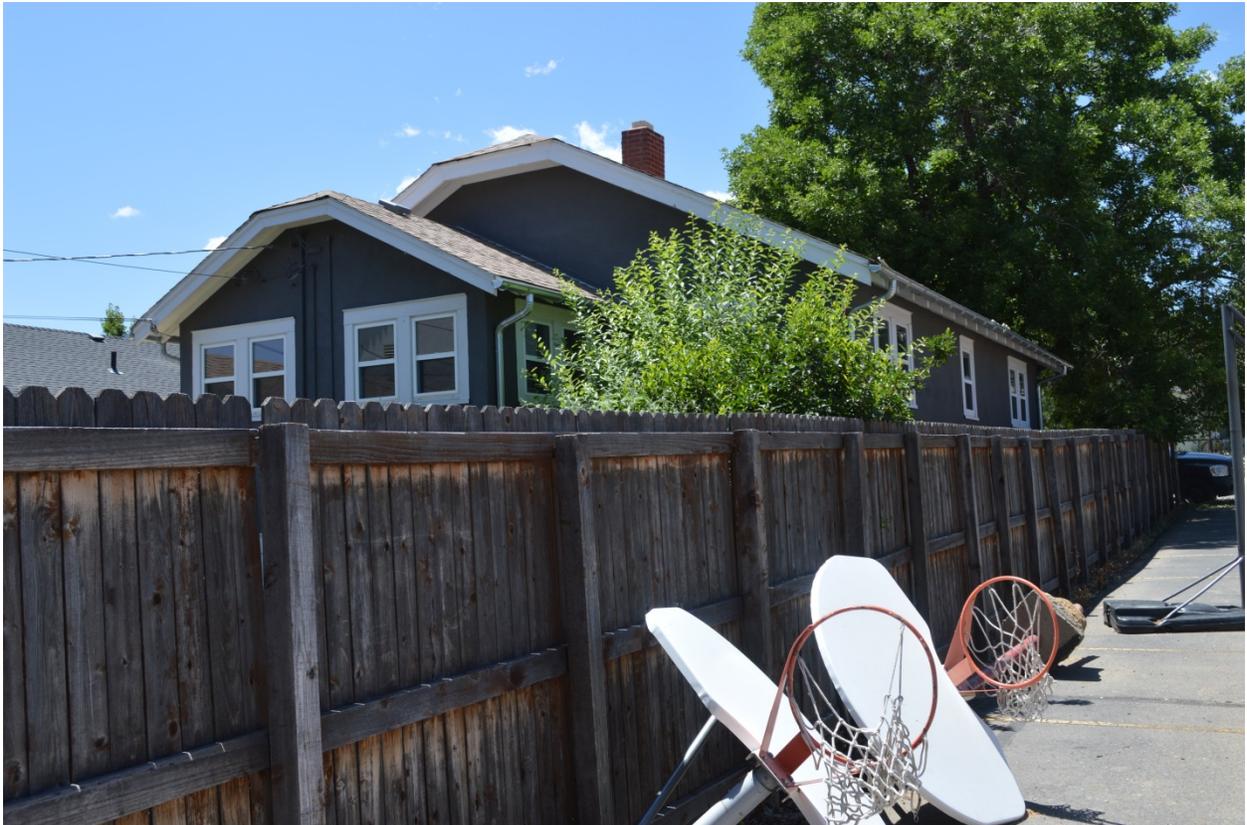
*920 Lincoln Avenue Northeast Corner - Current Photo*

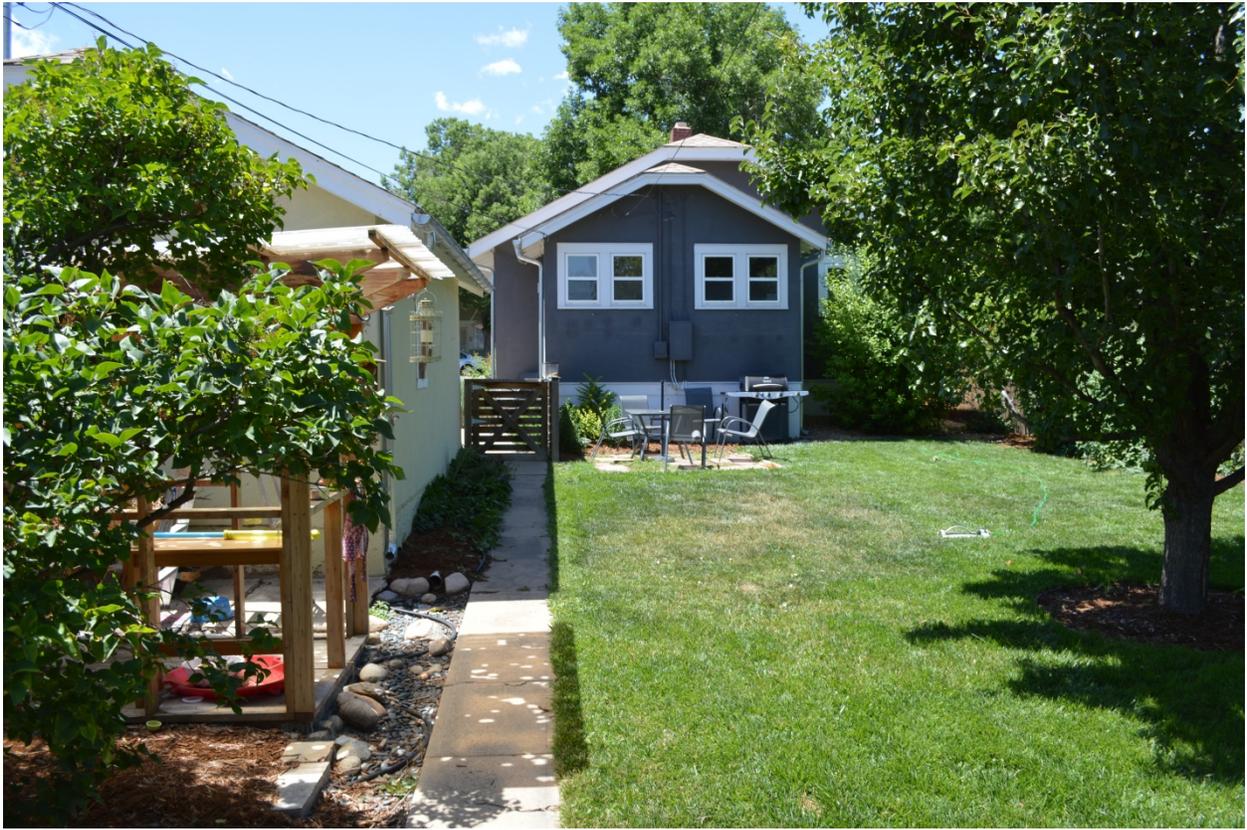
*920 Lincoln Avenue – East Elevation - Current Photo*

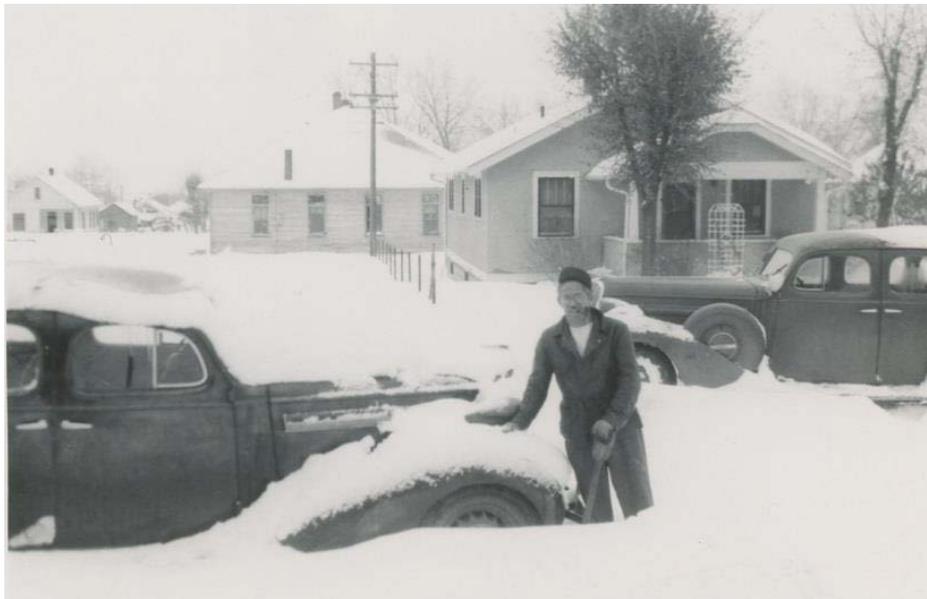
*920 Lincoln Avenue – 1940s Photo*

The windows openings appear to be the same but the windows were replaced with smaller frames after 1948. This can be seen in the 1940s photo which shows a 4/1 double-hung wood window in the northernmost bay on the front façade. The current windows in the structure are 1/1, double-hung windows.

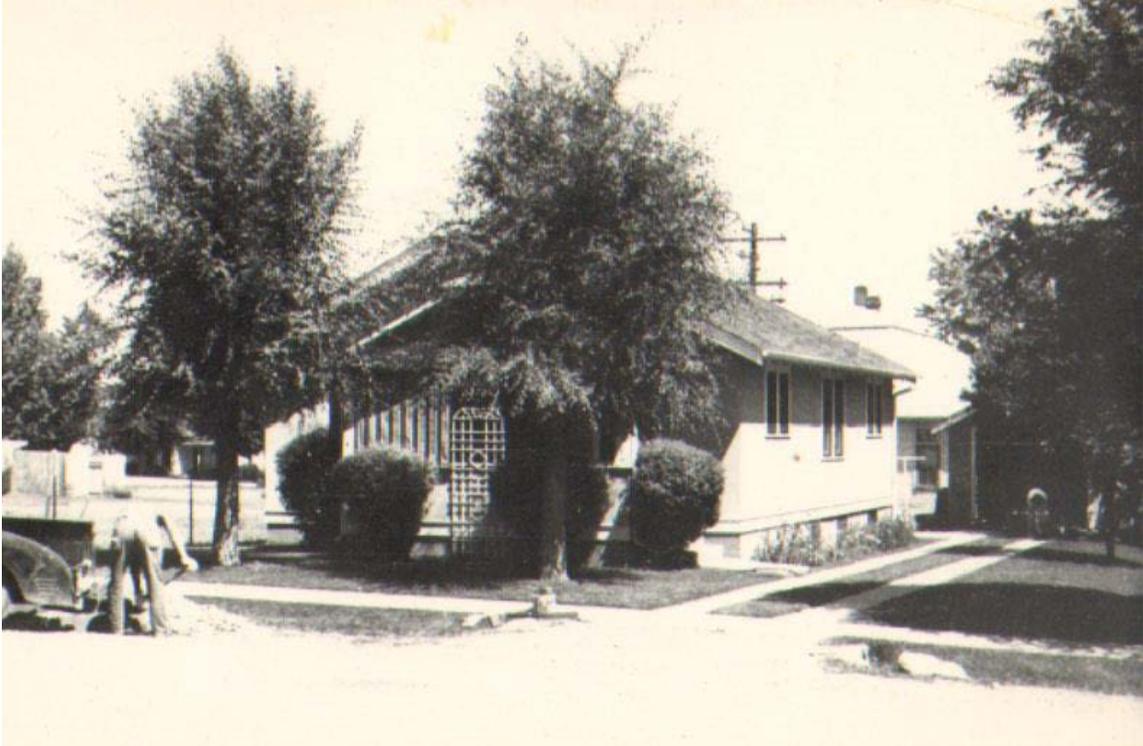
*920 Lincoln Avenue – 1948 Assessor Photo*

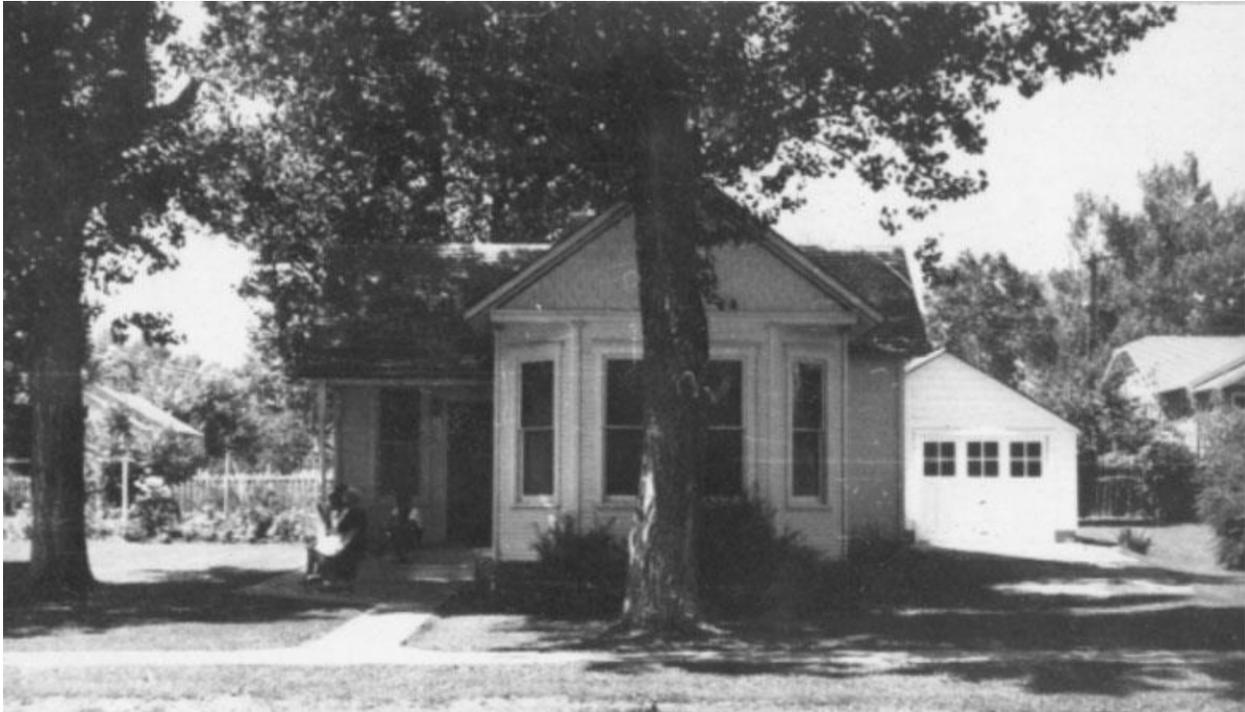
*725 Lincoln Avenue East Elevation - 1948 Assessor's Card*

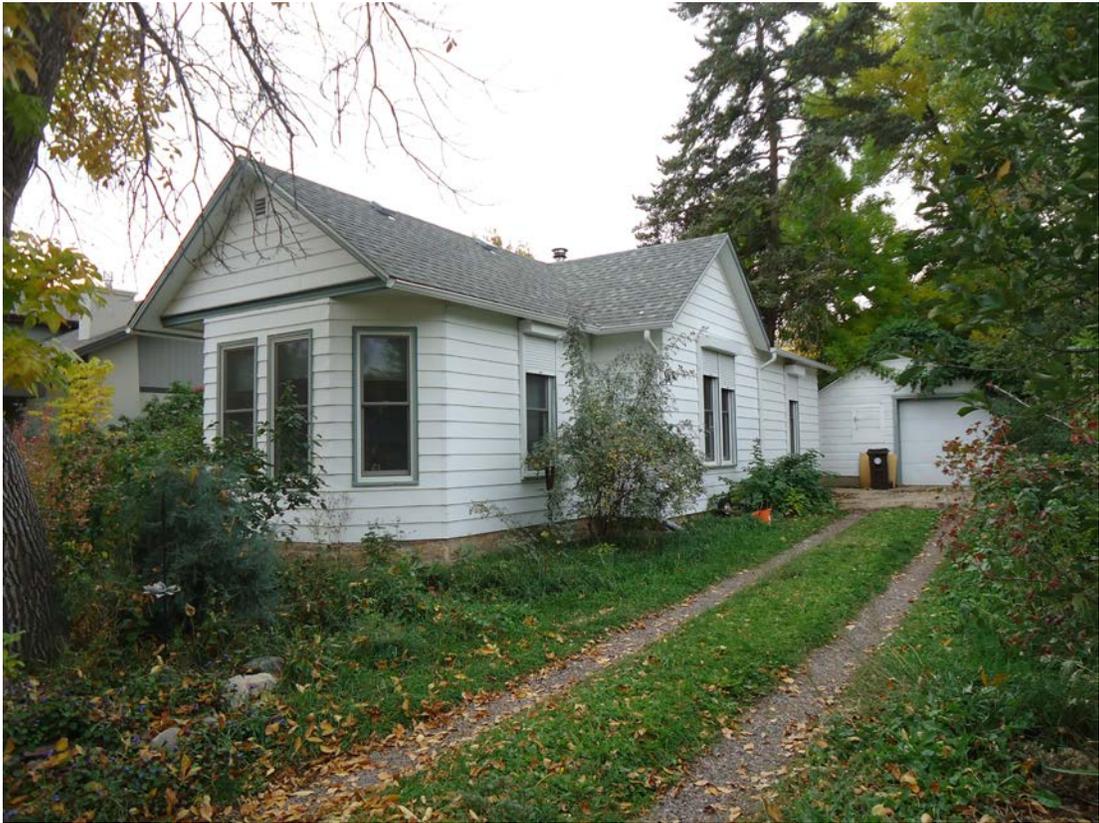
*725 Lincoln Avenue Northwest corner – Current Photo*

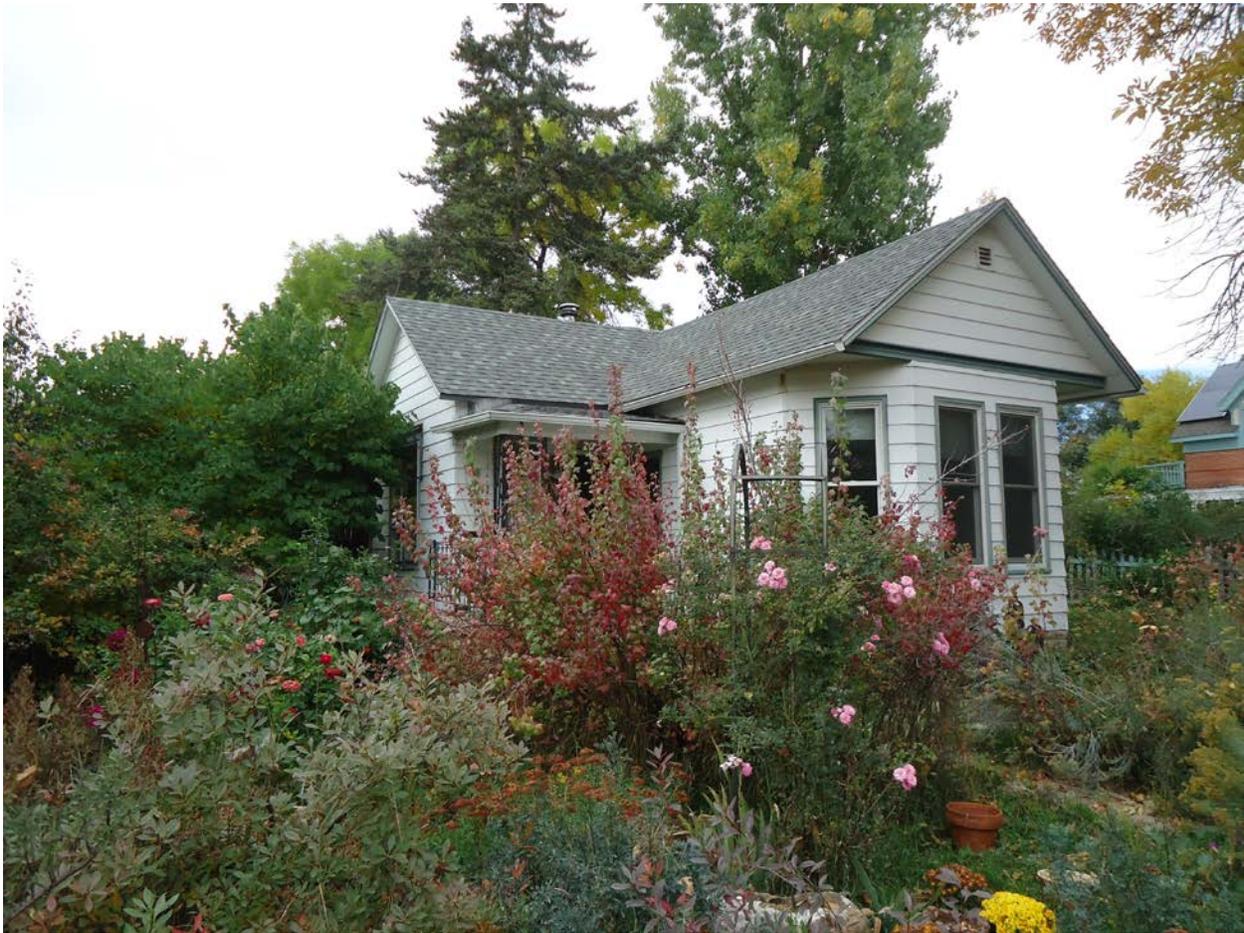
*725 Lincoln Avenue Southwest Corner – Current photo*

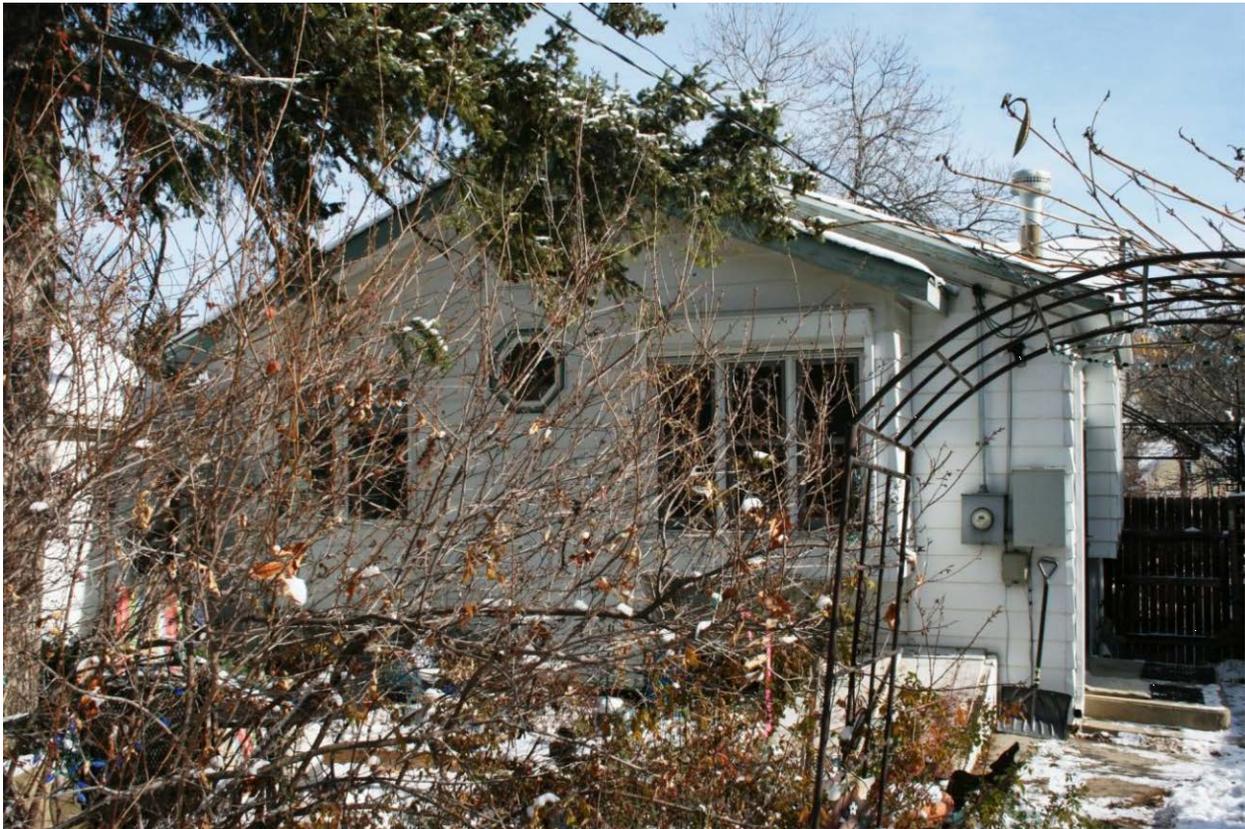
*725 Lincoln Avenue West Elevation – Current photo*

The applicant requests an alteration certificate to reconfigure the west elevation, add a one-story addition on the southwest corner of the existing house, and replace windows throughout the structure.

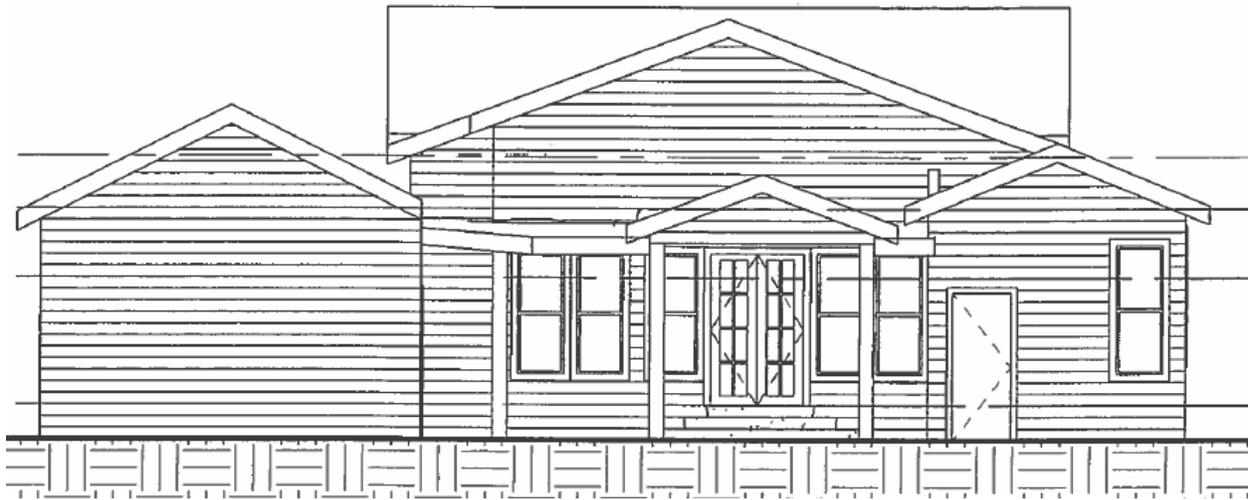
*Proposed West Elevation*

The proposed addition is a one-story, gable structure on the southwest corner of the existing structure. The proposed addition is connected by a rear porch to the existing garage with minimal visibility from Lincoln Avenue. The proposed addition picks up elements of the early 20<sup>th</sup> century style associated with the historic structure. The conceptual design is not specific on materials. The Historic Preservation Commission can recommend materials as a part of this approval. The existing structure is clad in aluminum siding.

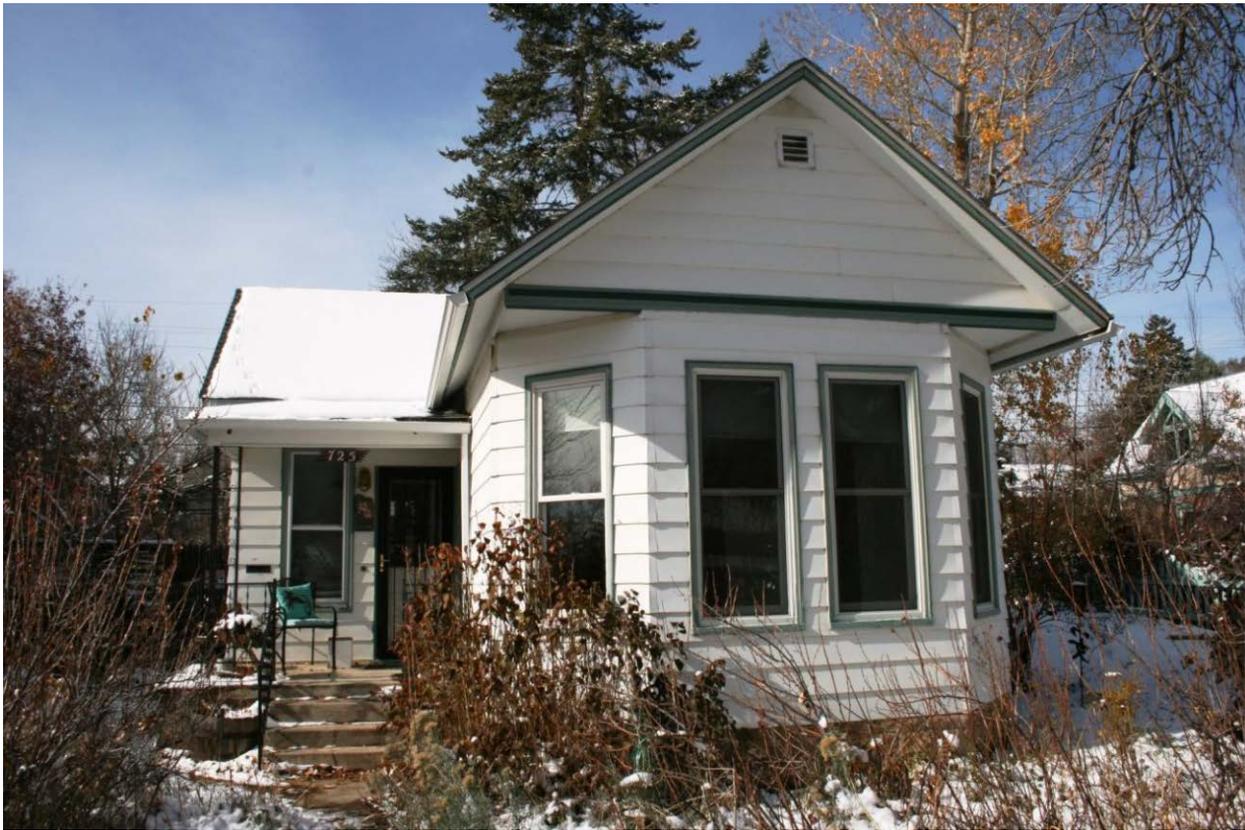
*725 Lincoln Avenue East Elevation – Current Photo*

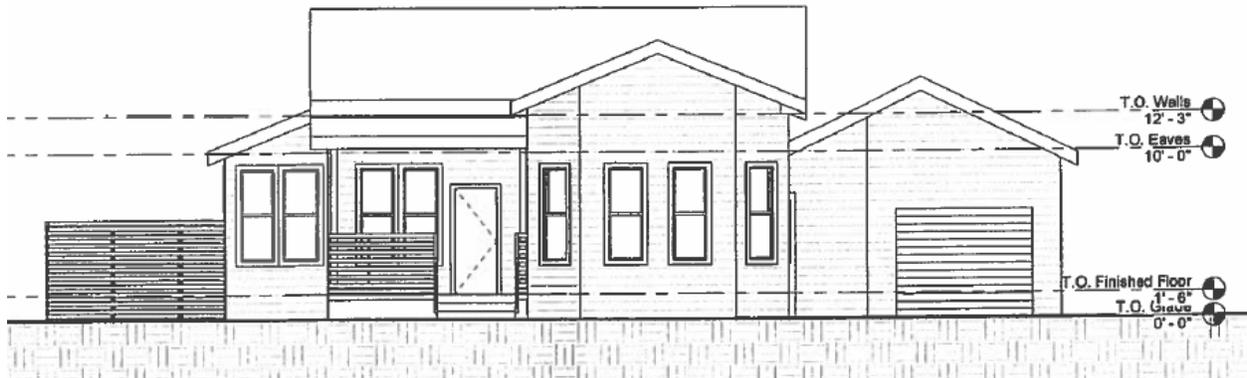
*Proposed East Elevation*

The proposal also includes altering the window on the front porch from a single window to a paired window and modifying the porch railing.

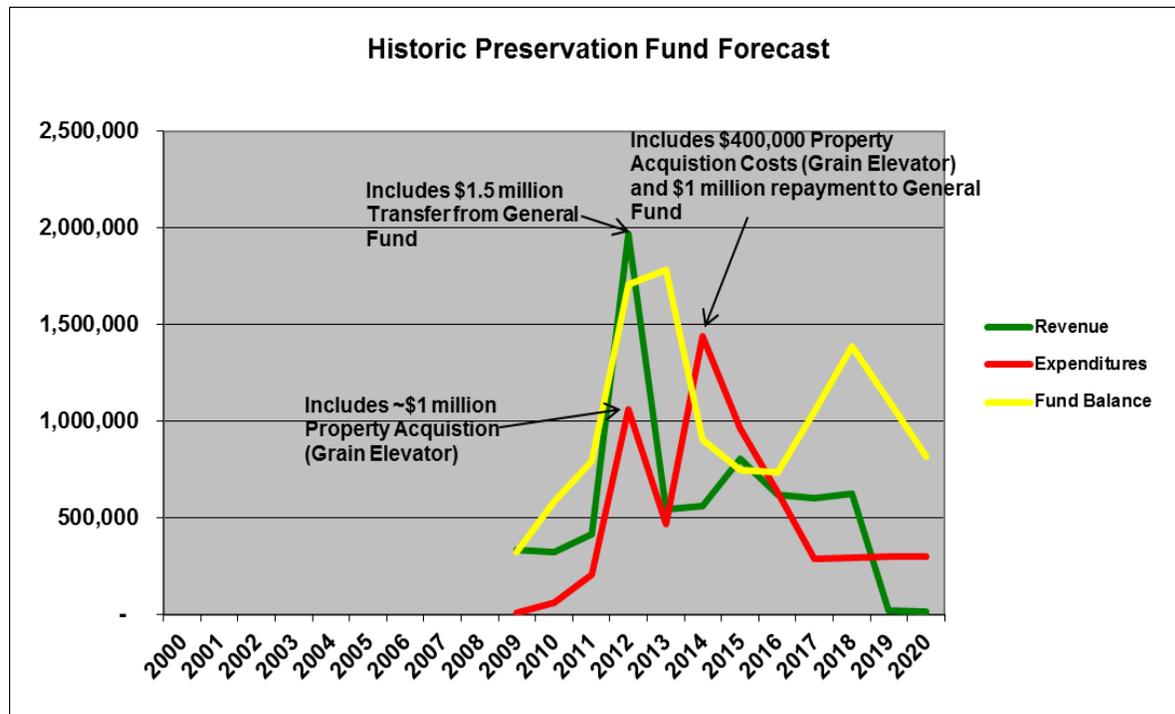
The following graph shows estimated Historic Preservation Fund revenues, expenditures and fund balance, not including the requested grant.

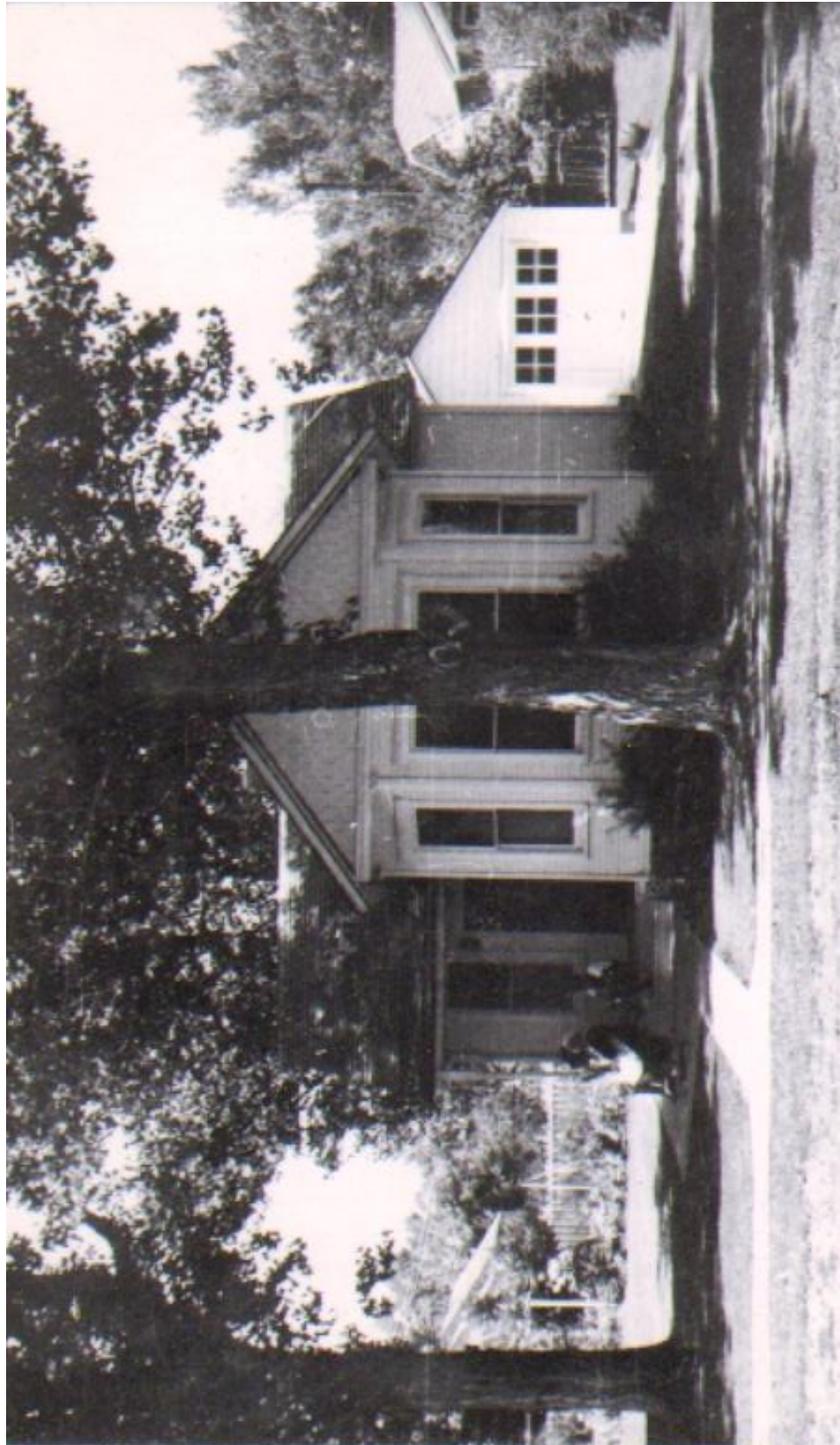
**1948 Assessor Card Image**

The assessor card shows that the massing of the building remains the same, as does the rhythm, proportion, and scale of the windows, but the siding has covered the decorative shingles in the gable end, the pilasters on the bay corners, and the window surrounds.

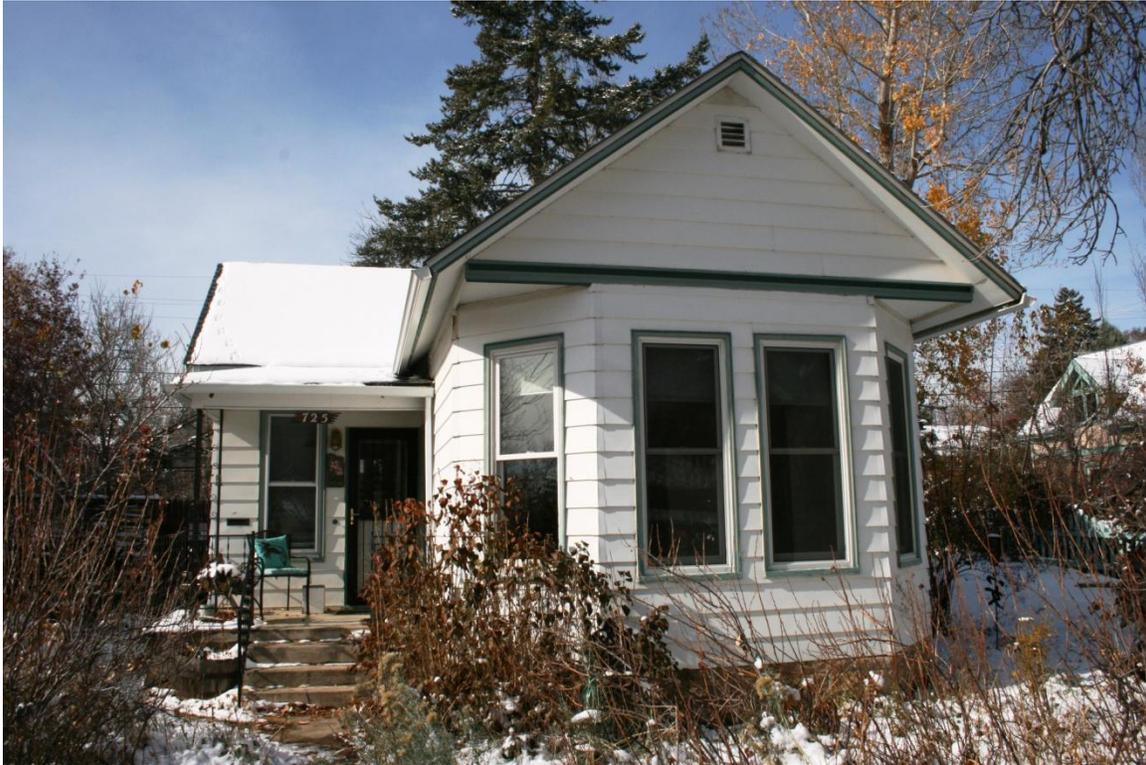
### East Elevation

725 Lincoln has a cross-gable form that sites a gable front prominently towards Lincoln Avenue while recessing the primary entrance on the south elevation ell. The projecting gable appears as a canted bay and features a one-over-one window on each of the sides with a pair of one-over-one windows centered below the gable. This projecting gable intersects at a ninety degree angle with a rectangular mass to the west and is slightly offset from center. To the rear of this side-gabled mass is a gable end which faces to the west and is the full width of the side-gable. The cross-gable plan that consists of the two intersecting rectangles that are closest to Lincoln appear to be the original form of the building, as evidenced by the assessor's card data and the inspection of the attic space, which found an older wood shingle roof covered by the gable end protruding to the west.

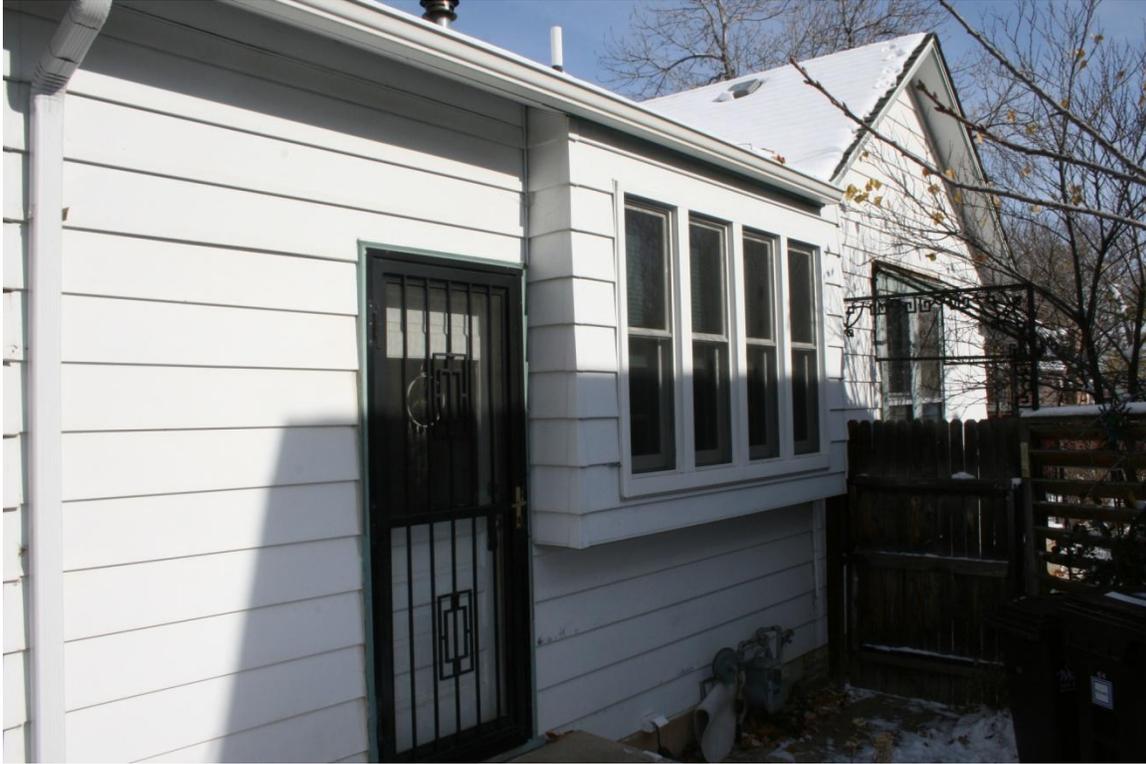
**South Elevation**

The home features two pedestrian entrances, the original location on the southeast ell which has a projecting entry porch roof and a south elevation entrance that access the kitchen.
