## ***Historic Preservation Commission***

### ***Agenda***

**July 18, 2016**

HISTORIC BUILDING CONDITION ASSESSMENT  
OF  
725 LINCOLN AVENUE, LOUISVILLE, COLORADO

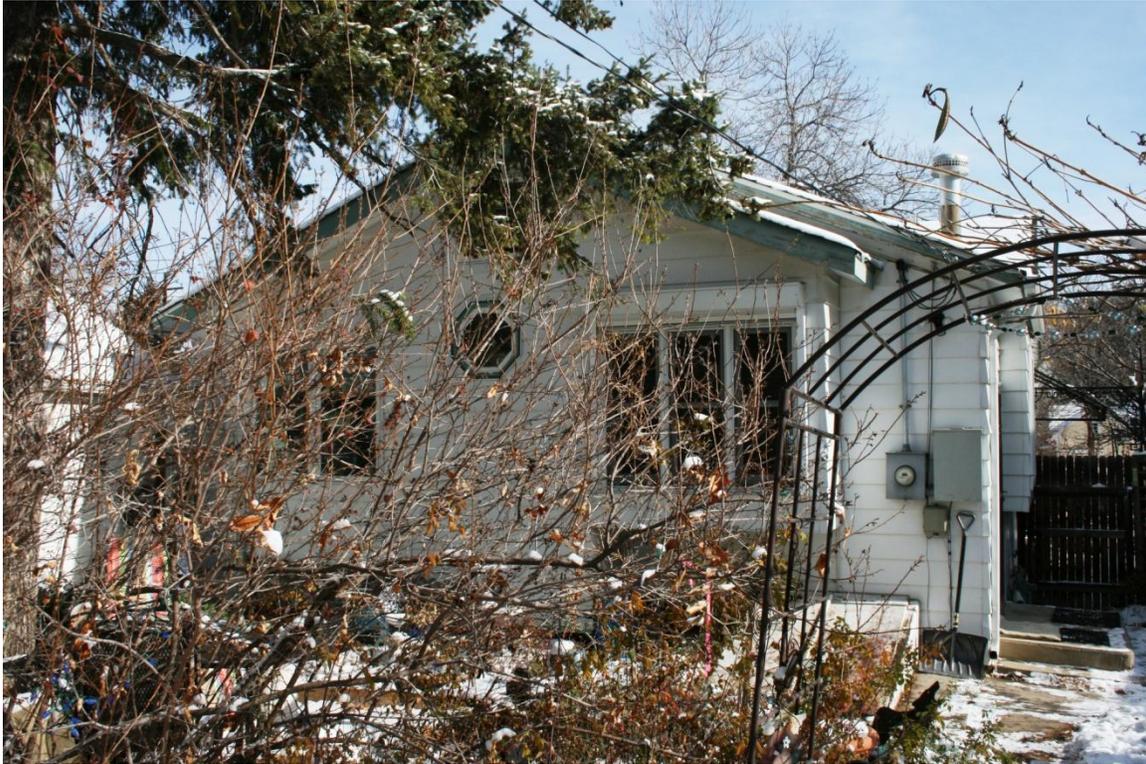
**West Elevation**

The exterior of the home appears to be in good repair with only a few areas of peeling paint on the west gable end fascia and on some of the wood window sills.

- Scrape loose paint, prime with a high quality product, and repaint
- Inspect drip edges around the roof perimeter to ensure that they flange out enough to allow rain and snow to fall clear of the fascia

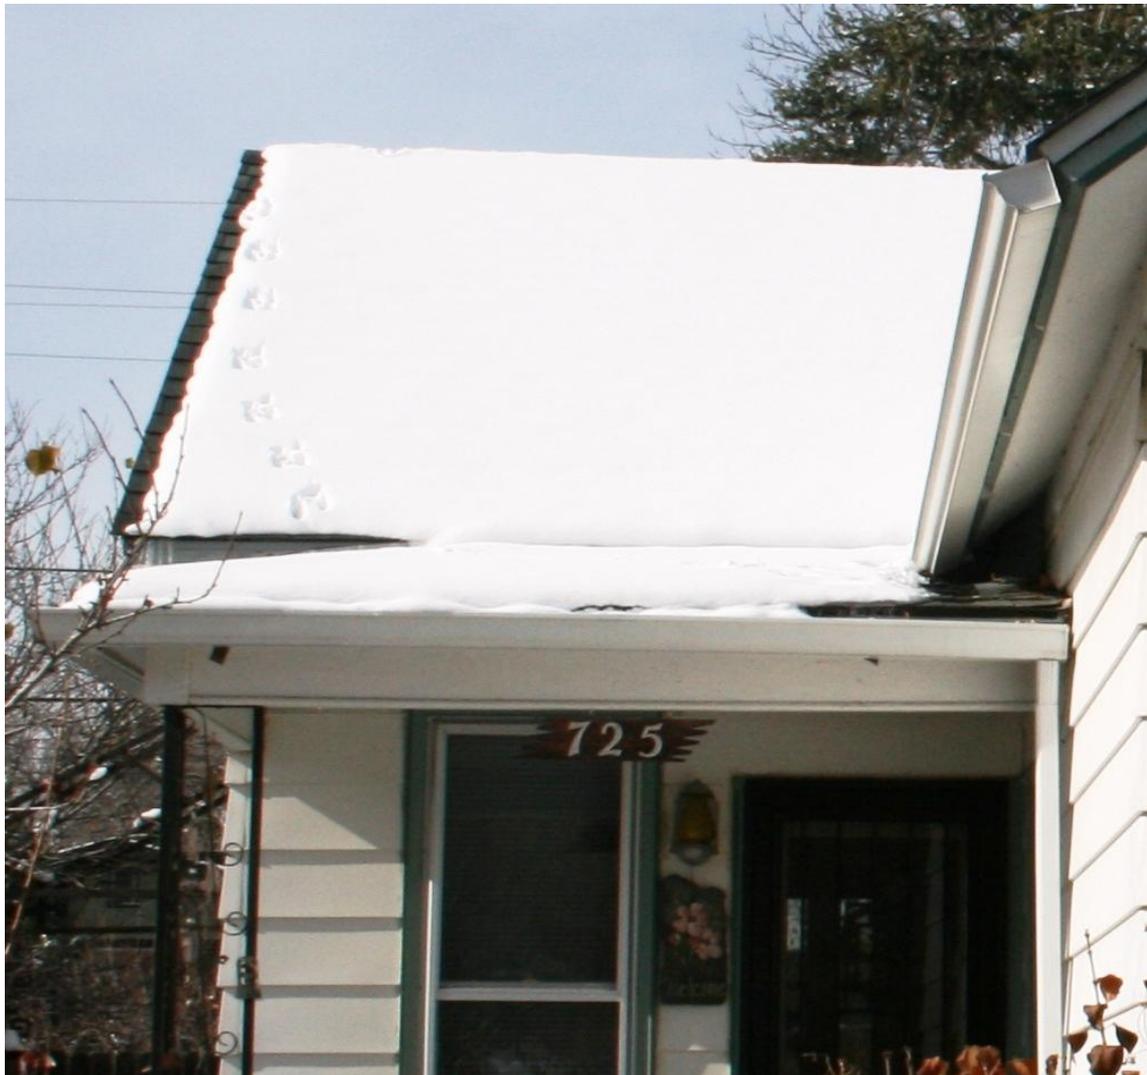
The porch roof has been damaged by squirrels which have used the roof junction as an access point to the attic. Footprints in the snow on the roof indicate that the access point is just under the overhanging eave where it connects to the porch roof.

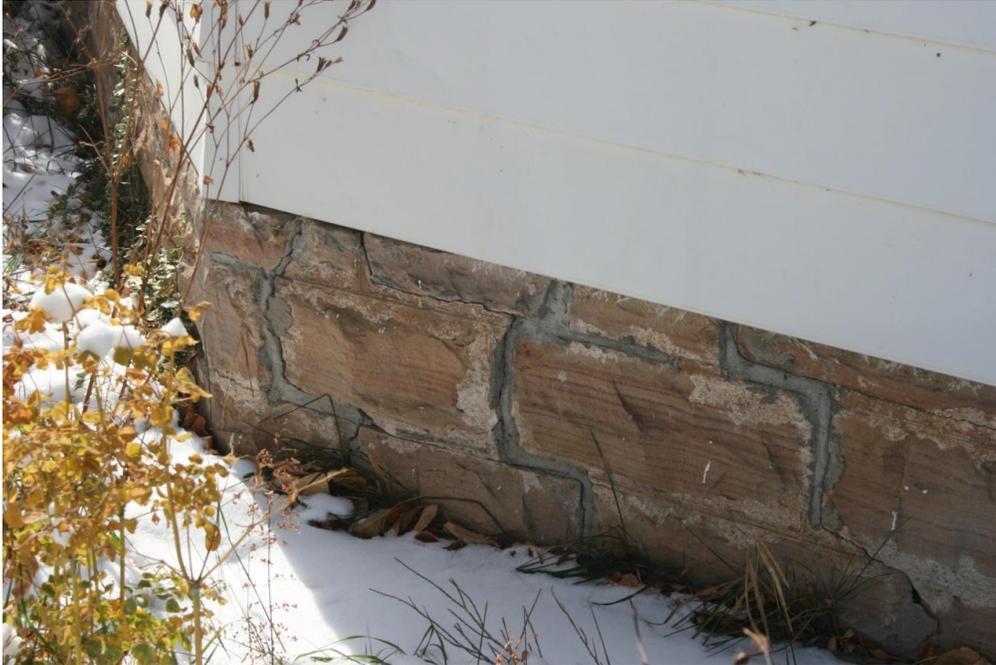
The more recent poured concrete foundation appears to be in good condition with no obvious defects. This portion of the house has been partially excavated to hold HVAC equipment. The older rubblestone foundation appears sound, but does have some cracked mortar and evidence of repointing in the past with Portland cement. The rubblestone foundation was only inspected from the exterior because there is only a very shallow crawl space under this portion of the house.

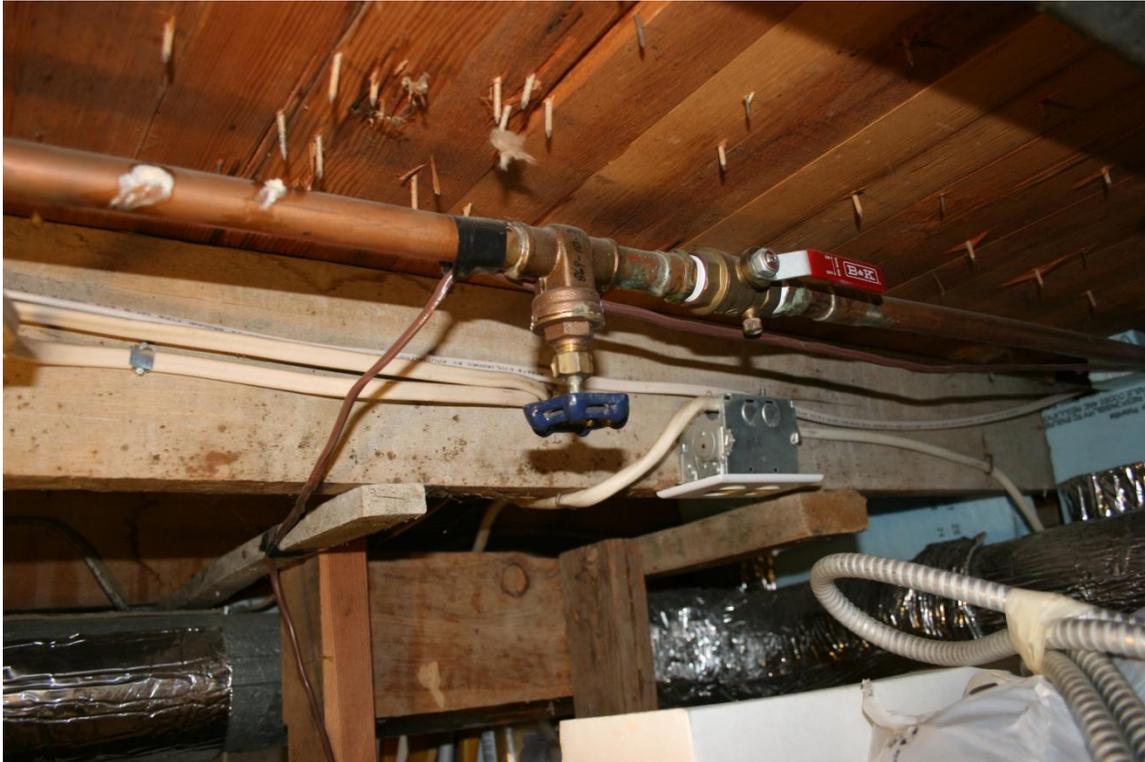
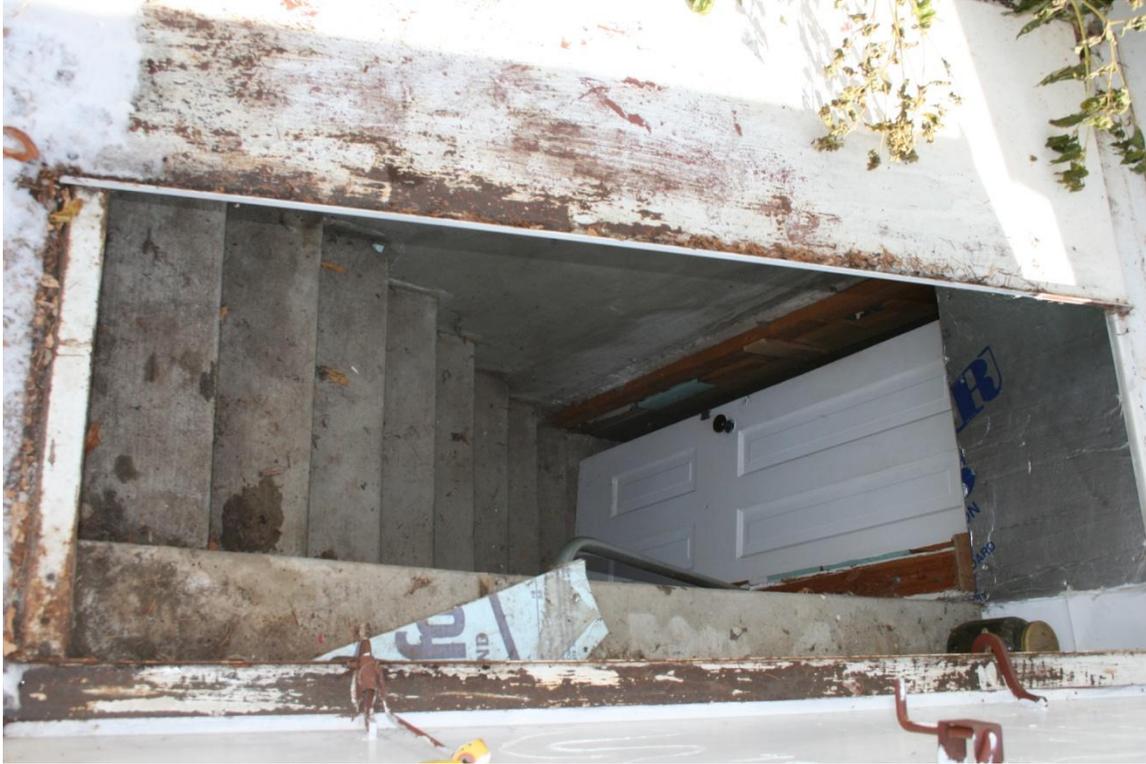
Access to the basement/crawlspace is via a hatch on the rear of the home set in the poured concrete portion of the foundation. The excavated space was made just large enough to hold the mechanicals for the home and provide some storage. Access to the crawl space is available by crawling over the masonry unit retaining wall.

Framing visible in the basement consisted of 2x6 joists that are 24" O.C. The excavated space measures approximately 11'3" x 6'10".

No ongoing rot, water damage, or insect damage was noted during this inspection.

- Create a maintenance checklist and inspect the house twice annually to catch any maintenance issues as they develop
- A good proactive approach would be to install a relative humidity and temperature monitoring device in the basement that would signal any changes that could lead to mold growth or water damage

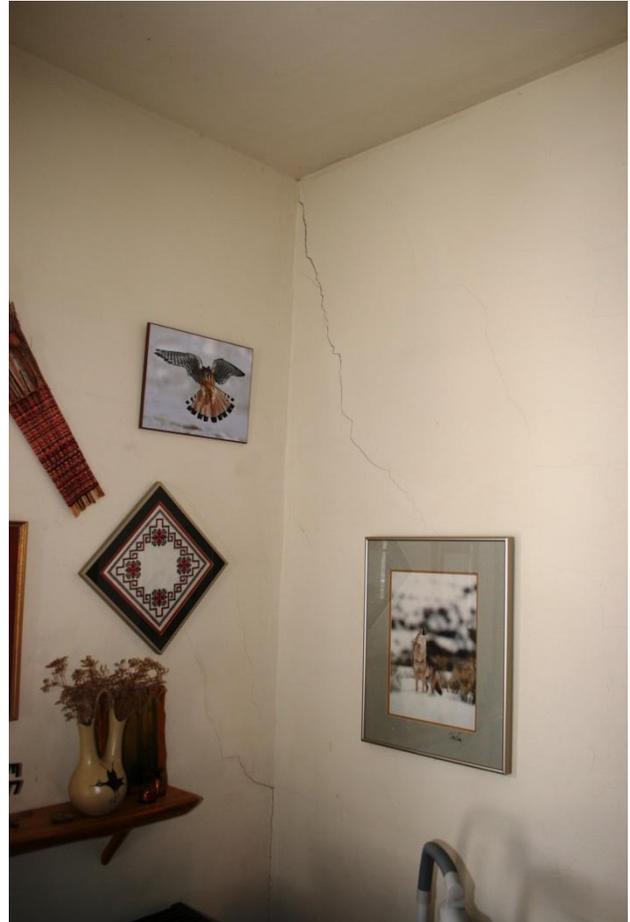
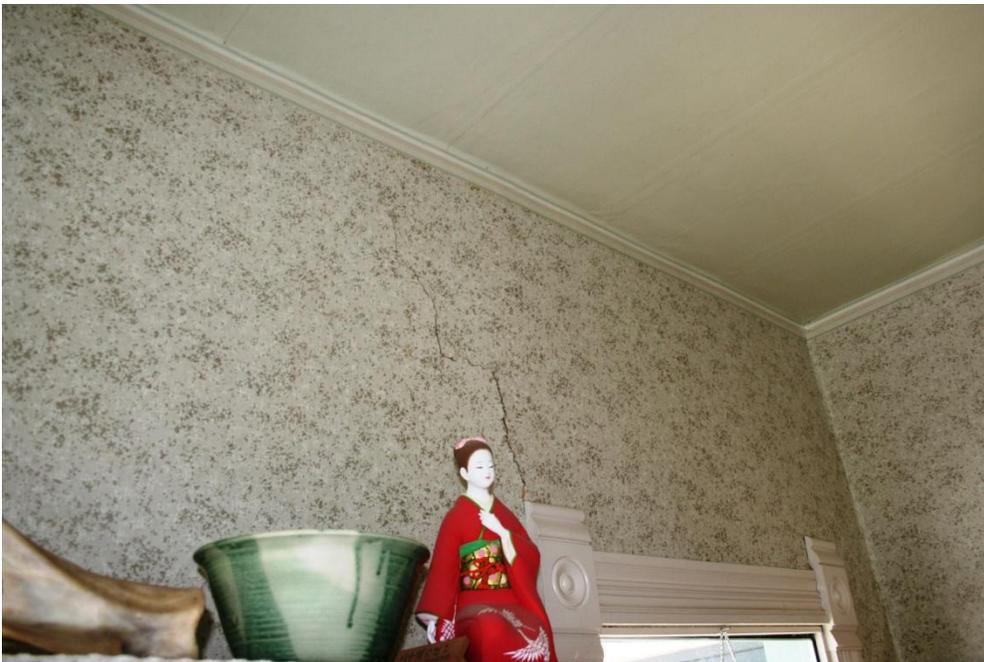
- Measure and document the cracks
- Fill the cracks and repaint, where appropriate. If the cracks reappear continue to monitor until movement has ceased
- In areas where wallpaper has cracked, it may make the most sense to simply monitor these cracks for at least a year to make sure that they have stopped moving before attempting any repairs

- If the cracks continue to grow, and especially if any approach an inch wide, a structural engineer should be brought in to consult

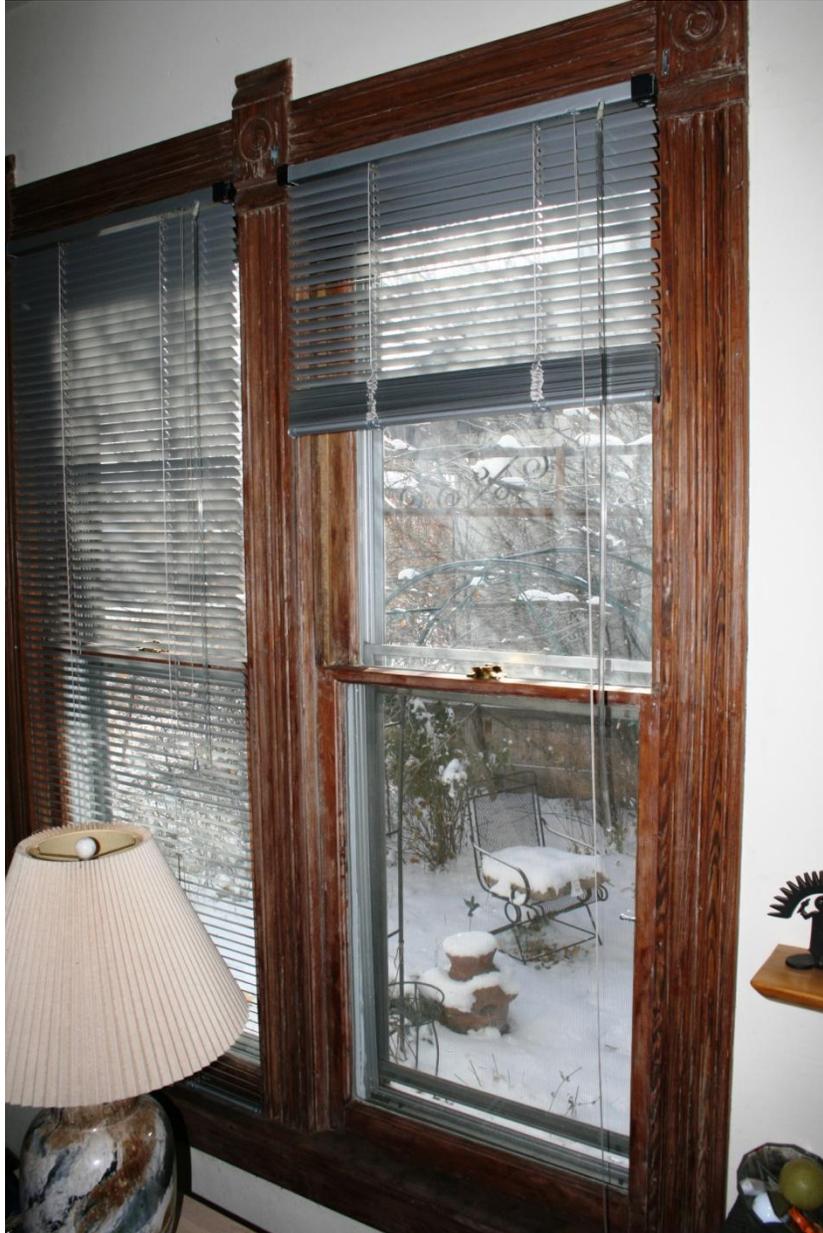
The living room windows are original one-over-one double-hung sash that utilizes spring pins to facilitate operation. They are finished on the interior and painted on the exterior. They have been restored within the past year and are in good condition.

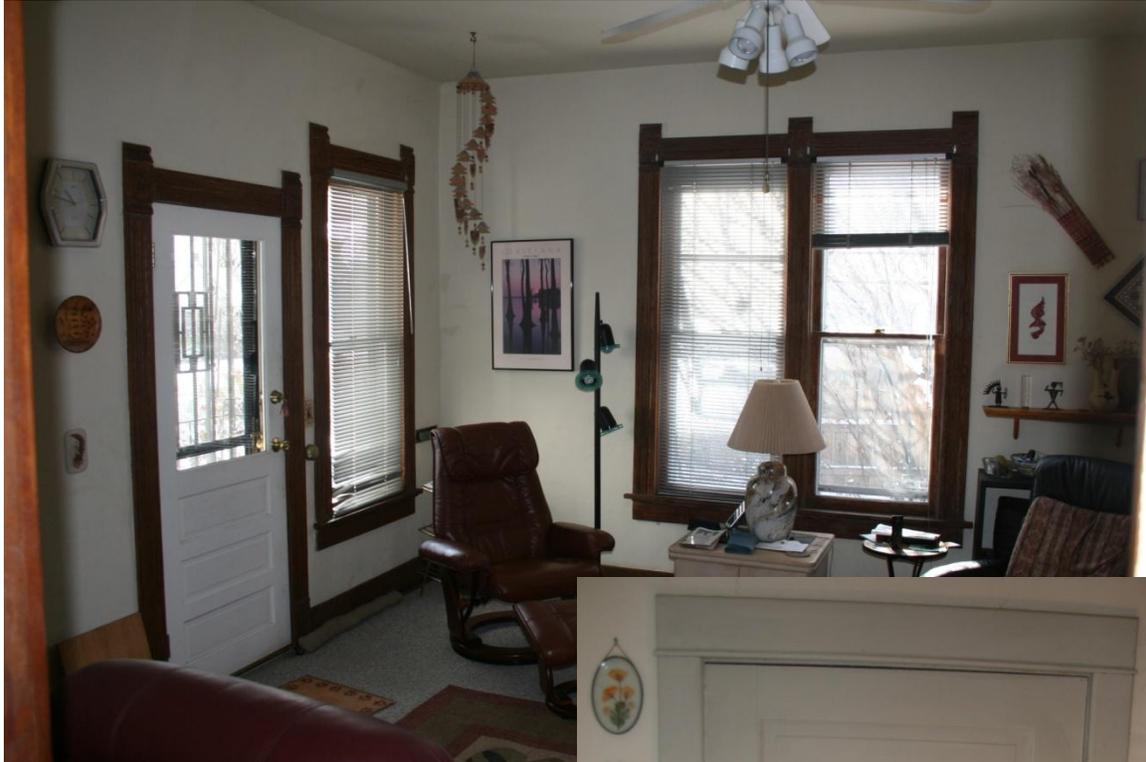
Trim around the windows and the front door in the original portion of the house is fluted with bullseye corner blocks. The trim around the windows and doors in the more recent portion of the house varies but includes flat stock on the sides and a header with a bead on the top. All of the doors and trim are in good condition.

- Periodically check the paint and weatherstripping on the exterior doors to make sure that any deterioration is quickly addressed.

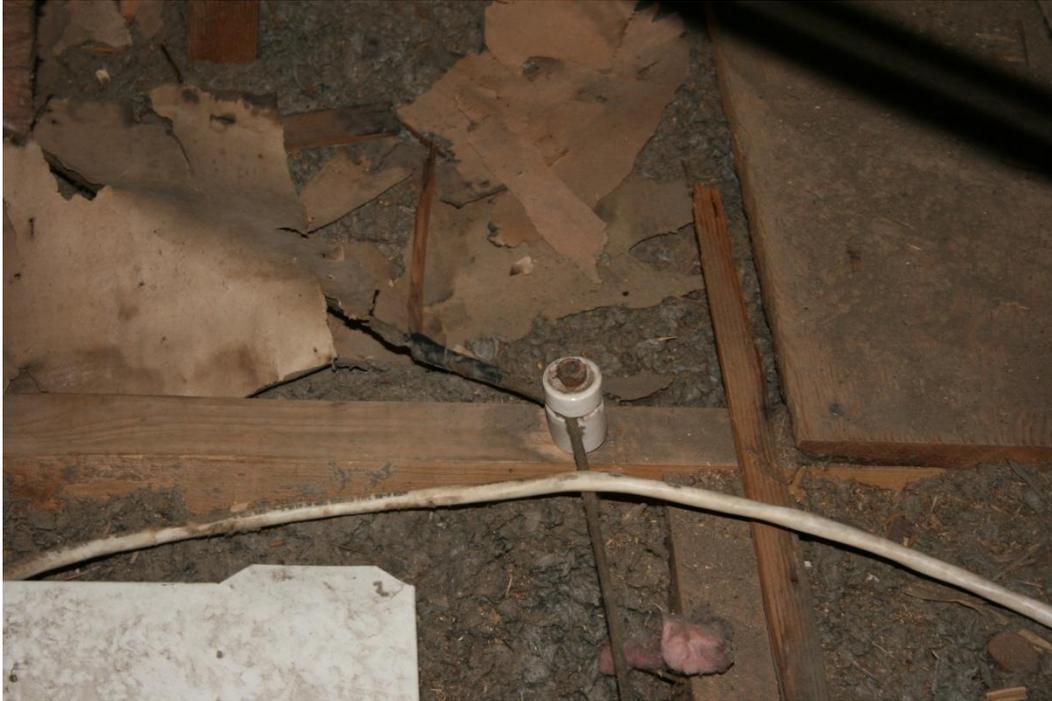
**Knob and Tube wiring is west gable end**

As described in the attic portion, the weak link in the electrical system is the knob and tube wiring that is exposed in the attic. While the wiring that remains in the wall may be in good condition, the visible portion in the attic appeared worn and is subject to potential damage due to its installation on the top of the joists. Finally, the presence of knob and tube in this location prevents the installation of adequate insulation, which should be a priority.

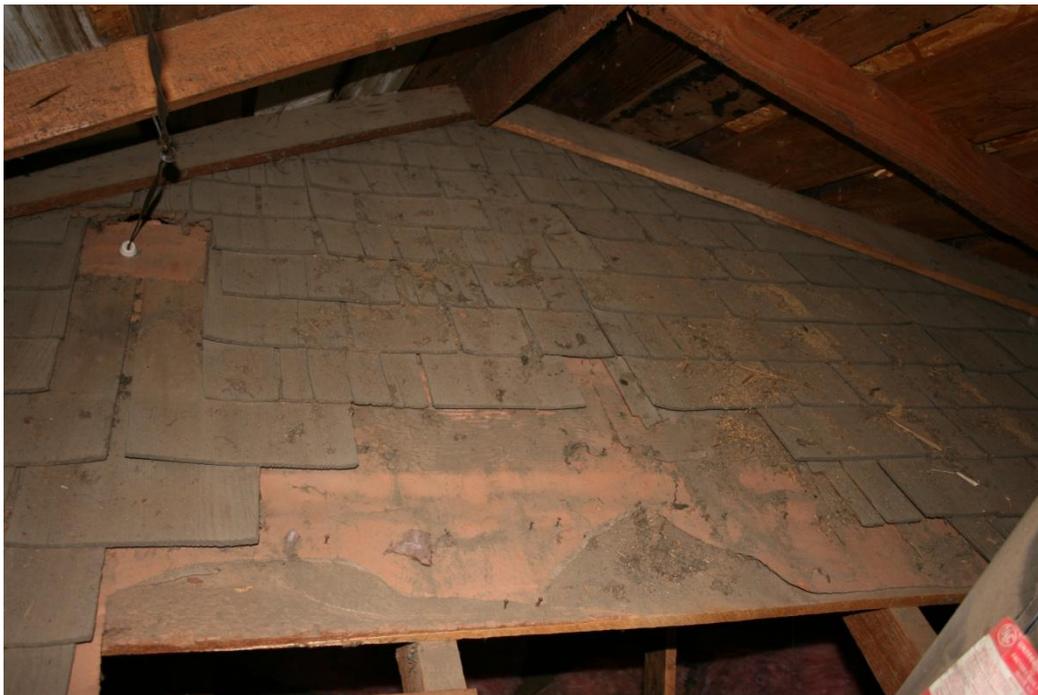
The original roof is visible at the east end of this attic space, and there is a hole cut for access to this portion of the attic, but a large exhaust vent has been placed in the opening which makes passage very difficult. A visual inspection was possible however, and there were no defects or trouble spots noted.

**Roofing/access to original portion of attic**

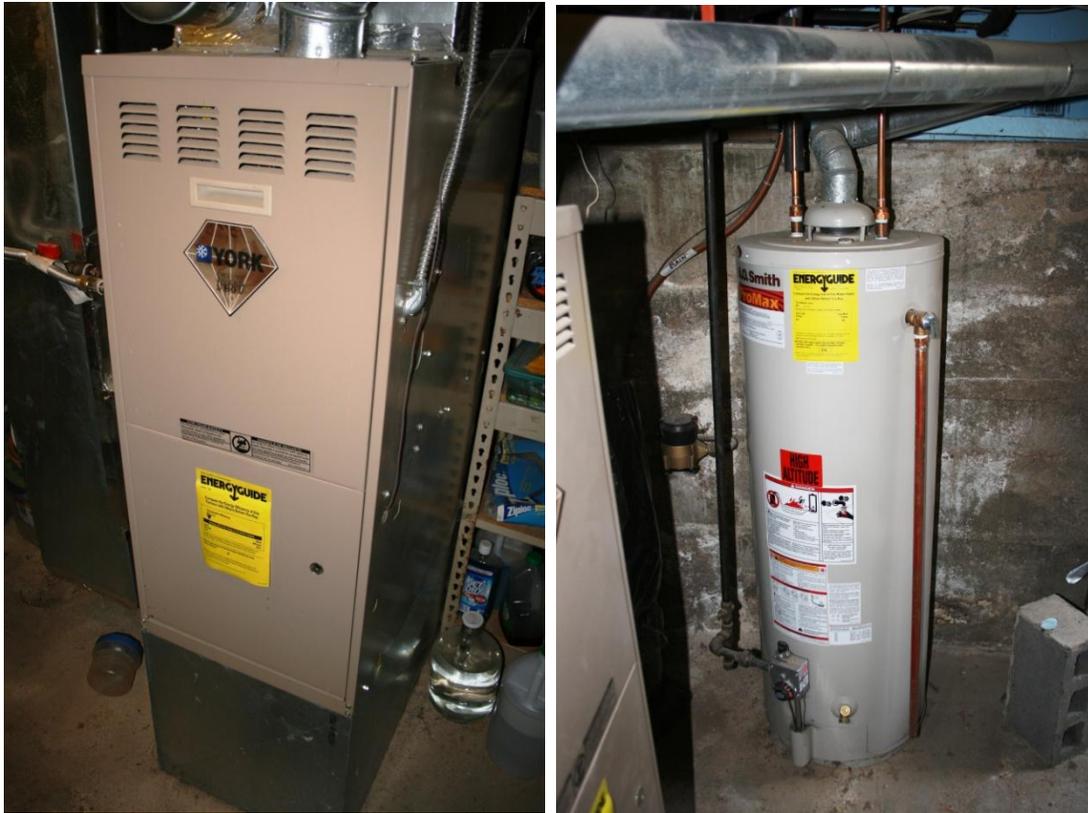
The Furnace is a York Deluxe Diamond 80 (80.0 AFUE), which is a model that is currently still being sold today. The water heater is an A. O. Smith ProMax model # FCG 40 248. The homeowners report no known issues.

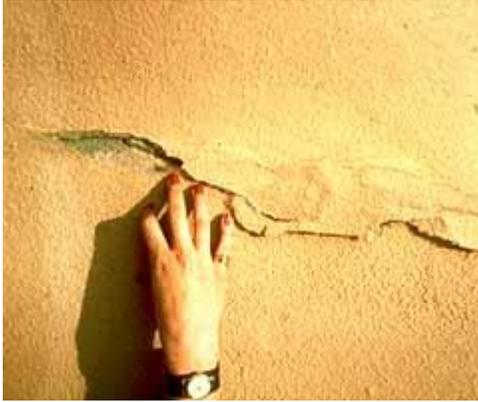
**Applying a waterproof coating to an above-ground masonry wall can trap moisture underneath, causing further damage to the historic material. Photo: NPS files.**

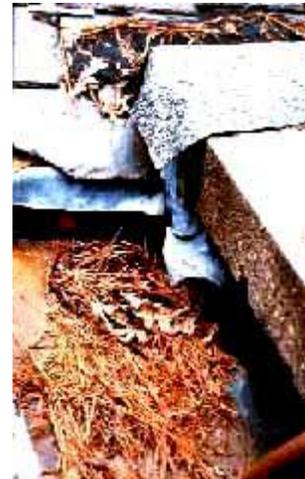
**Debris will impede the normal flow of water from the roof's gutter and downspout system to the ground and result in moisture problems. Photo: NPS files.**

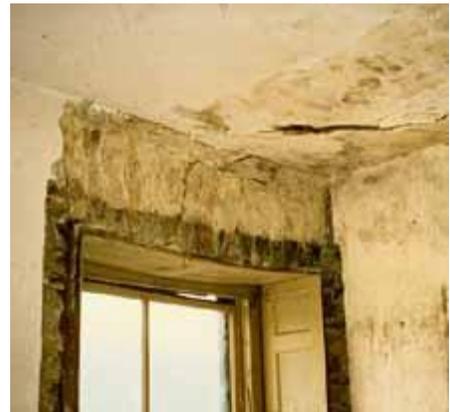
**Damp interior plaster around windows generally indicates moisture has entered from the outside. Photo: NPS files.**

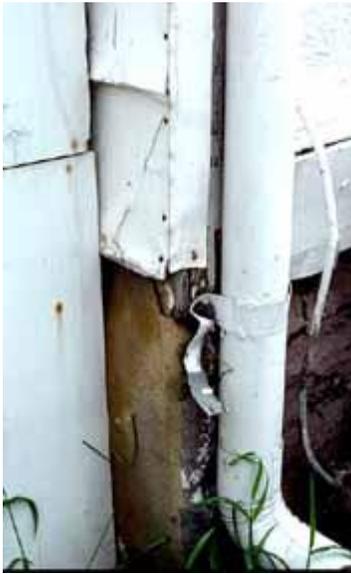
**A clogged or broken downspout causes the water to pour directly into the ground. NPS files. Photo: NPS files.**

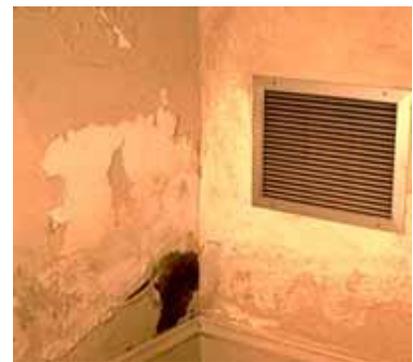
**If adequate ventilation is installed, damage to interior walls such as this can be prevented. NPS files.Photo: NPS files.**

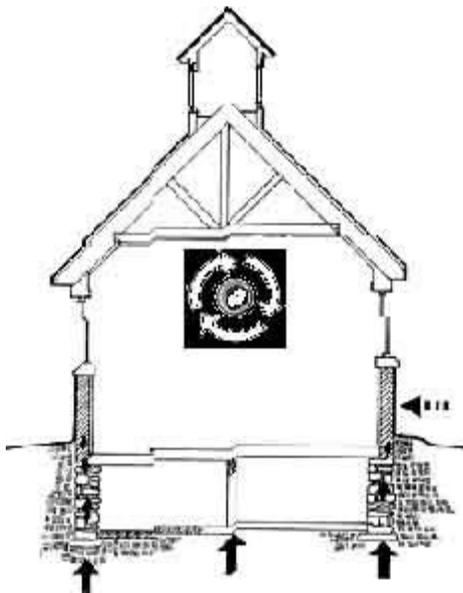
The dynamic forces that move air and moisture through a building are important to understand, particularly when selecting a treatment to correct a moisture problem. This drawing shows how moisture can invade "inward" from the exterior; "upward" from the ground; and be generated from "within" the interior. All have damaging effects. Drawing: NPS files.

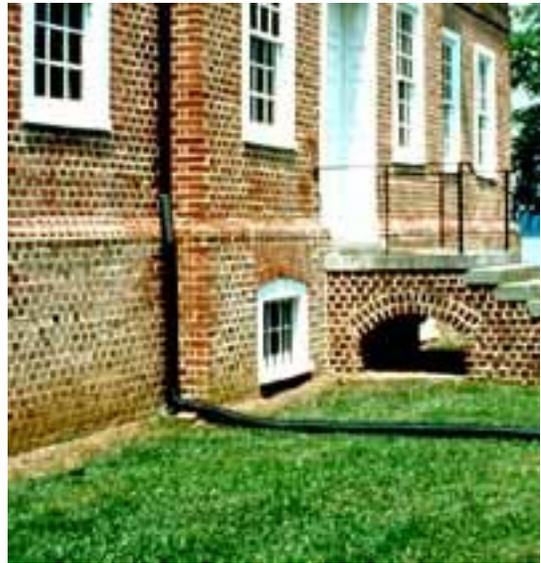
**The owner used long black extender pipes to test a theory that it was faulty roof drainage causing the problem.**

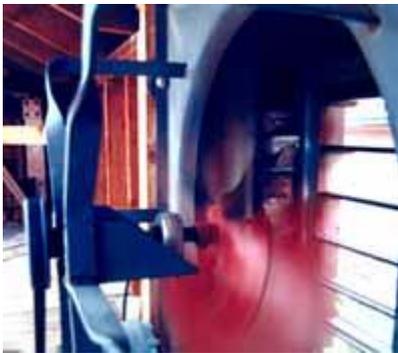
**Installing ventilating fans can improve damp conditions or reduce cooling loads. Photo: NPS files.**

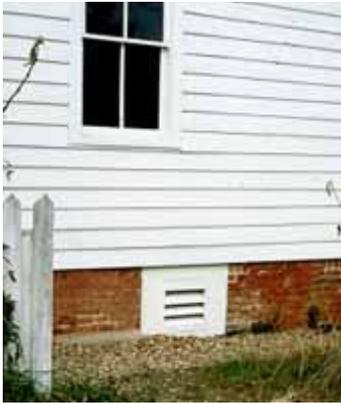
**A vent may be added if there is none. Close grilles in the summer, if hot humid air is getting into air conditioned spaces. Photo: NPS files.**

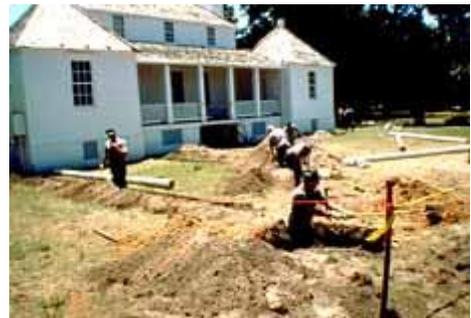
**New drainage systems for roof run-off may be installed in order to remove moisture from the base of the building. Photo: NPS files.**
