***Historic Preservation Commission
Agenda
March 16, 2020***

PROJECT INFORMATION:
ADDRESS: 925 Jefferson Avenue
LEGAL DESCRIPTION: Lots 6-7, Block 11, Jefferson Place
DATE OF CONSTRUCTION: 1891

REQUEST: A request to Landmark 925 Jefferson Avenue and a request for an Alteration Certificate and Preservation and Restoration Grant at 925 Jefferson Avenue.

HISTORICAL STRUCTURAL ASSESSMENT
925 JEFFERSON AVE, LOUISVILLE, COLORADO
December 01, 2019

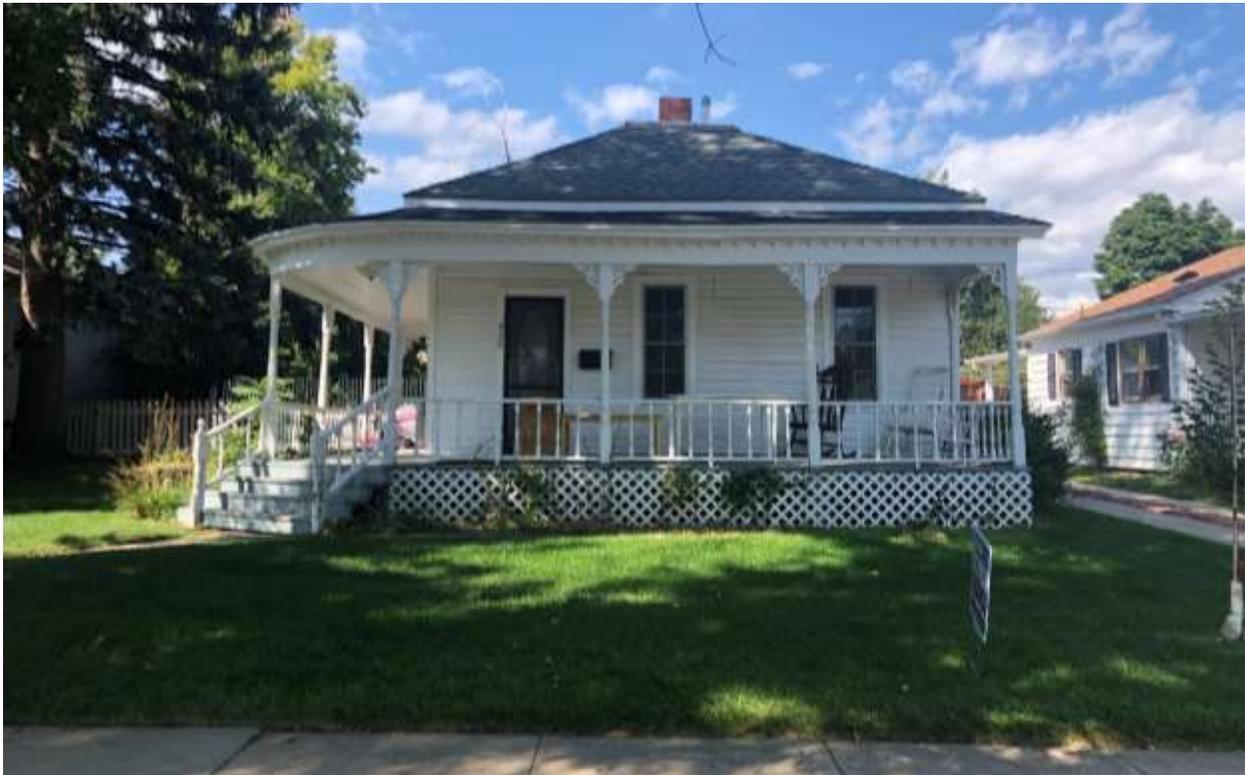
925 Jefferson Avenue, east view – Current Photo

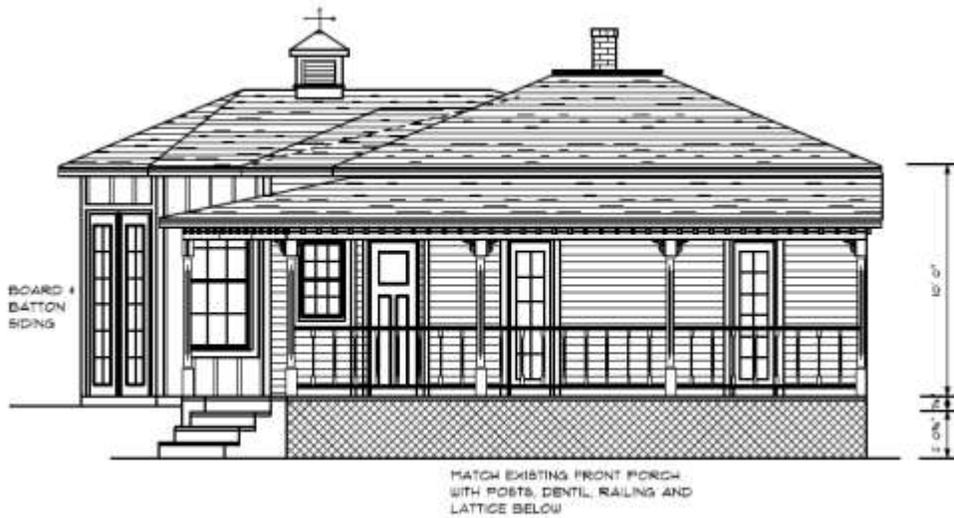
925 Jefferson Avenue – East Elevation, proposed

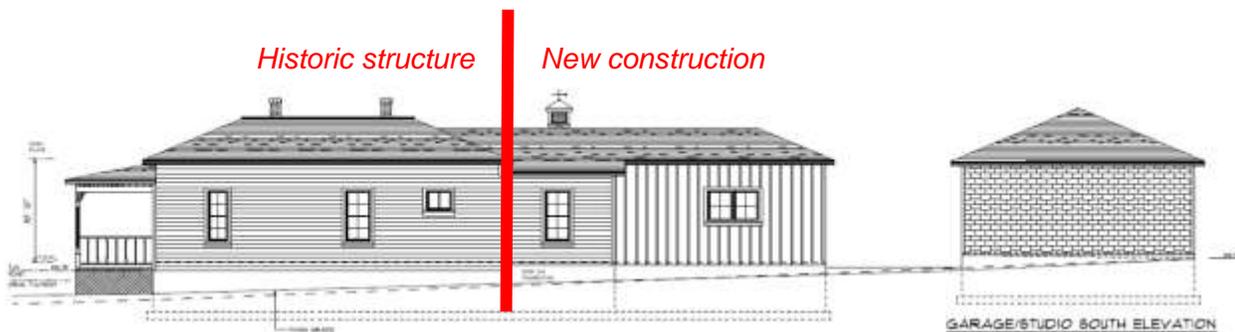
925 Jefferson Avenue – North Elevation, proposed

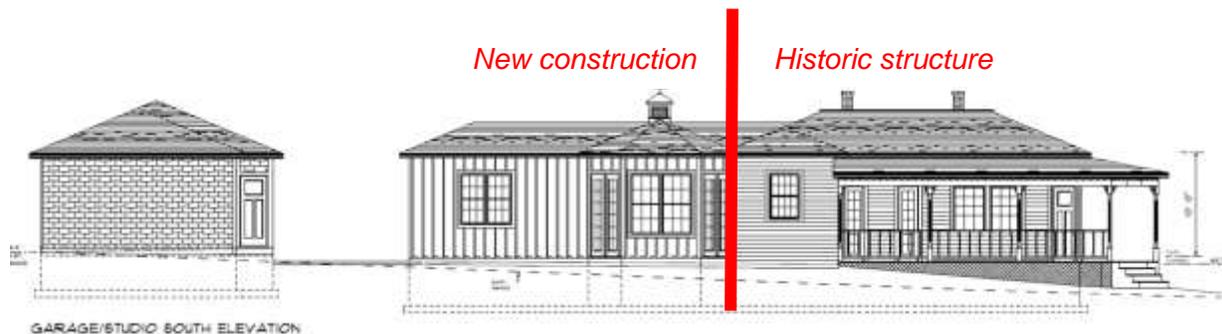
925 Jefferson Avenue – South Elevation, proposed

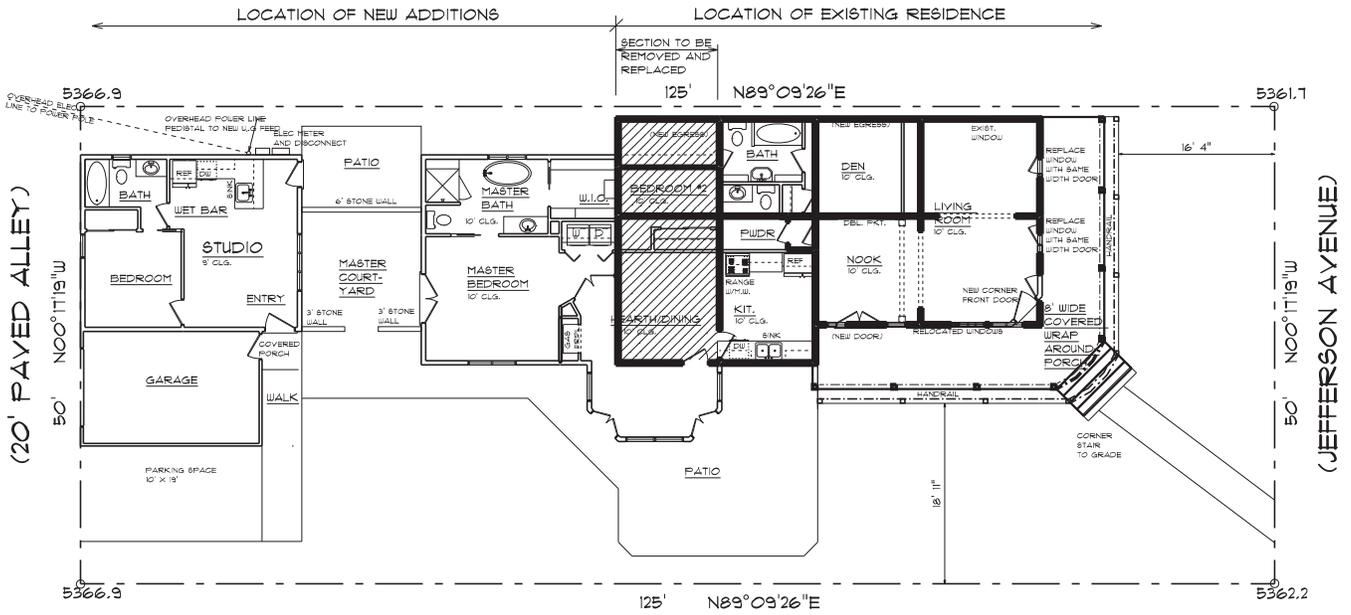
925 JEFFERSON AVE. EXISTING STRUCTURE
TRANSPOSSED OVER NEW STRUCTURE

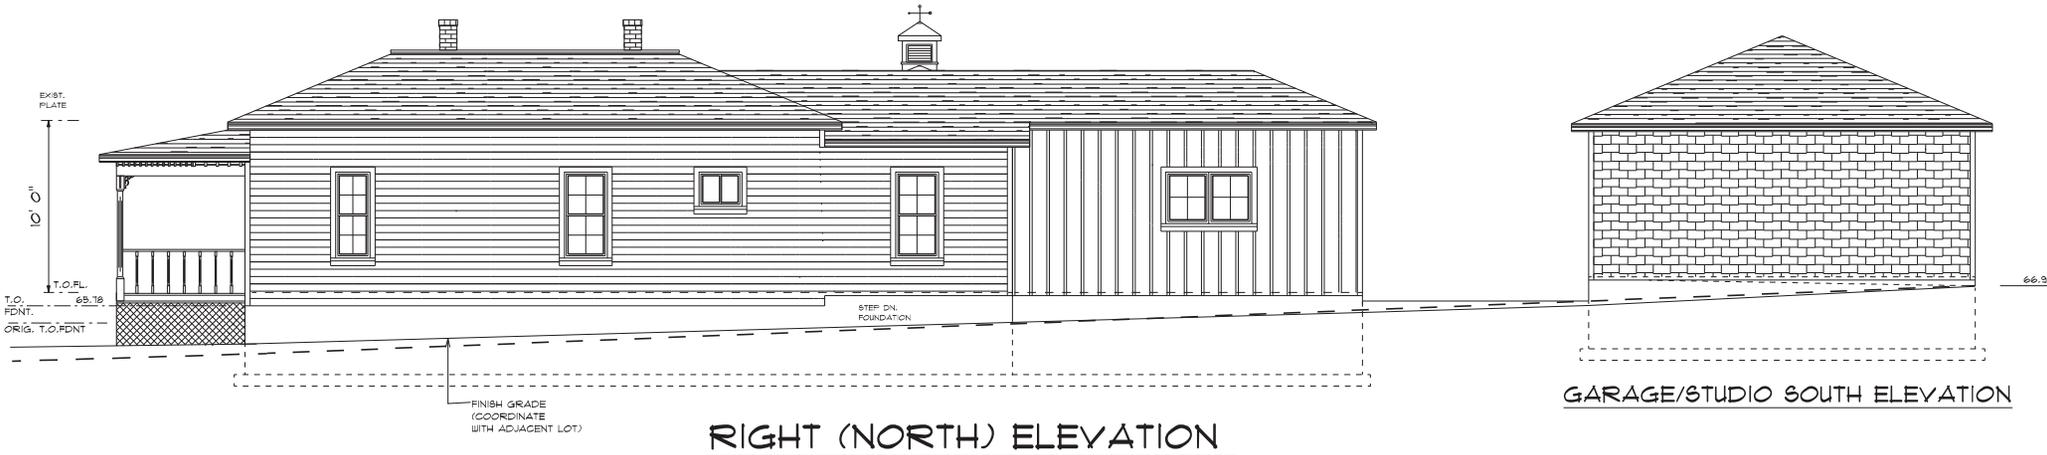
PROPOSED FRONT ELEVATION

RIGHT (NORTH) ELEVATION

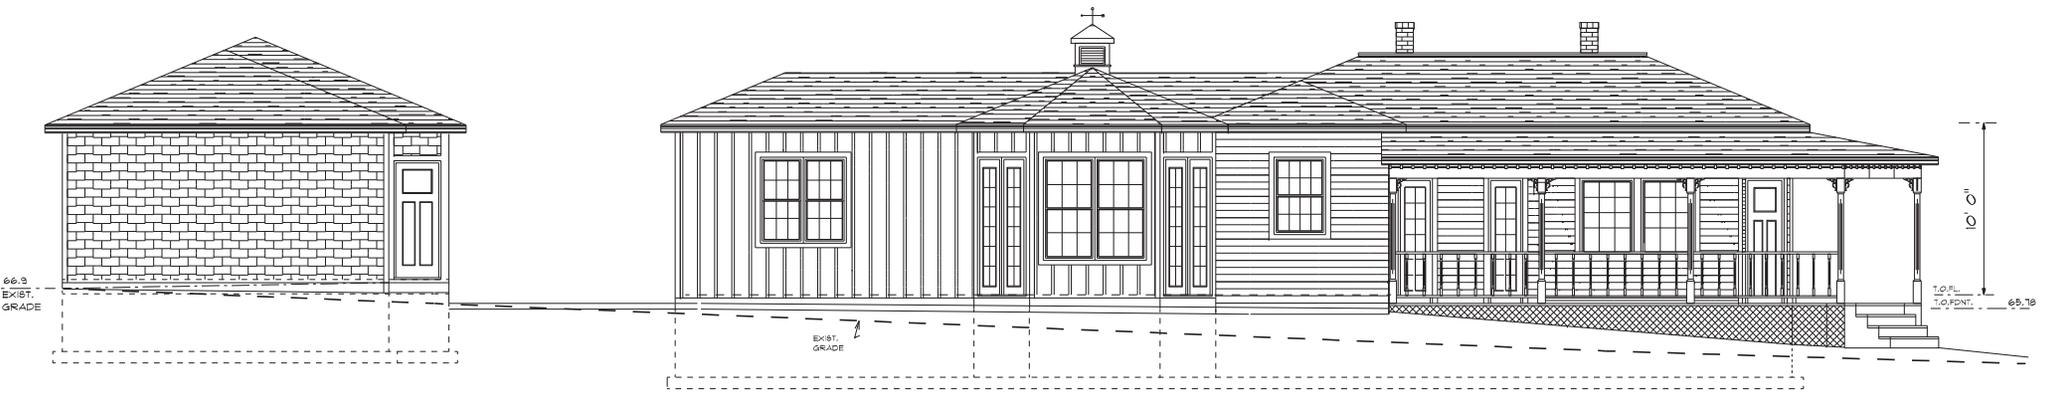
GARAGE/STUDIO SOUTH ELEVATION

LEFT (SOUTH) ELEVATION

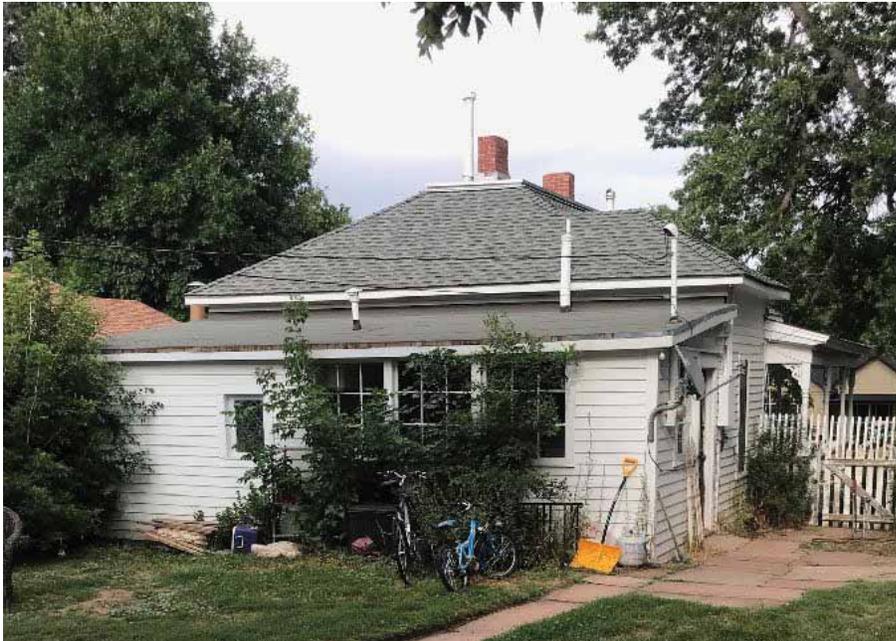
A Rear Addition was completed in 1957. This addition functioned as a Mud Room with a washer, dryer and large sink. It also includes a steep stair with access to a small underground cellar. This cellar currently holds a gas fired furnace and water shut off valve. The addition is a slab-on-grade, and does not have a foundation.

Full width rear addition with vertical trim connection and wider profile siding, low back wall and shed roof.

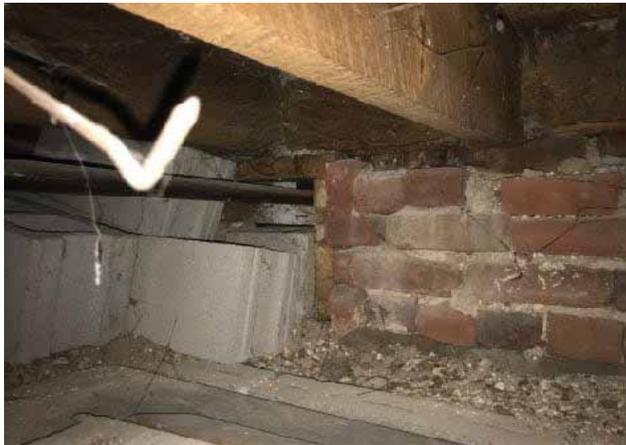
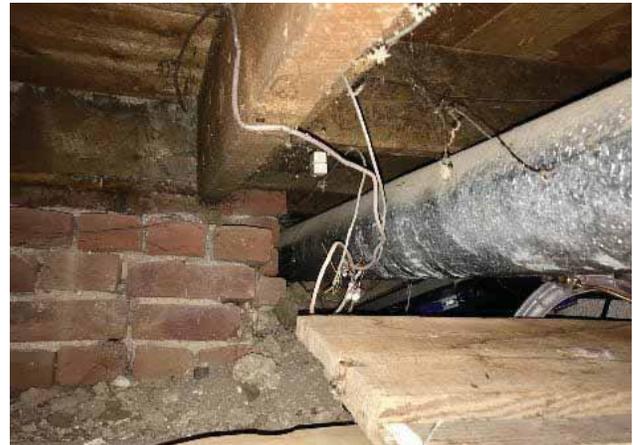
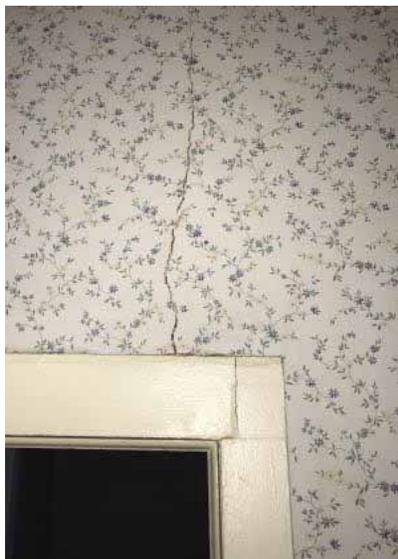
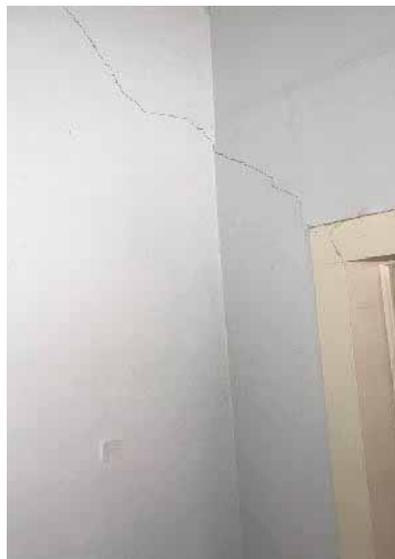
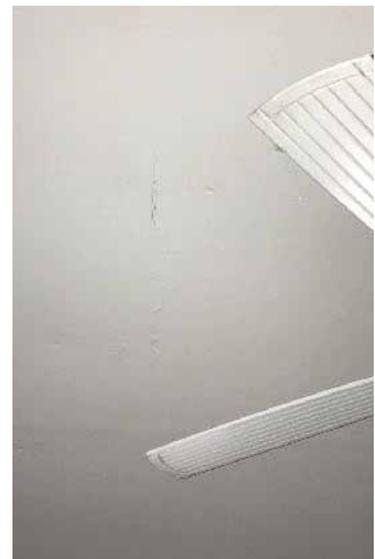
Recommendations: The Engineer recommends the foundation be replaced with a reinforced concrete foundation extending at least to the frost depth. Repair and repointing of the existing masonry will not reduce the possibility of future movement due to frost heave and expansive soils. Evidence of past foundation repairs (Such as the new concrete wall on the north side of the house indicate foundation problems have occurred in the history of the structure.

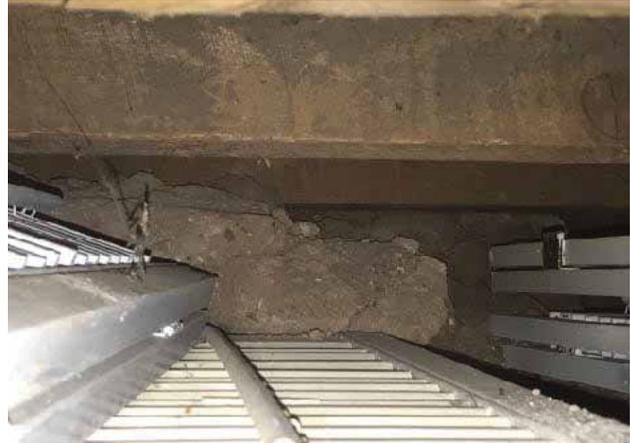
Description: The floor consists of wood 2x8 floor joists with random supports in varying directions. The framing for the front porch floor is similar. Several locations under the porch and main level floor were supported by wood posts bearing on grade. The crawl-space toward the front of the house was small and not accessible.

joists should be reinforced or replaced. The ends of the joists bearing directly on the foundation should be observed and protected from moisture. The framing for the front porch should be replaced with properly designed joists suitable for exterior conditions.

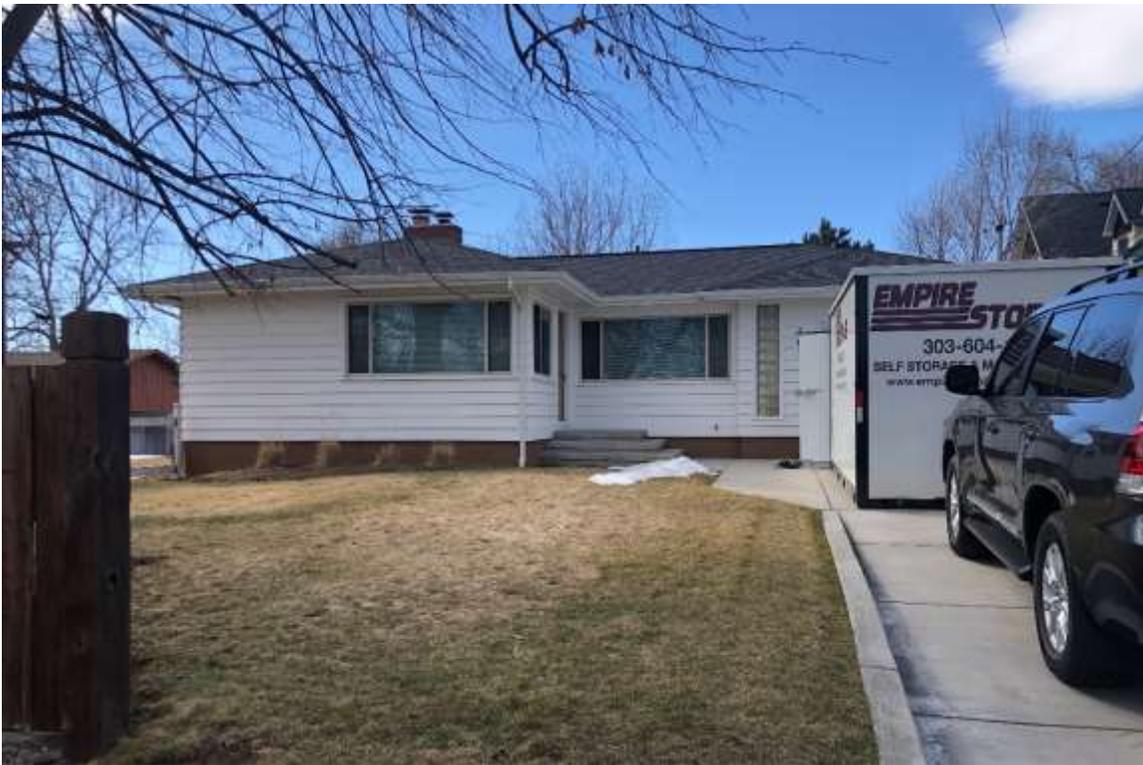
105 Roosevelt Avenue. East view, 2020.

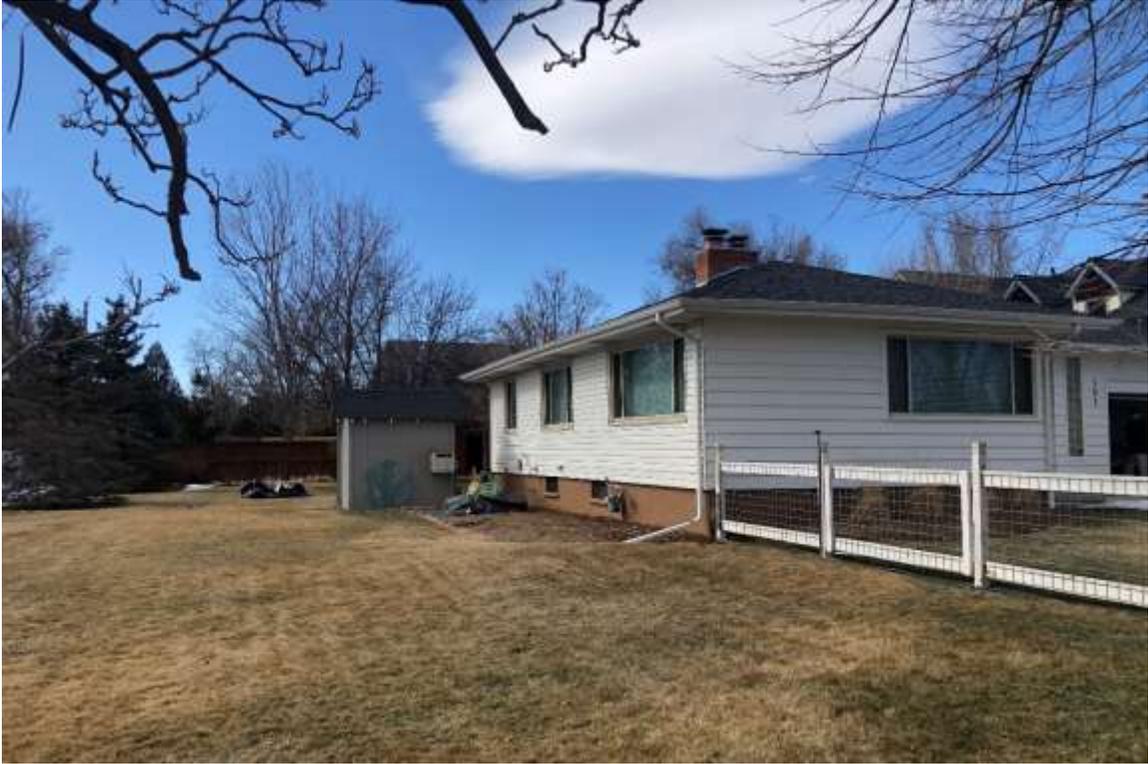
105 Roosevelt Avenue. Southeast view, 2020.

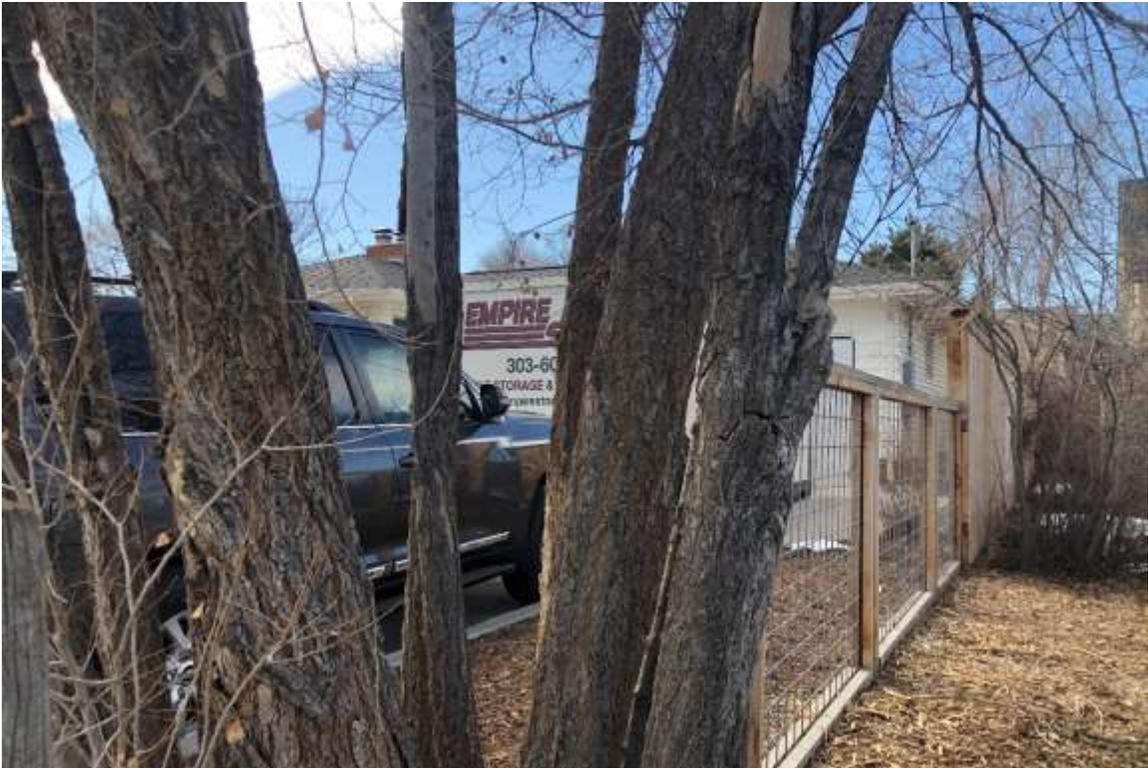
105 Roosevelt Avenue. North view, 2020.

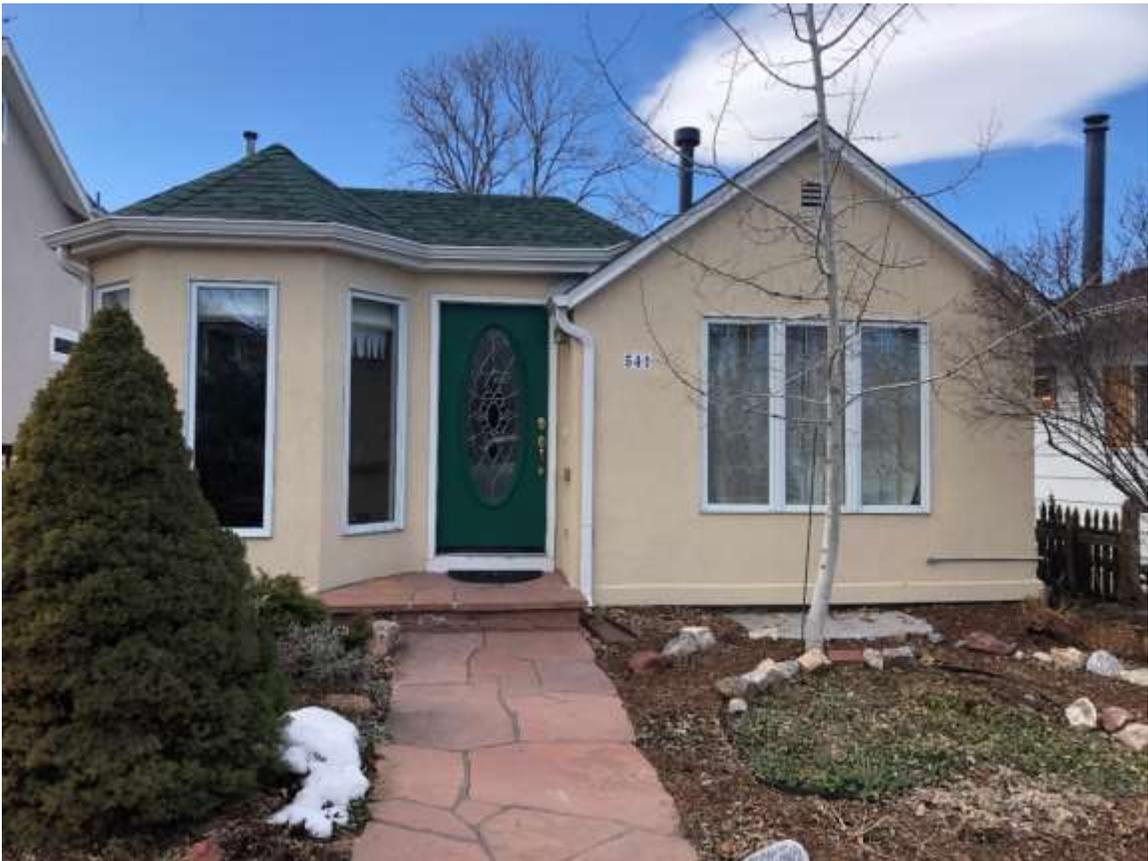
541 Jefferson Avenue, east view – Current Photo

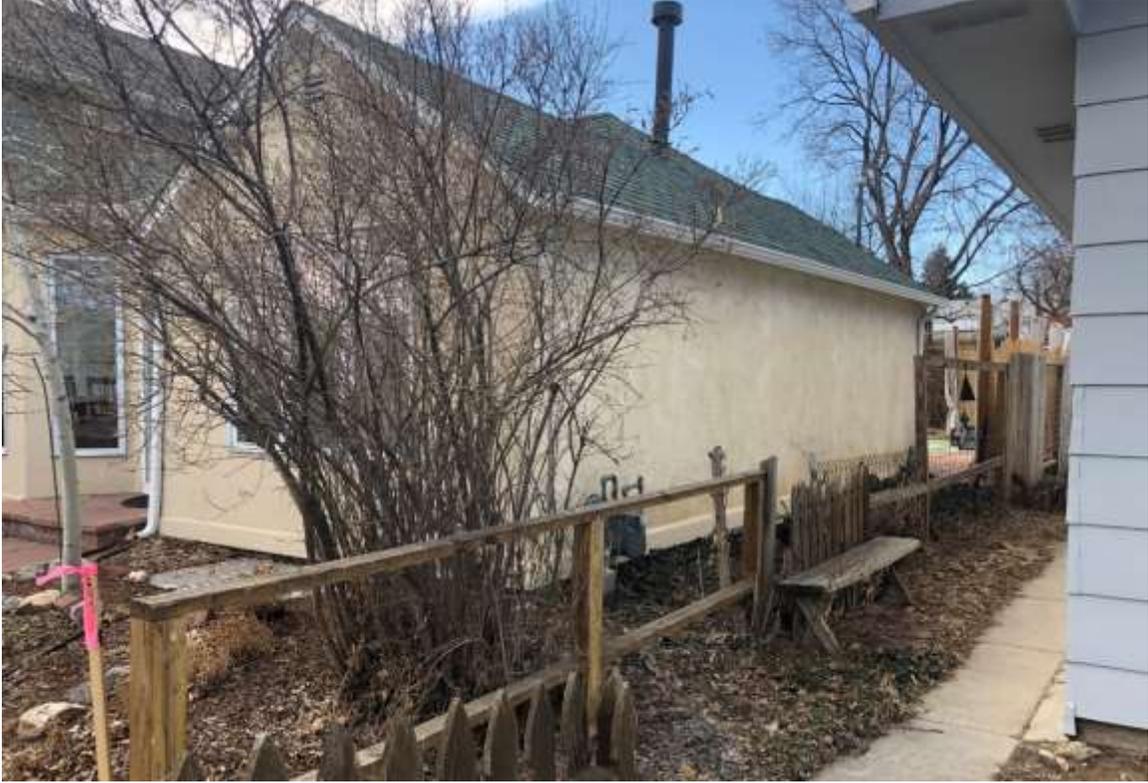
541 Jefferson Avenue, northeast view – Current Photo

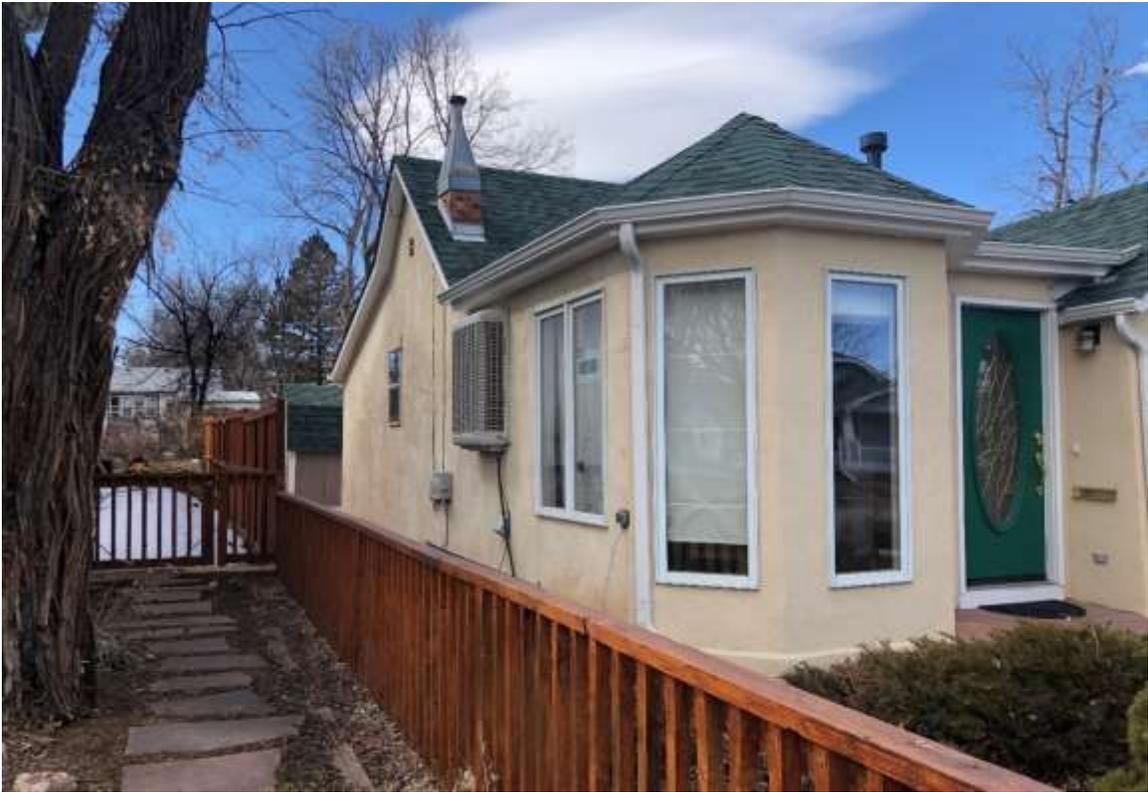
541 Jefferson Avenue, south view – Current Photo

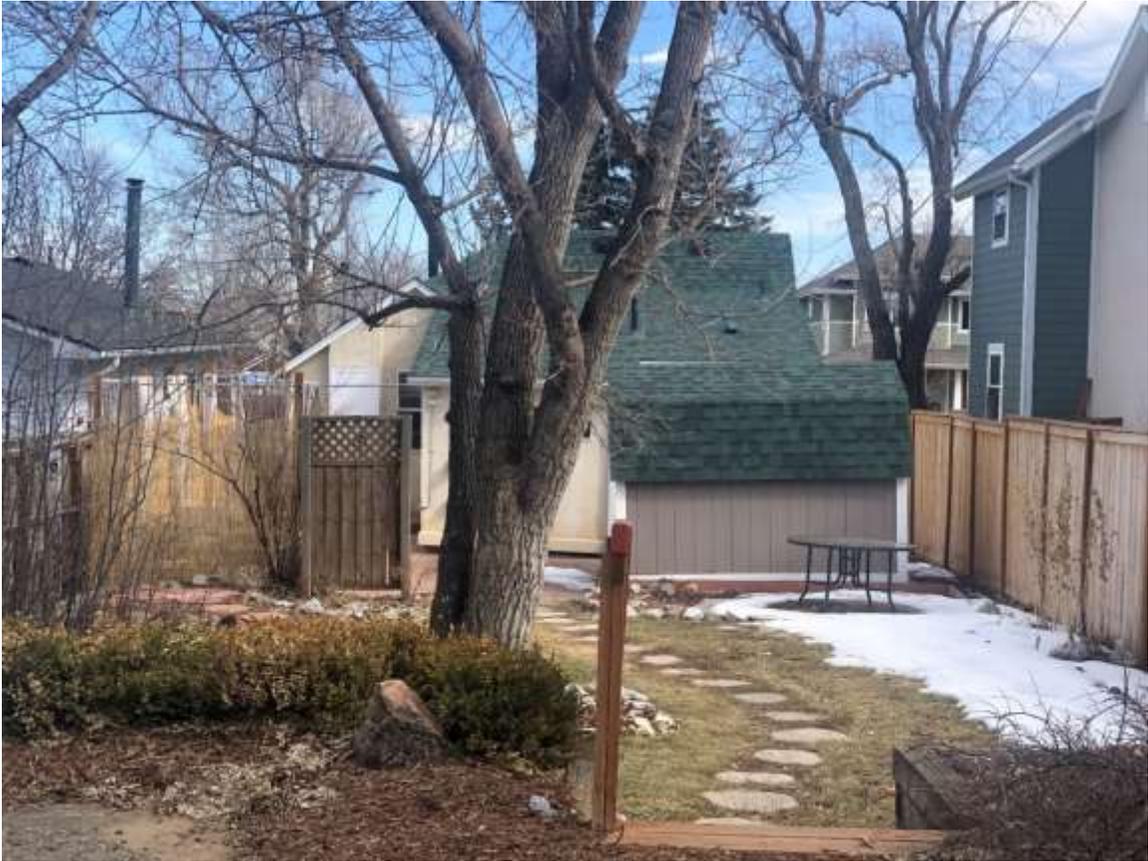
541 Jefferson Avenue, west view – Current Photo
