## HISTORIC STRUCTURAL ASSESSMENT 741 JEFFERSON AVENUE, LOUISVILLE, COLORADO

October 16, 2024

Andy Johnson, AIA  
DAJ Design  
922A Main Street, Louisville, CO 80027  
303-527-1100; [andy@dajdesign.com](mailto:andy@dajdesign.com)

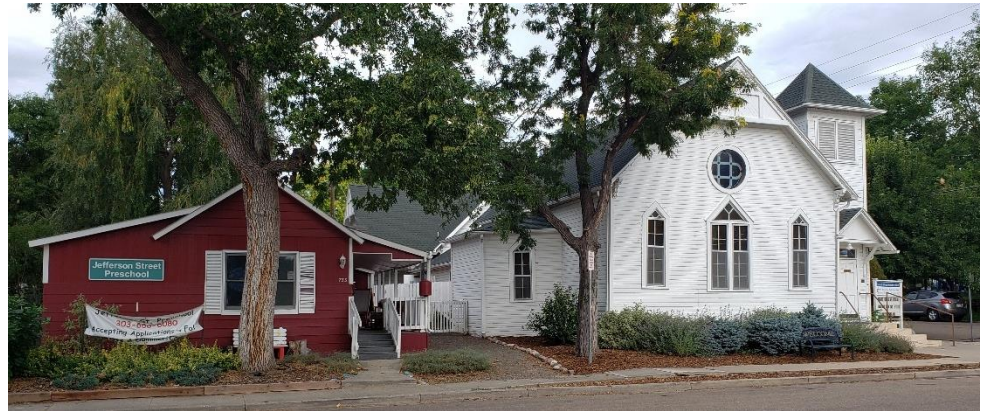
With the building footprint and attached deck covering much of the site, there are minimal landscape features to analyze. Overall, the landscape features are in good condition and appear to be well maintained. The trees and large shrubs appear to be healthy and well maintained and there are no areas of ground overgrowth or signs of neglected landscape maintenance.

*Well maintained landscaping and mature trees along Jefferson Avenue with the preschool on the left.*

1. Work with a licensed arborist to maintain the mature trees and shrubs. Ensure that growth does not interfere with the building roof, siding, or foundation.
2. Keep overgrowth trimmed away from the house and overhead electrical lines and remove any overhead branches.

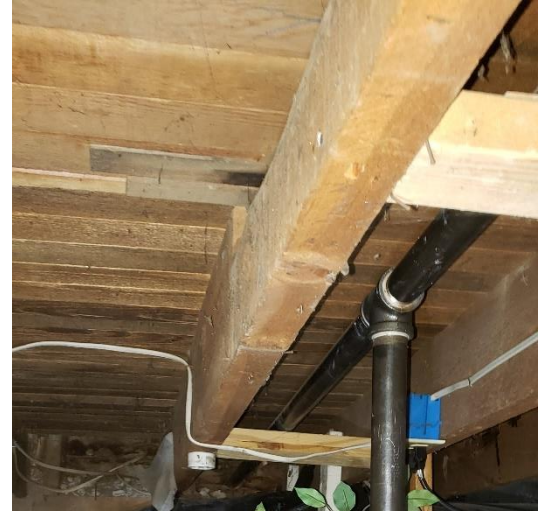
The floor joists of the original 1892 construction are 2x8 rough-sawn joists at 16-inches on-center running in the north-south direction and spanning approximately 12 feet to a center beam line. The central beam line is supported with adjustable pipe columns that are not original and it is unclear if the columns bear on proper footings, if any. The north addition appears to be constructed in a similar manner to the original construction, though this crawlspace area is minimally observable from within the basement. The floor joists appear to be of the same size and span in the same direction, but supports could not be determined.

*Original construction floor framing & underside of flooring seen in the basement.*

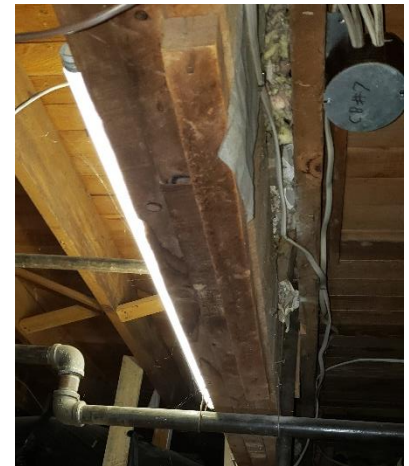
There is a 3-ply 2x8 dropped beam that supports the original west exterior wall at the transition from the original construction to the 1941 addition. This beam is not properly supported throughout but spans the full length. The 1941 addition has 2x8 nominal floor joists at 16 inches on-center spacing that span in the north-south direction. These floor joists are spliced on a center grade beam constructed of poured concrete, within the crawlspace area. The entire crawlspace is not visible but the grade beam and floor joists extend as far as is visible.

*3-ply beam at transition from original floor (right) to the 1941 addition (left).*

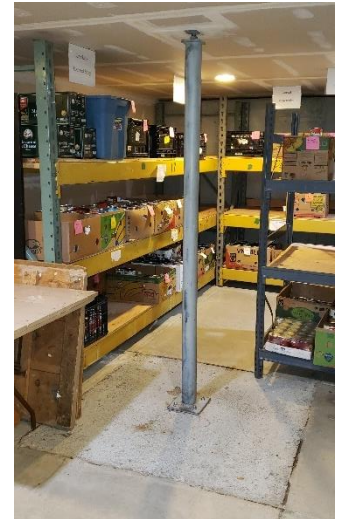
*Steel column and footing in the 2000 basement.*

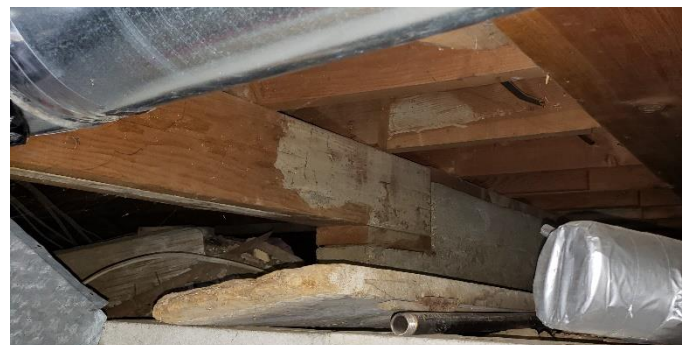
The various beam supports, other than the 2000 addition, are in poor condition as well. The beam supports consist of poured concrete grade beams and adjustable steel columns, but it is unclear if any of these elements are supported by footings. The materials, sizing, and construction methods of the beam supports do not meet minimum IRC code requirements for today's standards. The steel columns and concrete footings seen in the 2000 basement appear to be in good condition. Further structural analysis of this area is required with deconstructive investigation to determine if all structural members were sized and built according to what is indicated by building records but there were no critical deficiencies observed in this part of the building to warrant that analysis.

*Floor framing and grade beam of the 1941 addition.*

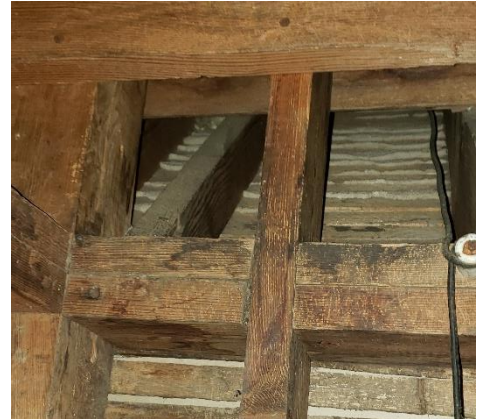
*Original roof framing is only partially visible from within the belltower. Original lathe and plaster ceiling can be seen.*

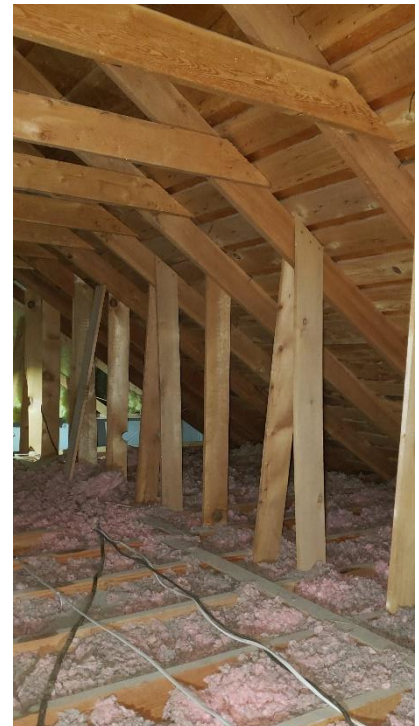
*Roof framing of the 1941 addition.*

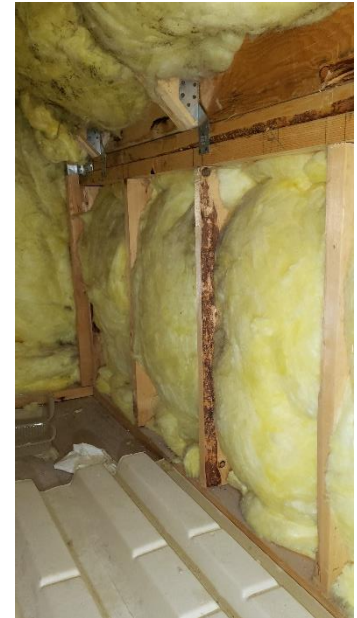
*Roof framing of the 2000 addition supported by a pony-wall.*

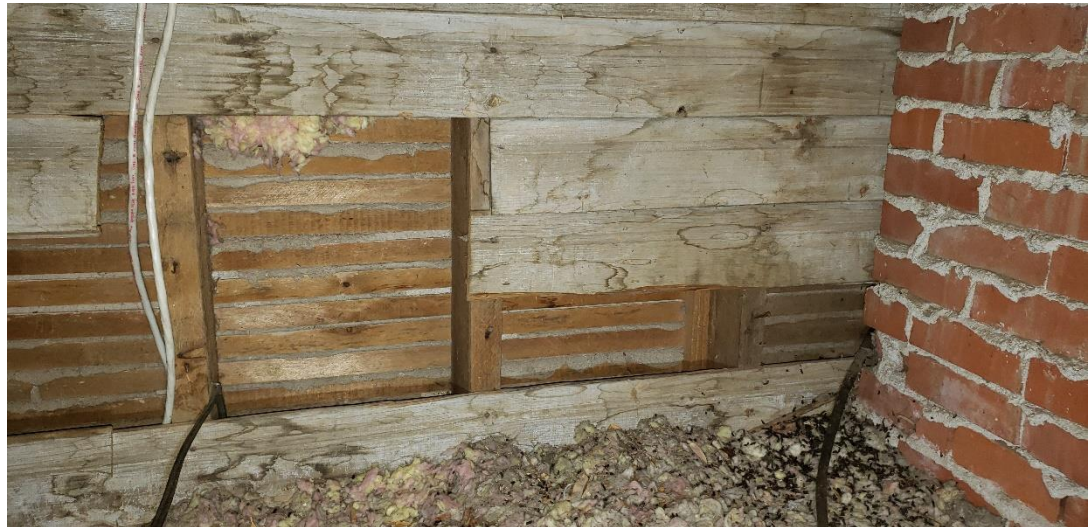
The original church structure appears to have 2x6 rough-sawn wall studs on regular spacing. The original wood siding is attached directly to the wall studs and in several observed locations, the original lathe and plaster remains on the interior face of stud. There does not appear to be any sheathing on the earliest phases of construction.

*Original west wall as seen in the attic of the 1941 addition.*

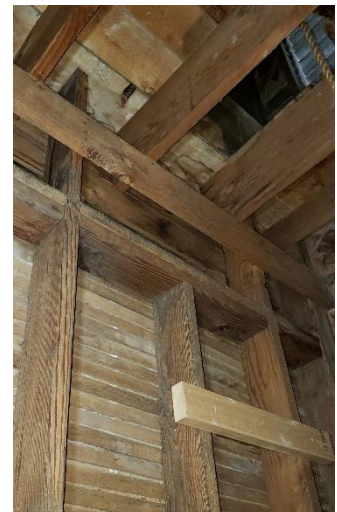
*Wall framing of the bell tower is likely similar to that of the original church.*

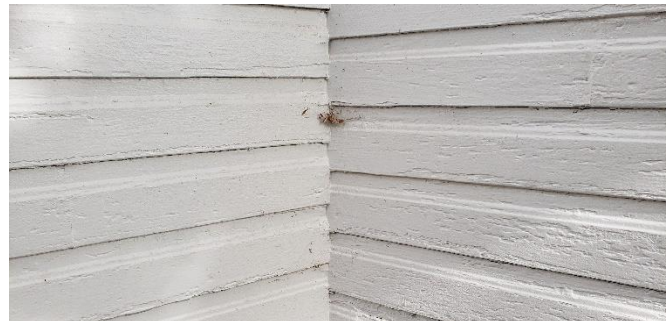
The original church structure is clad in painted wood shiplap siding that is attached directly to the wall studs. The siding has a profile that is similar to a Dutch cove profile but with an added bead at the base of the cove. This siding profile has not been found on other historic buildings in Louisville and a style name could not be determined (based on research conducted by DAJ Design). This siding appears to be original and is only found on the original church structure and the south bay addition.

*Original shiplap siding where the south addition meets the original church structure.*

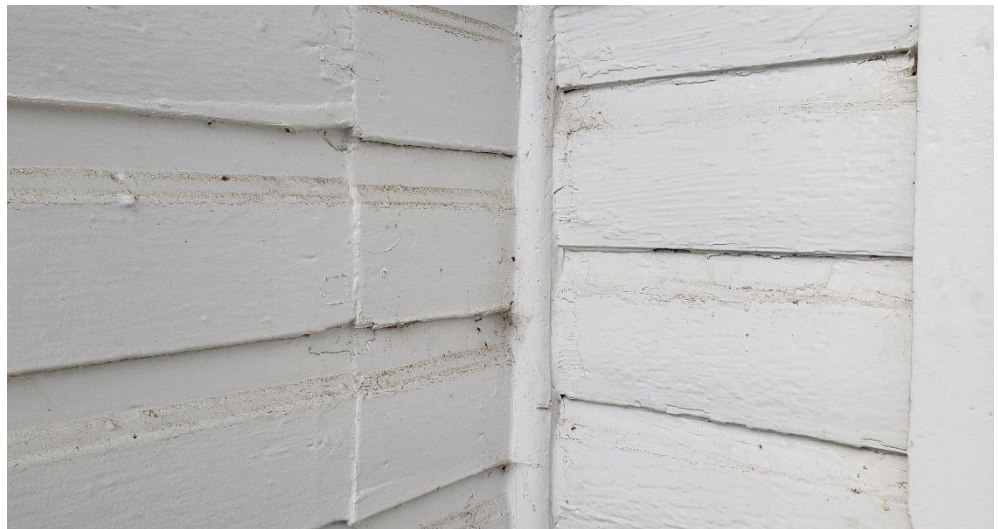
*Original wood siding (left) next to the dutch-cove profile used in later additions (right).*

1. The siding on the entire structure except for the 2000 addition should be scraped, repaired, refinished, or replaced as necessary.
2. The siding of the 2000 addition should be further evaluated for water damage at the base of the siding where it is near or at grade. Replace any damaged boards.
3. The siding of the 2000 addition, where the exterior walls meet lower roof aspects, should be replaced. The siding should be held off the top of the roof shingles by 4 inches. The step flashing beneath may need to be replaced or modified and painted to match the siding.

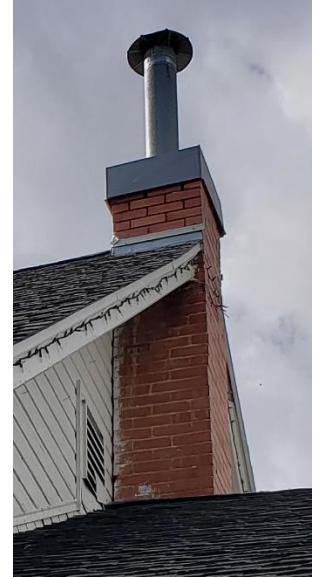
The chimney is in fair condition where visible. The chimney is enclosed on the main floor so the condition of this part of the chimney cannot be assessed. Furthermore, the exposed part of the chimney above the roof could not be accessed to fully analyze its condition, but visually it appeared to be in fair condition where exposed to the elements.

*Brick chimney in 2024.*

1. The chimney should be further evaluated where it is enclosed on the main floor to fully determine the condition. Additionally, the chimney should be further analyzed above the roof where it is exposed to weather.
2. The chimney's masonry may need to be tuck-pointed to stabilize its condition.

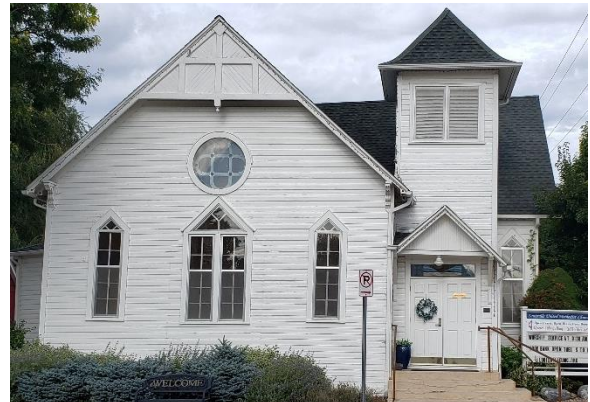
*Church entrance in 2024.*

2. The stairs to the front entrance should be replaced with new concrete stairs in the same location and the same size as the current stairs. Proper waterproofing measures and metal flashing should be added to the building prior to pouring a new landing and stairs. New stairs and handrails shall meet all local building codes.

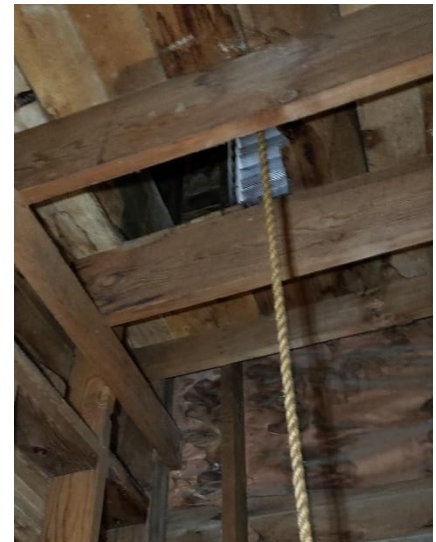
*Framing seen in the bell tower and the bell pull rope.*

The original entrance, bell tower, and west room have all been entirely removed. Evidence remains of all three in photographs and repurposed materials. The new bell tower is in fair condition. The siding and the framing materials and techniques used on the bell tower are in similar condition to those found on the other parts of the church that predate 1941. The bell tower roof framing was not visible for analysis and therefore its condition is unknown. The gable roof framing over the front entrance was also not visible for analysis and therefore its condition is also unknown. However, the gable roof does not appear to be properly supported by the diagonal wood bracing, and it is unclear how the support structure is attached to the bell tower wall. The concrete front stoop is in poor condition. The concrete and finish are cracked at multiple locations throughout and it is likely that there is wood siding that the concrete was poured against that is not waterproofed and is likely rotting.

1. Without the opportunity to fully observe the bell tower and front entrance roof structure, we do not have any recommendations currently. If the opportunity presents itself, the exterior walls and roofs should be assessed by a licensed structural engineer. The owner is to note that the walls will need to be evaluated if any remodels or additional load is to be added. It is likely that additional studs may need to be added for the increased loads above in combination with the wind load on the building. Also, if any remodel or addition plan is in place, new braced wall lines may be added by adding OSB or gypsum board on the interior side of exterior walls to resist wind loading.

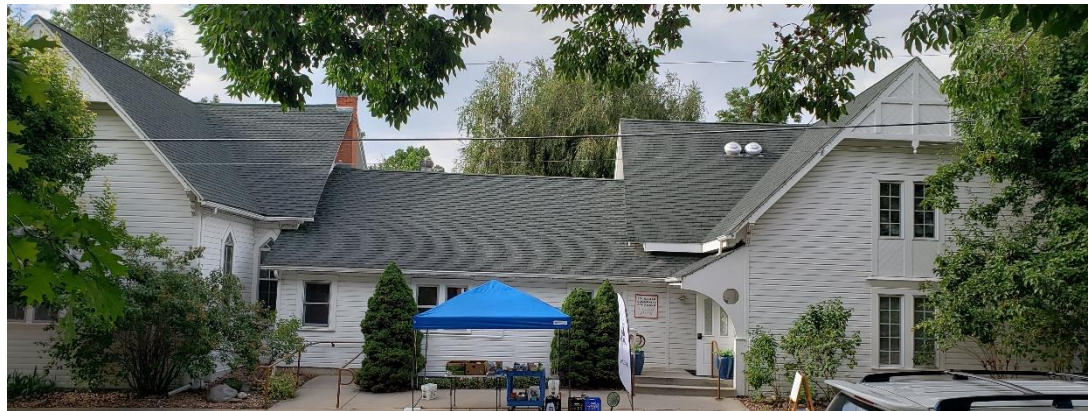
*An asphalt composite shingle roof covers all aspects of the building.*

The asphalt composition shingle roof seems to be in good condition. The cricket at the east side of the church appears to be at a roof pitch steep enough to allow for asphalt shingles per code. Roof venting does not appear to be adequate for the amount of attic space.

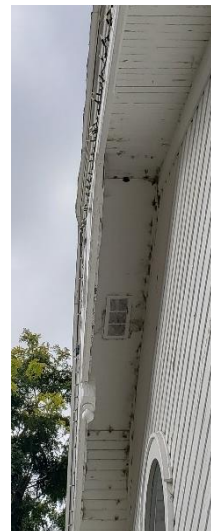
*Venting at the original barge rafters.*

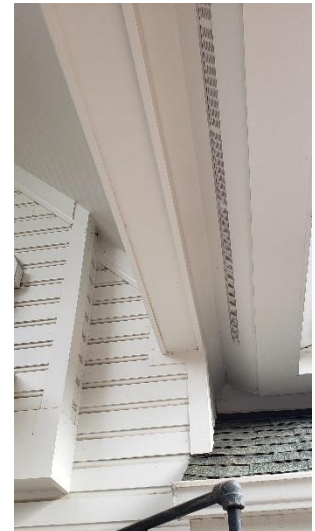
*Soffit venting at the 2000 addition roof eaves.*

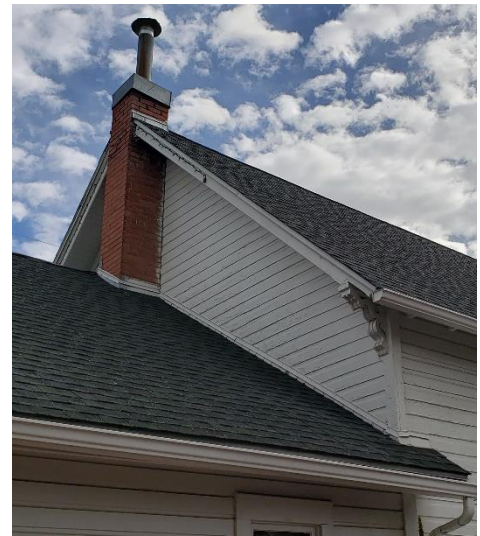
The roof flashing appears to be in good condition but access to fully analyze all flashing locations was minimal. Flashing appears to be located at all location required by code and appears to be properly attached and caulked. It is likely that all roof flashing areas were assessed and any repairs made during the most recent re-roof.

*Flashing at the chimney roof penetration and where the low roof meets the original wall face.*

1. The metal flashing should be fully analyzed by a licensed professional when the opportunity presents itself. Special attention should be given to all areas where low roof aspects meet exterior walls and at the chimney connection to the roof. Repair or replace any damaged or missing flashing.

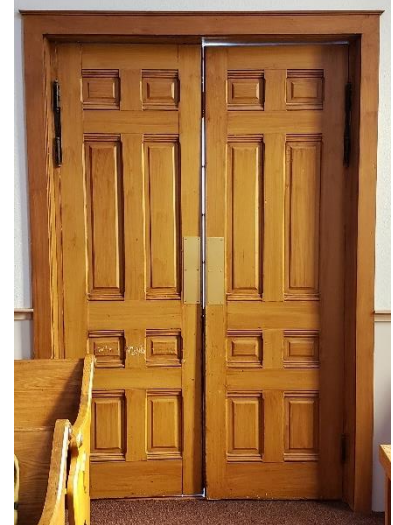
*Original front entrance doors now located inside the church.*

1. We do not have any recommendations for the exterior doors at this time.
2. Further investigation should be made to determine the historic nature of the interior wood doors at the entry. If these doors are indeed found to be the historic front doors, proper maintenance should be performed to prolong their lifespan. The repurposing of these doors fits the historic nature of the lifecycle of the church and therefore their current locations should remain.

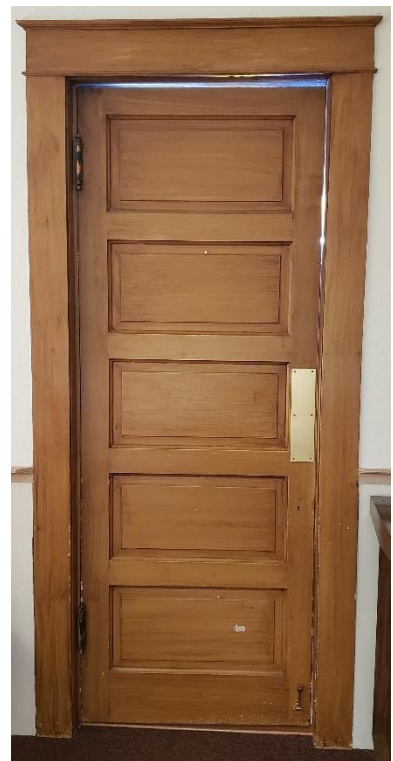
*Interior door once used as a main entrance door.*

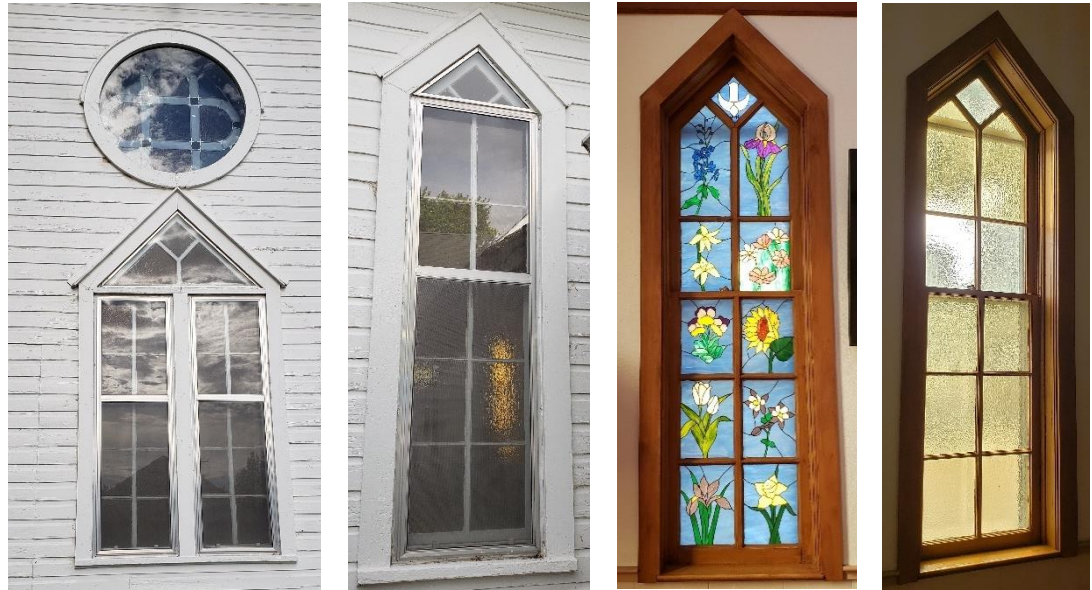
*Typical windows found on the earliest parts of the church.*

Overall, the windows are in good to poor condition. Operation was not tested on all windows, but some windows appear to be operable to various extents while others do not. The windows of the 2000 addition appear to be in good condition and still within their expected lifespan. The windows of the 1941 addition appear to be in fair condition, create good seals, and these windows have aluminum storm windows for added protection. Some of the counterweight windows throughout the church have missing or damaged weight attachments and it is unclear if the weights are still present or if they have been removed. The windows that predate 1941 are in poor condition as they are well beyond the expected lifespan of such windows. However, these windows appear to have been well maintained over the years and the aluminum storm windows have likely prolonged their lifespan.

1. All of the windows other than those that are part of the 2000 addition should be properly restored as described below. Windows should be made to be operable, create proper seals, and only use replacement parts where no other option is available.
  - a. Remove and replace all window putty.
  - b. Clean and restore all glass panes with special care given to stained glass.
  - c. Repair and refurbish all wood window sash elements including stiles, rails, and muntins.
  - d. Repair and refurbish all wood window frames.
  - e. Repair and refurbish all counterweights and restore to operability.
  - f. Repair and refurbish all pin-stops.
  - g. Repair and refurbish all hardware including locking mechanisms. Restore to original locks where replacements have been installed.
  - h. Install new storm and screen windows with minimum frames.

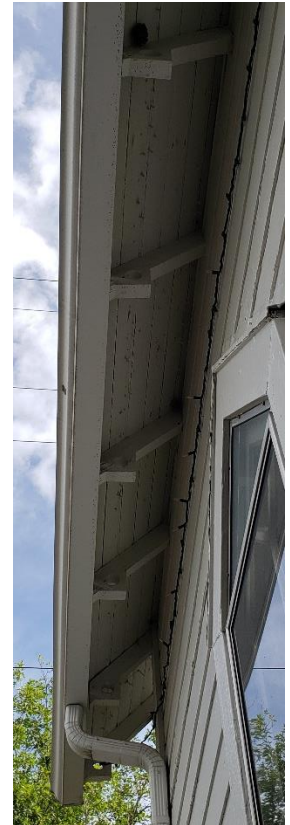
Overall, the exposed wood rafter tails, barge rafters, clapboard, soffit and fascia range from good to poor condition. It is difficult to fully assess the condition of the wood elements as the layer of paint is significantly deteriorated. However, some of the wood is exposed and evidence of weather damage is visible as can be expected for exposed wood of this age. Generally, the soffit, fascia, and barge rafters of the 2000 addition are in good condition. These same elements range from fair to poor on the older parts of the church.

*Original church rafter tails.*

Scrape, repair, refinish, or replace all exposed painted wood roof elements.

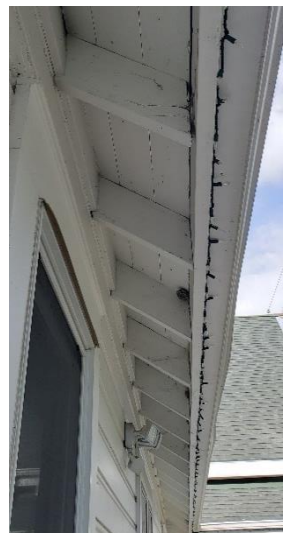
*1941 addition rafter tails.*

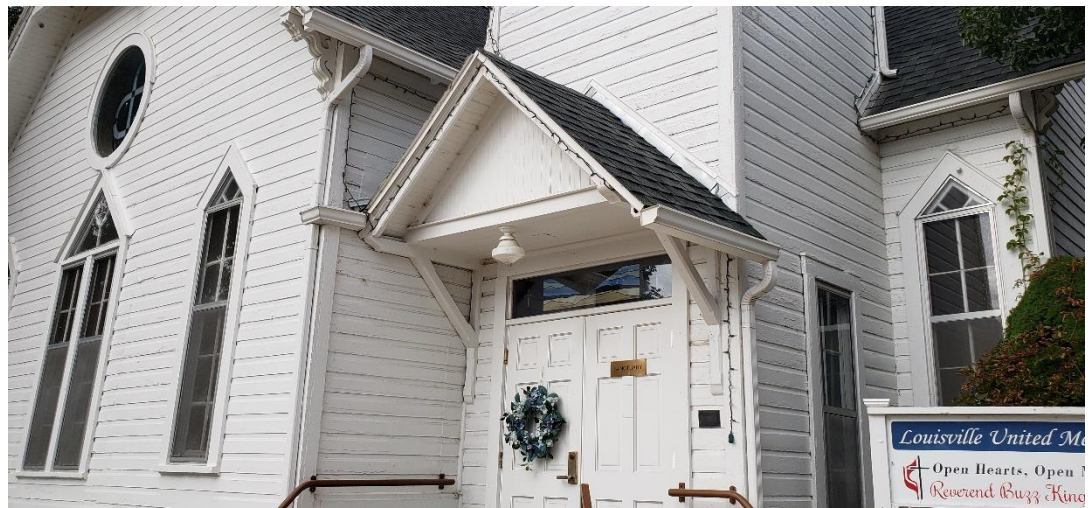
*Painted wood trim pieces typical throughout the church.*

Overall, the painted wood trim ranges from good to poor condition. The trim of the 2000 addition is in good condition as this is all relatively new and still within the expected lifespan. The wood trim of the 1941 addition and earlier construction appears to have been well maintained over the years, but the wood appears to be largely original and is well beyond the expected lifespan for wood elements exposed to weather. Some of the wood trim at the top of the walls is in fair condition as it is protected from weathering by the roof overhangs.

Repair, replace or restore the window and door trim, frieze board, and corner trim.

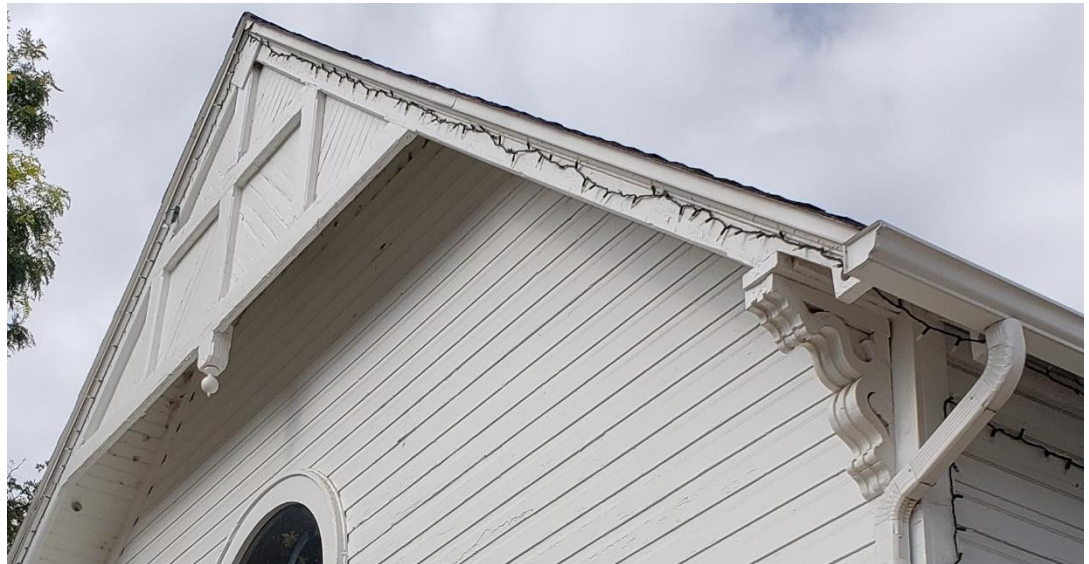
*Gable end barge boards, pendants, and brackets found on the original construction and 2000 addition.*

Overall, the painted wood ornamentation ranges from good to poor condition. The ornamentation of the 2000 addition is in good condition as this is all relatively new and still within the expected lifespan. The ornamentation of the pre-2000 construction appears to have been well maintained over the years, but the wood appears to be largely original and is well beyond the expected lifespan for wood elements exposed to weather. Some of the wood trim pieces at the top of the walls are in fair condition as they are protected from weathering by the roof overhangs.

Repair, replace or restore the decorative barge rafter brackets and the decorative barge boards.

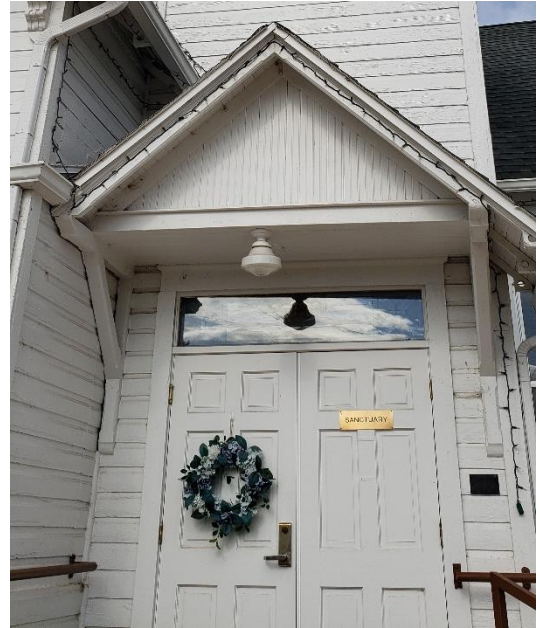
*Main entrance pendant light fixture.*

1. Further analysis of the light fixture at the front entrance should be done to determine whether the fixture is historic. If determined to be an historic fixture, the fixture should be repaired as needed.
2. Consider installing new exterior lighting that complies with Dark Sky regulations at all non-historic locations.

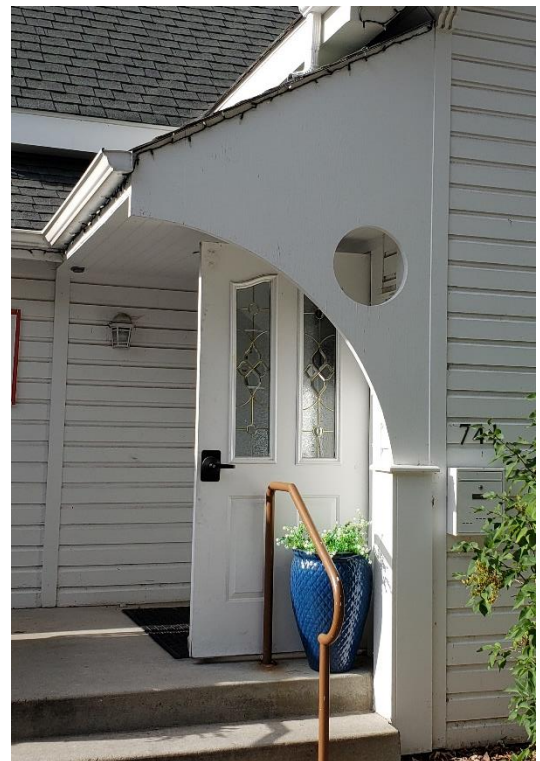
*Several matching exterior light fixtures appear to have been added in 2000.*
