**Historic Preservation Commission
Agenda
June 15, 2020
6:30 pm**

PROJECT INFORMATION:
ADDRESS: 925 Jefferson Avenue
LEGAL DESCRIPTION: Lots 6-7, Block 11, Jefferson Place
DATE OF CONSTRUCTION: 1891

REQUEST: A request to Landmark 925 Jefferson Avenue and a request for an Alteration Certificate and Preservation and Restoration Grant at 925 Jefferson Avenue.

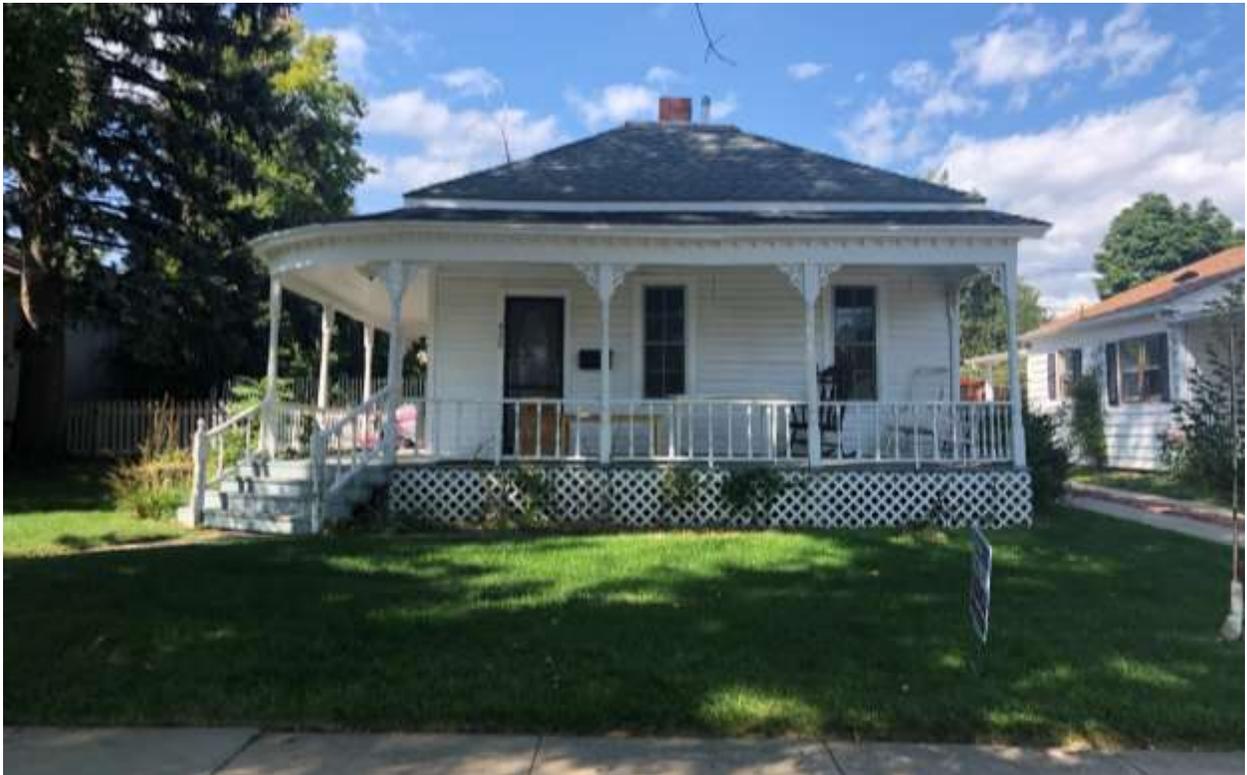
925 Jefferson Avenue, east view – Current Photo

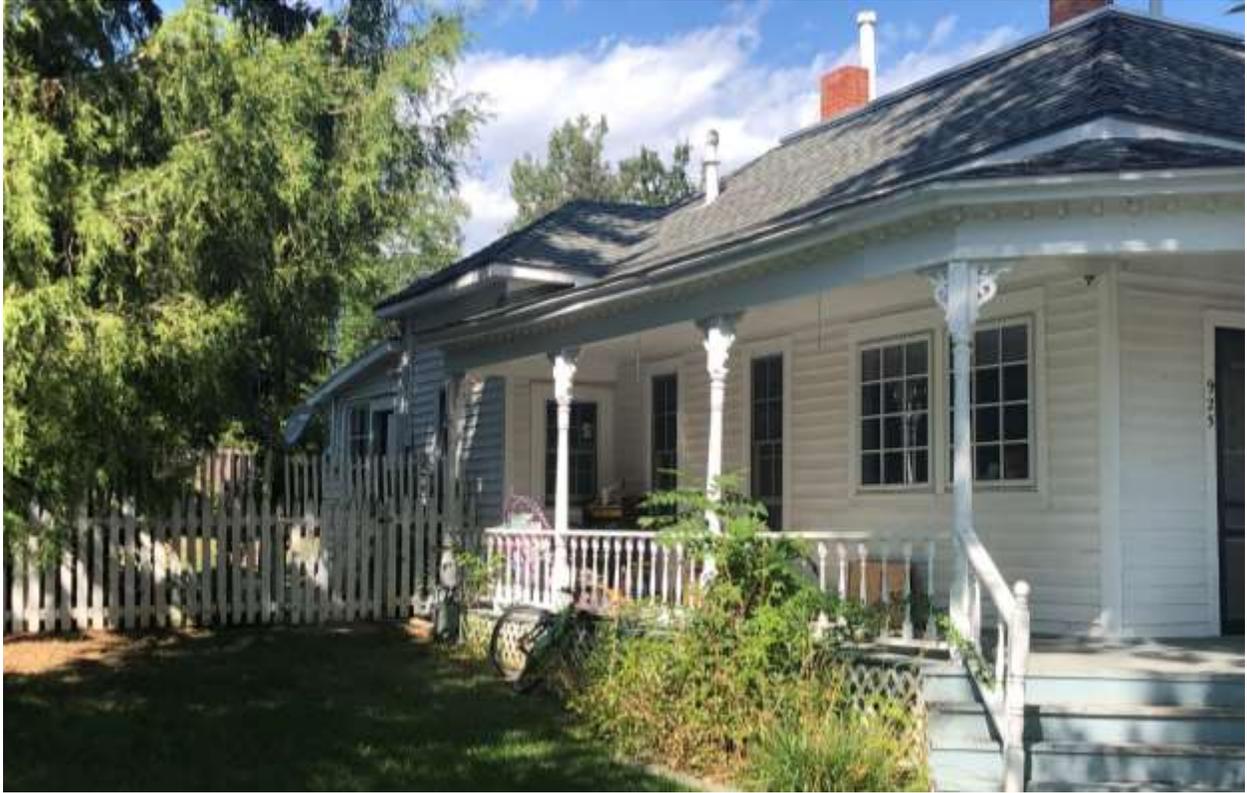
925 Jefferson Avenue, south view – Current Photo

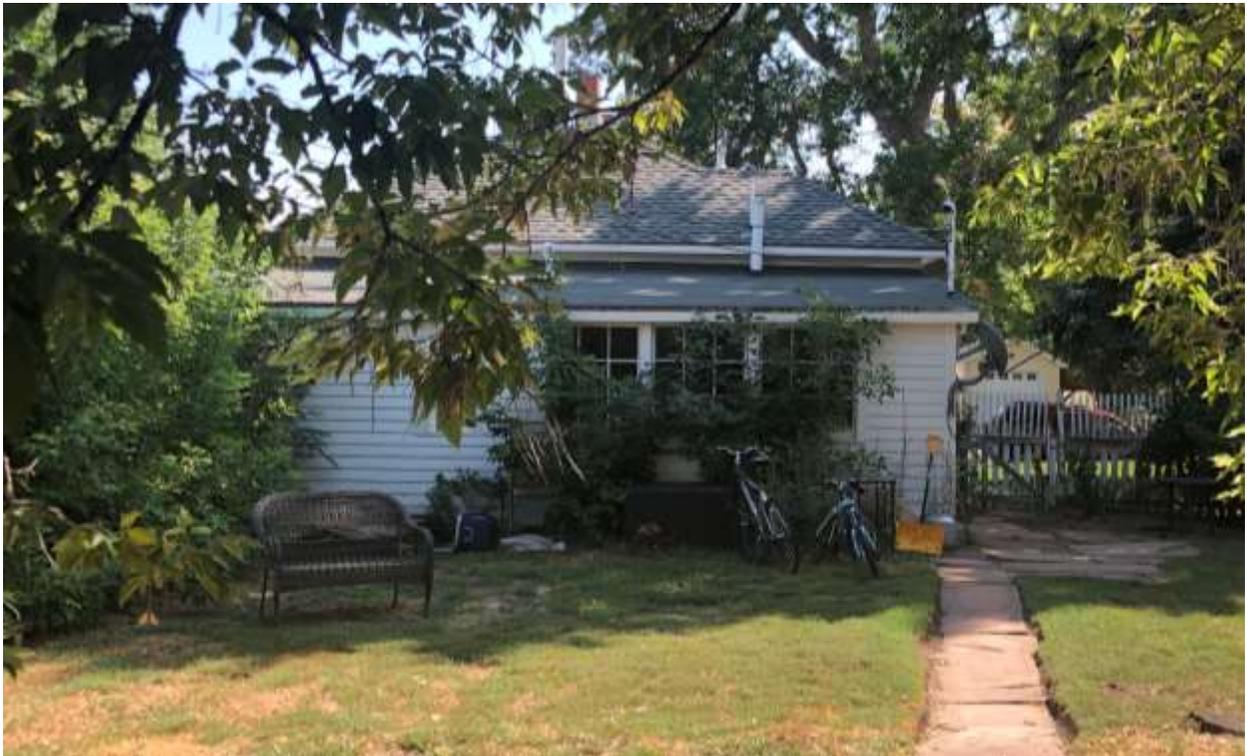
925 Jefferson Avenue, west view – Current Photo

925 Jefferson is a one-story wood frame structure with a rectangular plan, with its primary facade facing east to Jefferson Avenue. The foundation is brick. The exterior is clad with horizontal wood lap siding painted white. The main roof is hipped with two red brick central chimneys. A wraparound porch stretches across the full width of the front facade and along the south side. The porch has a hip roof with a frieze and dentils. The porch roof is supported on turned wood posts with decorative brackets. A concrete walk leads to four wooden steps at the corner of the porch. The stairs have a newer turned wood posts and railings. The porch floor is wooden boards painted blue, and the soffit is bead board painted white. The front door is clear finished wood with a nearly full-height oval glass light. A crawl space below the porch is enclosed with painted wood latticework. The west end of the house is a 1957 addition. This extends the full width of the house and has similar wood lap siding, a shed roof, three 9-light wood windows and a side door leading to the back yard.

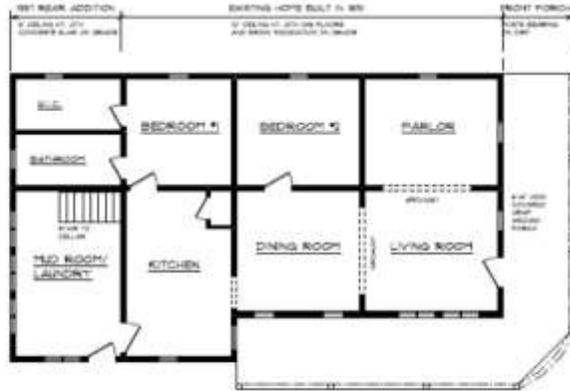
925 JEFFERSON AVENUE
HISTORIC RESIDENCE

New construction | *Historic structure*

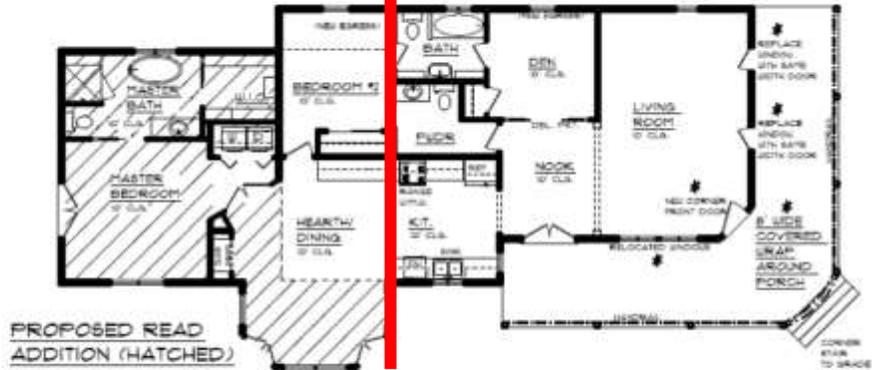
925 JEFFERSON AVENUE
PROPOSED ADDITIONS

- Raise the house in place and install a new foundation and crawl space;
- Reinforce and support the existing floor and roof framing;
- Deconstruct and rehabilitate the wraparound front porch (save and reuse existing posts and ornamental trim);
- Mechanical and electrical demolition and re-installation of new systems per current codes;
- Re-grading for proper drainage;
- On the front façade:
 - Remove and relocate the existing front door to the southeast corner of the house (match design of existing non-conforming front door);
 - Remove the replacement windows and replace with doors;
 - Rebuild and expand the width of the front porch;
- Remove the rear addition to the house (circa 1957) and replace with a modern addition with a larger footprint.

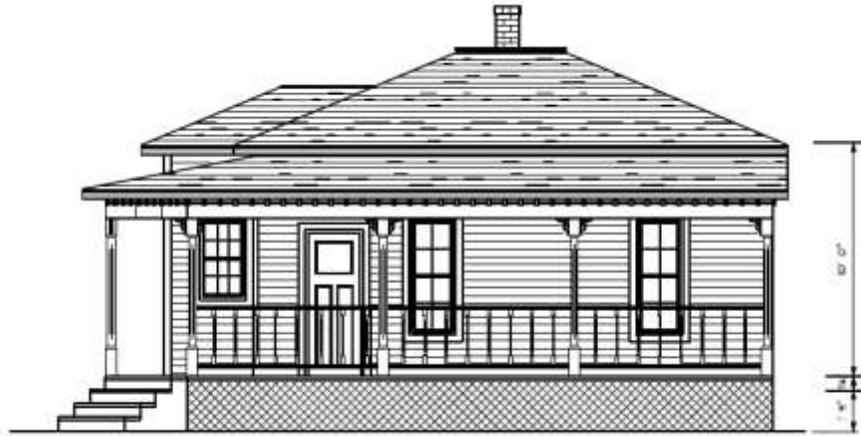
925 Jefferson Avenue – East Elevation, current

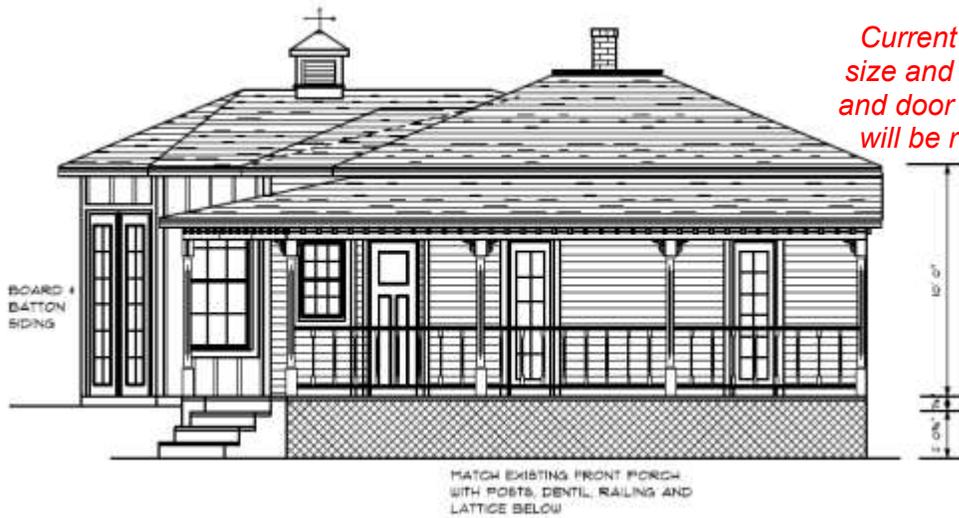
Current window size and location and door location will be retained.

925 Jefferson Avenue – East Elevation, proposed

Staff believes the proposed changes, specifically the changes to the front façade, would result in the loss of the historic character of the historic building. Section 15.36.120 of the LMC gives the criteria for evaluating alteration certificates and based on the proposed design, staff finds that the proposed design fails to meet the standards.

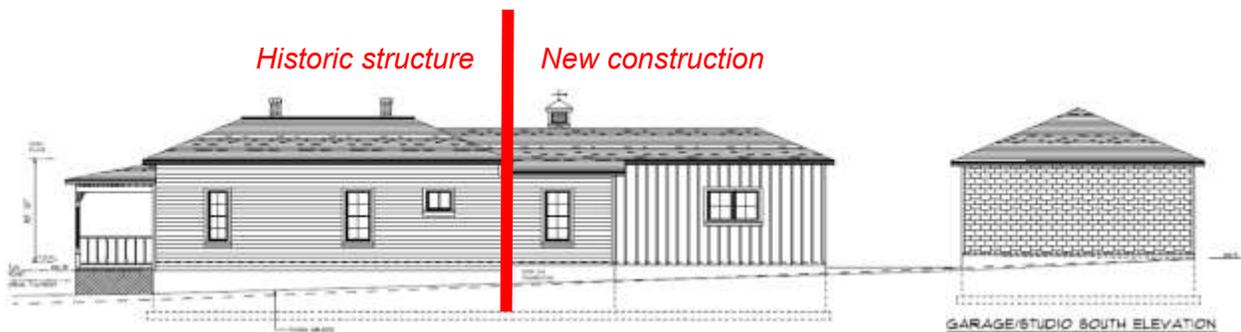
925 Jefferson Avenue – North Elevation, proposed

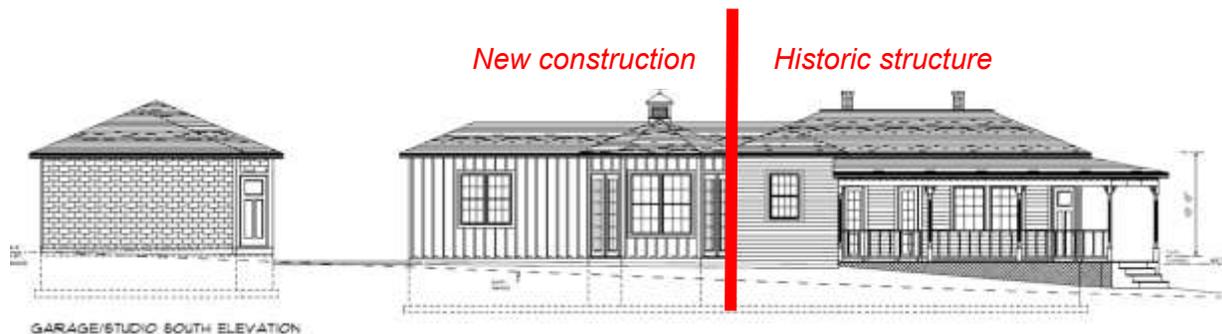
925 Jefferson Avenue – South Elevation, proposed

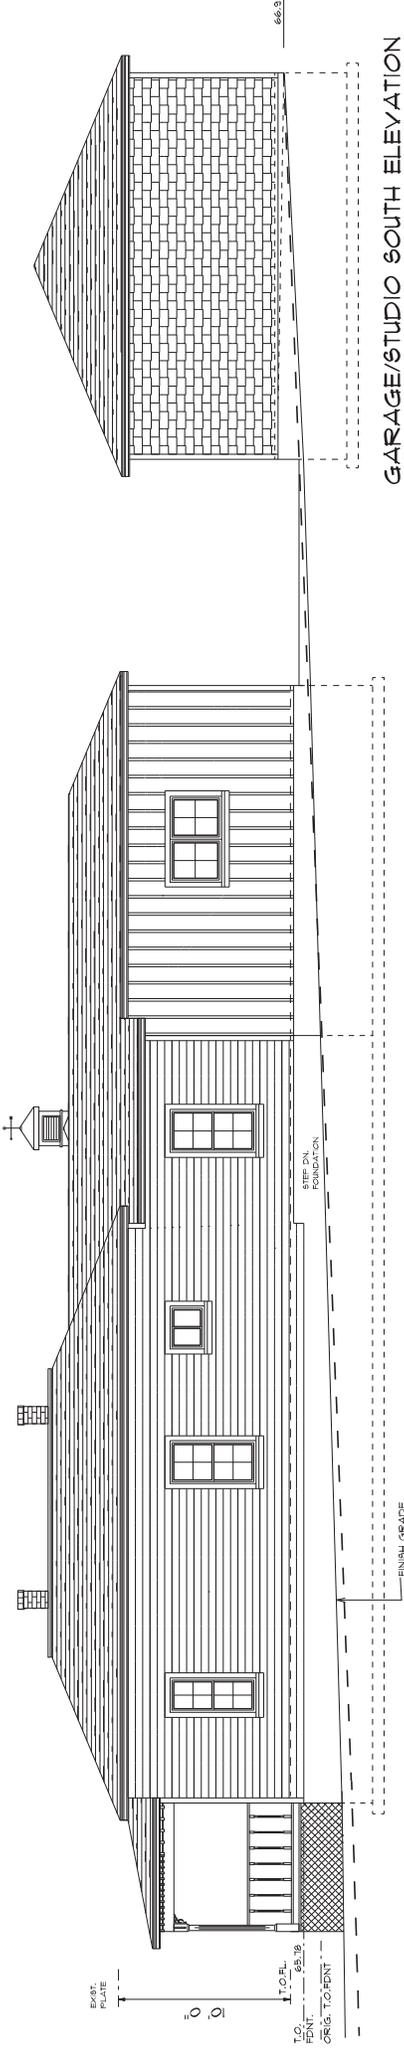
RIGHT (NORTH) ELEVATION

GARAGE/STUDIO SOUTH ELEVATION

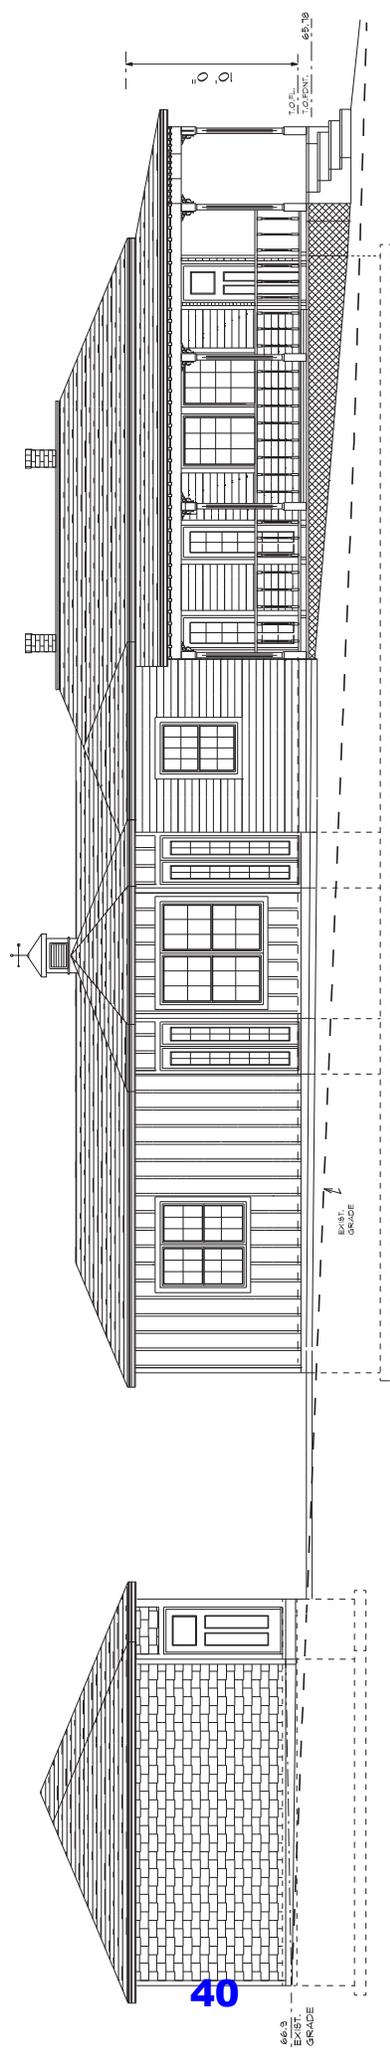
LEFT (SOUTH) ELEVATION

GARAGE/STUDIO SOUTH ELEVATION

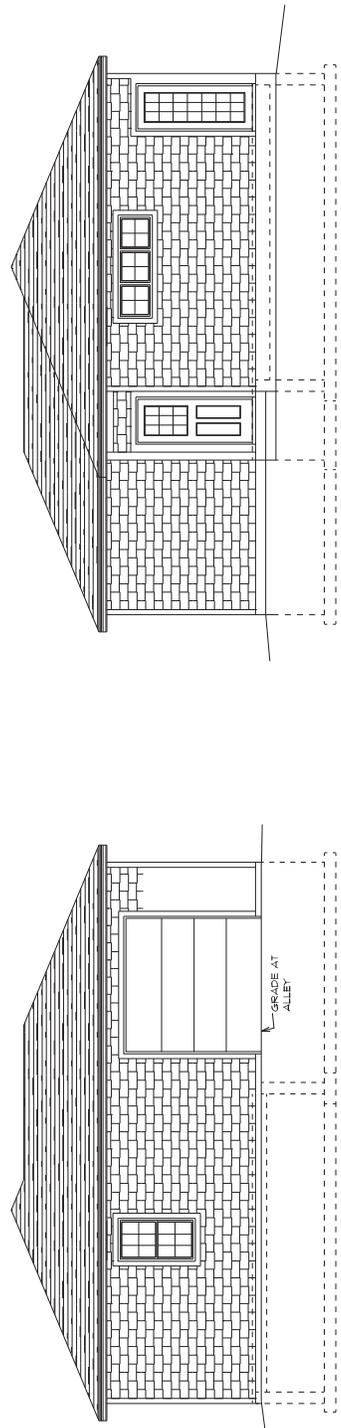
GARAGE/STUDIO WEST ELEVATION
FACES TO ALLEY

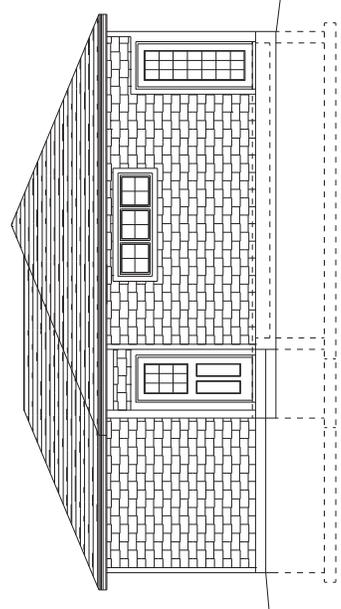
GARAGE/STUDIO EAST ELEVATION
FACES TO MASTER BEDROOM COURTYARD

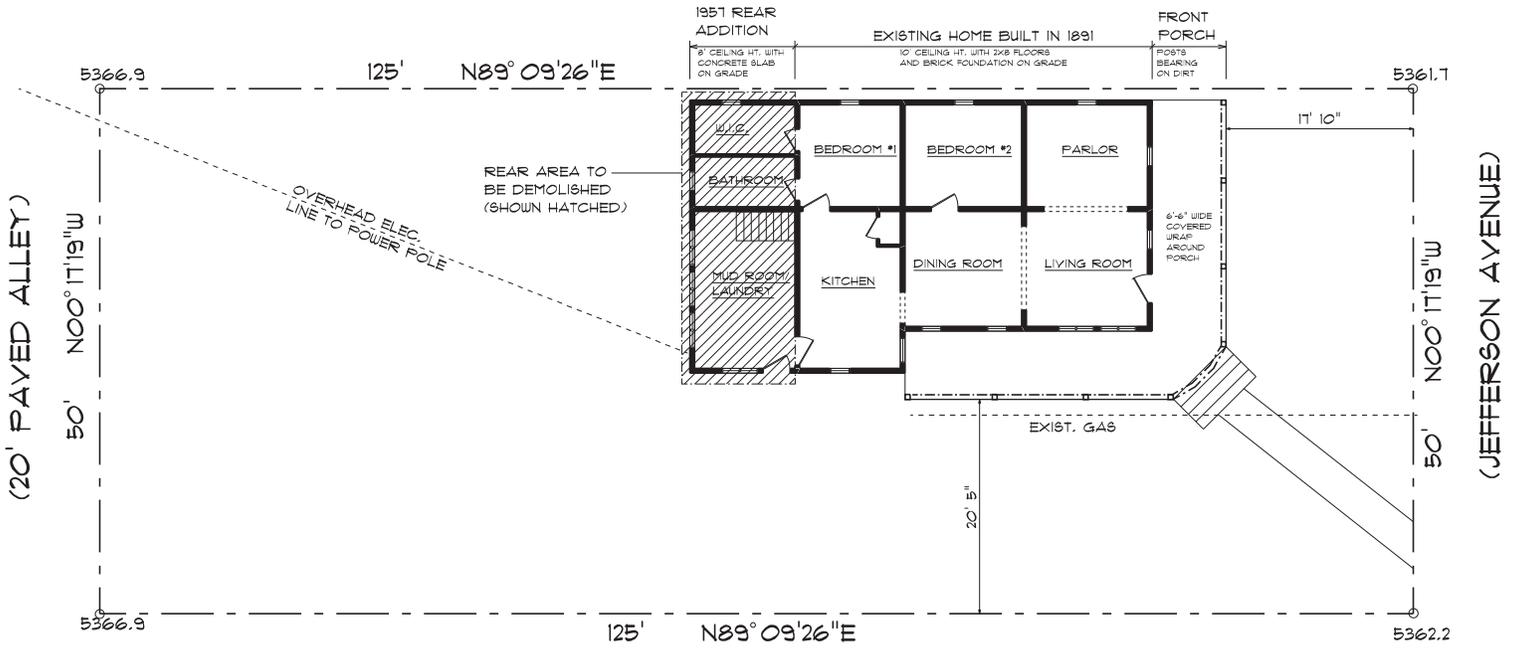
925 JEFFERSON AVENUE
EXISTING SITE PLAN

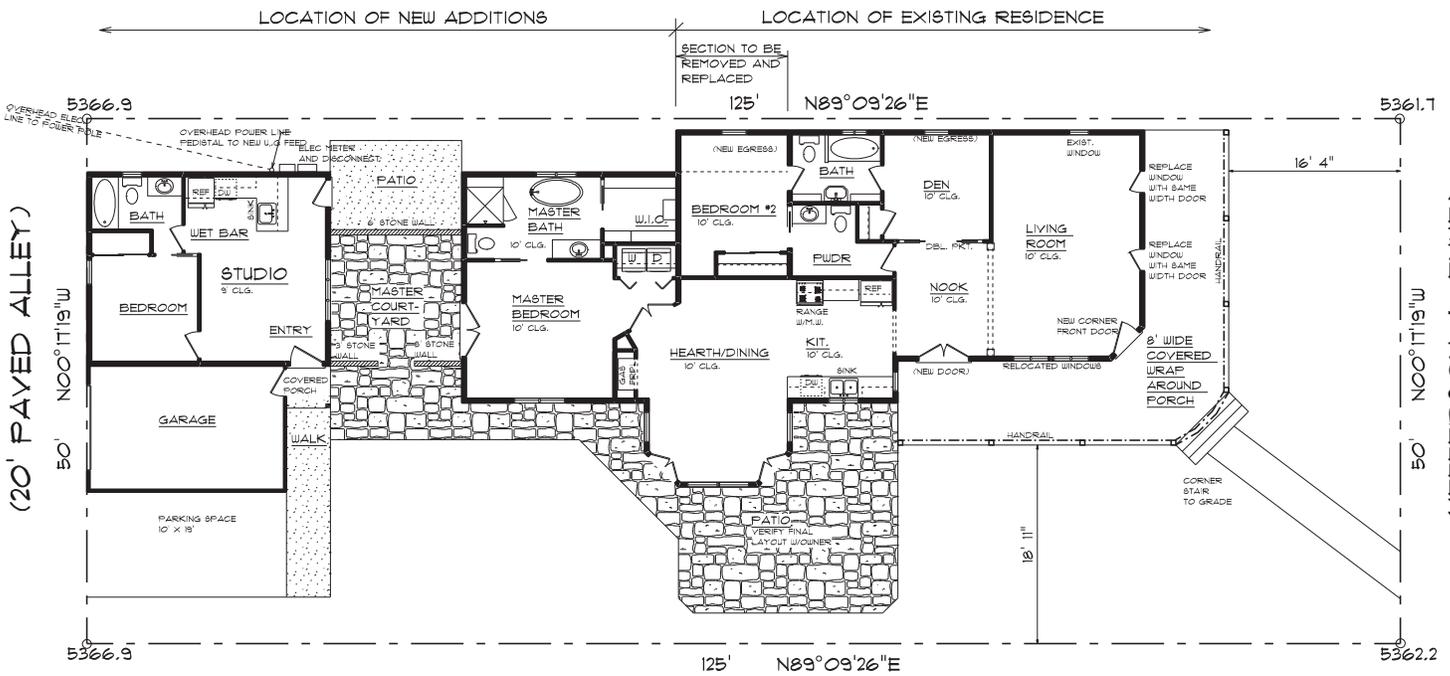
925 JEFFERSON AVENUE
PROPOSED SITE PLAN

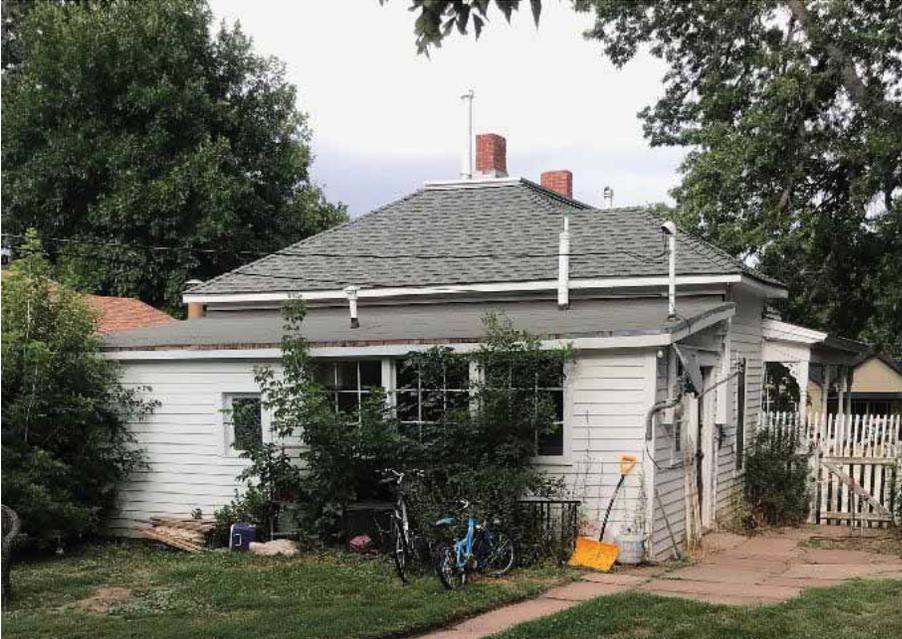
Full width rear addition with vertical trim connection and wider profile siding, low back wall and shed roof.

A Rear Addition was completed in 1957. This addition functioned as a Mud Room with a washer, dryer and large sink. It also includes a steep stair with access to a small underground cellar. This cellar currently holds a gas fired furnace and water shut off valve. The addition is a slab-on-grade, and does not have a foundation.

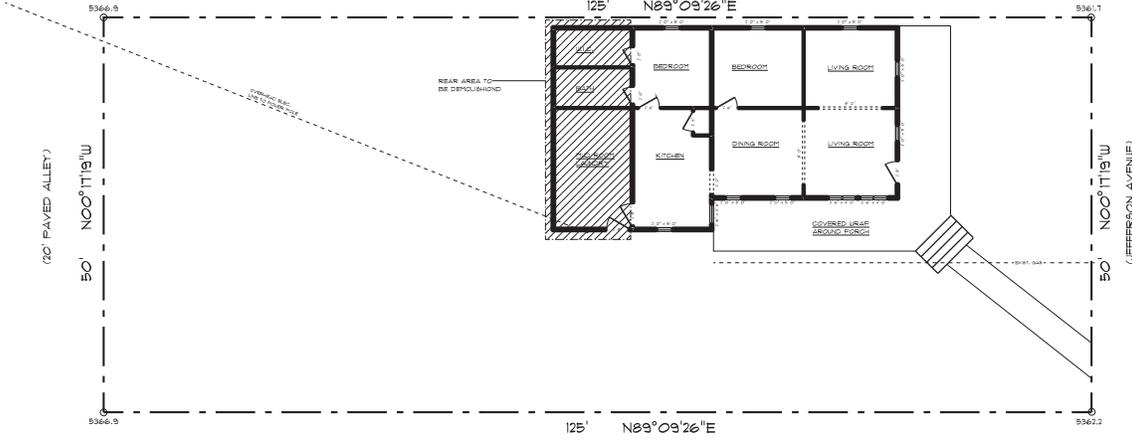
The original footprint of the house as observed. Rear addition in 1957 shown hatched.

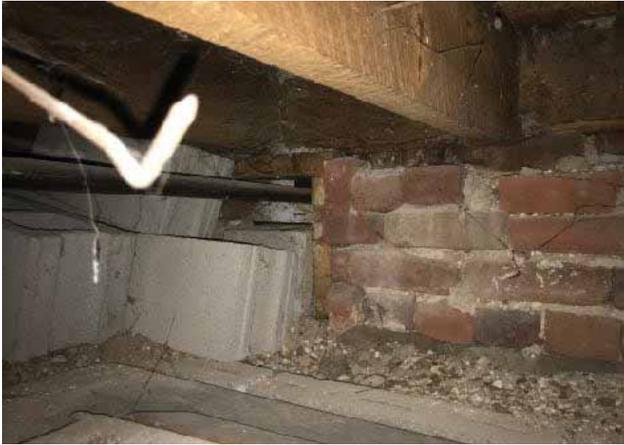
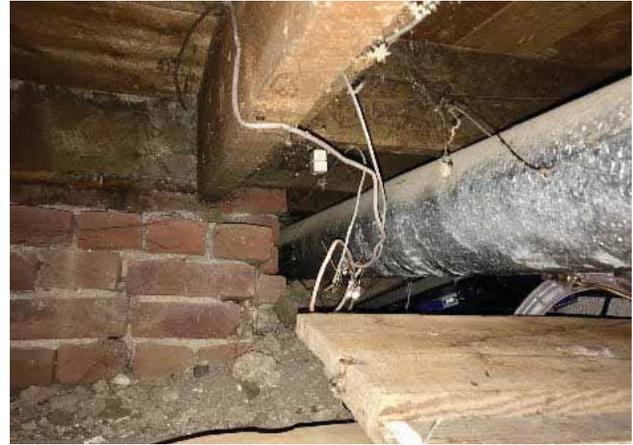
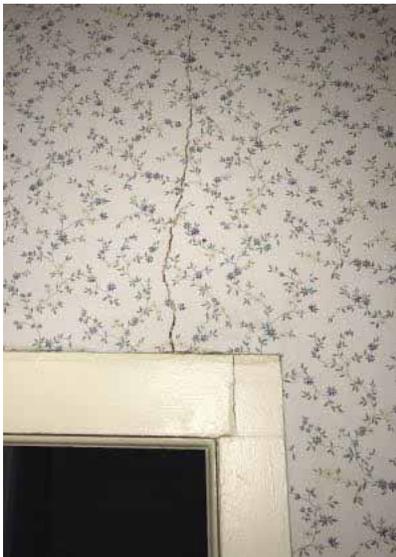
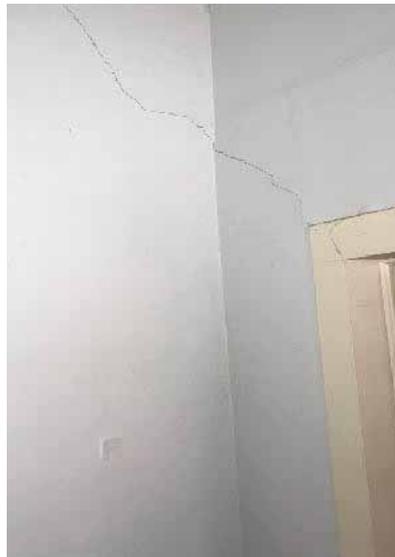
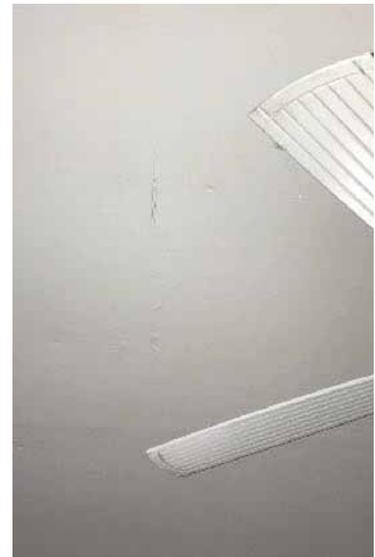
Condition: The condition of the visible brick foundation is fair. Some cracks are visible and some daylight is visible in the crawl-space and should be expected in construction of this type and age. It should be assumed that little or no reinforcement is present. The foundation for the front porch was not accessible and could not be verified. The CMU block supporting the earth for the cellar space is in fair condition and shows signs of movement.

Recommendations: The Engineer recommends the foundation be replaced with a reinforced concrete foundation extending at least to the frost depth. Repair and repointing of the existing masonry will not reduce the possibility of future movement due to frost heave and expansive soils. Evidence of past foundation repairs (Such as the new concrete wall on the north side of the house indicate foundation problems have occurred in the history of the structure.

Foundation: The condition of the visible brick foundation is poor. Some cracks are visible and some daylight is visible in the crawl-space and should be expected in construction of this type and age. It should be assumed that little or no reinforcement is present. The foundation for the front porch was not accessible and could not be

Foundation: Our firm recommends the foundation be replaced with a reinforced concrete foundation extending at least to the frost depth. Repair and repointing of the existing masonry will not reduce the possibility of future movement due to frost heave and expansive soils. Evidence of past foundation repairs (Such as the new concrete wall on the north side of the house, and the gyp-board overlay of the lath and plaster) indicate foundation problems have occurred throughout the history of the structure.

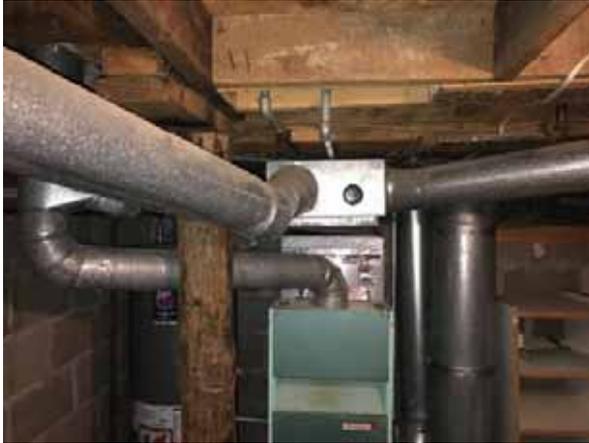
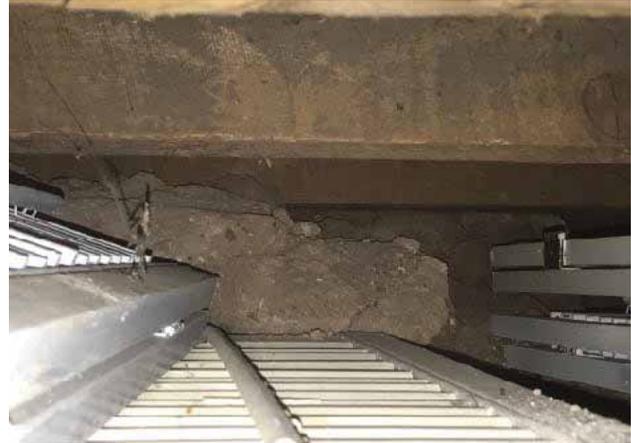
Description: The floor consists of wood 2x8 floor joists with random supports in varying directions. The framing for the front porch floor is similar. Several locations under the porch and main level floor were supported by wood posts bearing on grade. The crawl-space toward the front of the house was small and not accessible.

Condition: The condition of the existing floor framing is fair. A floor system of this type would not be used under current codes. There are some areas in the home where floor movement can be felt. Some deflection is evident in the joists and there is little room to make any repairs. Some joists have been notched for plumbing or electrical lines. The framing for the front porch showed some signs of rot and a repair of the floor decking had occurred in the past already. The deck framing and floor boards are in poor condition.

Recommendations: The Engineer recommends the floor joists should be reinforced and re-supported with an organized beam and foundation system. Severely notched

joists should be reinforced or replaced. The ends of the joists bearing directly on the foundation should be observed and protected from moisture. The framing for the front porch should be replaced with properly designed joists suitable for exterior conditions.

Floor Framing: The condition of the existing floor framing is fair. A floor system of this type would not be used under current codes. There are some areas in the home where floor movement can be felt. Some deflection is evident in the joists and there is little room to make any repairs. Some joists have been notched for plumbing or electrical lines. The framing for the front porch showed some signs of rot and a repair of the floor decking had occurred in the past already. The deck framing and floor boards are in poor condition.

Floor Framing: The floor joists should be reinforced and re-supported with an organized beam and foundation system. Severely notched joists should be reinforced or replaced. The ends of the joists bearing directly on the foundation should be observed and protected from moisture. The framing for the front porch should be replaced with properly designed joists suitable for exterior conditions.

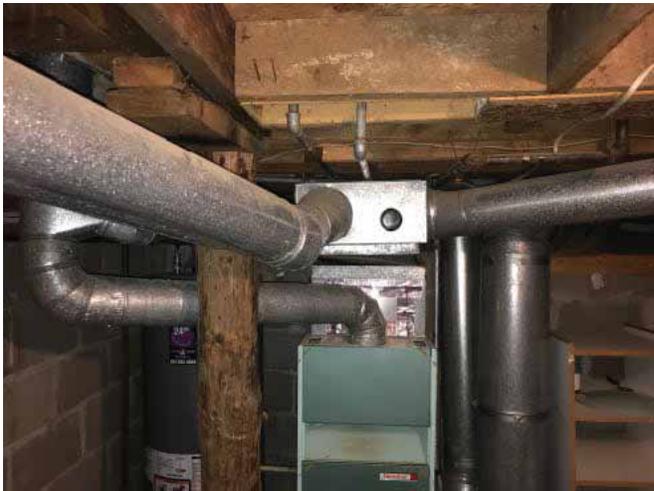
Existing furnace located in small cellar.

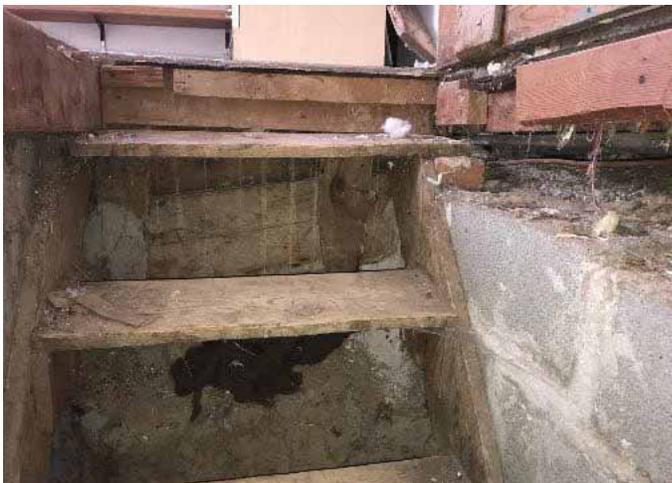
Stair to existing cellar.

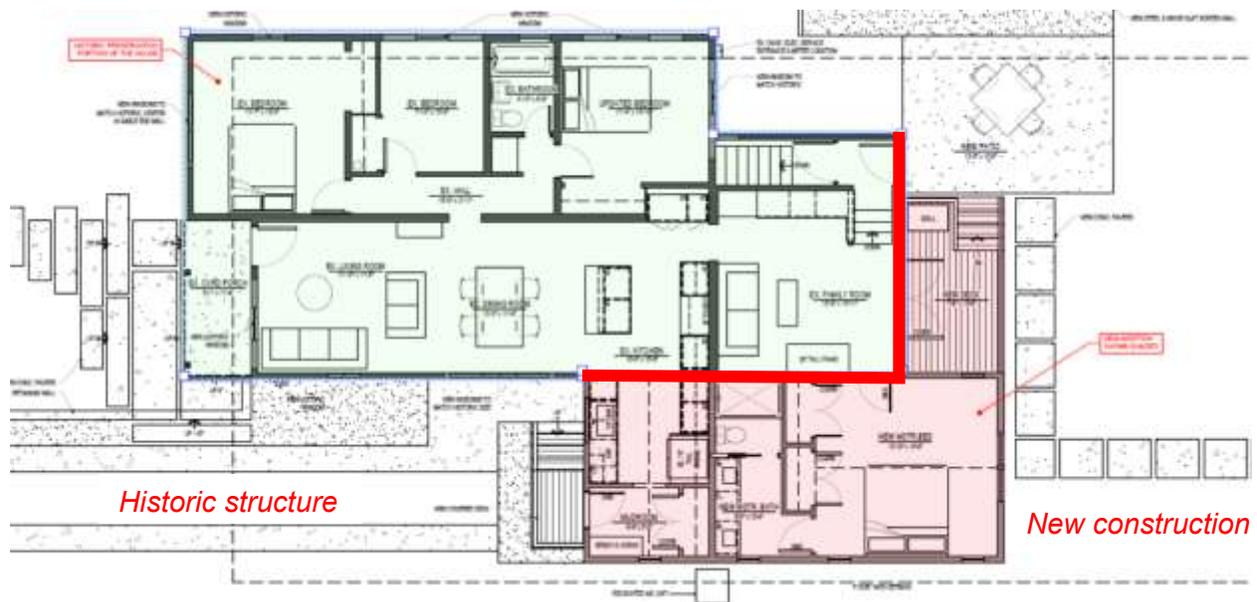
1016 Grant Avenue – Site Plan

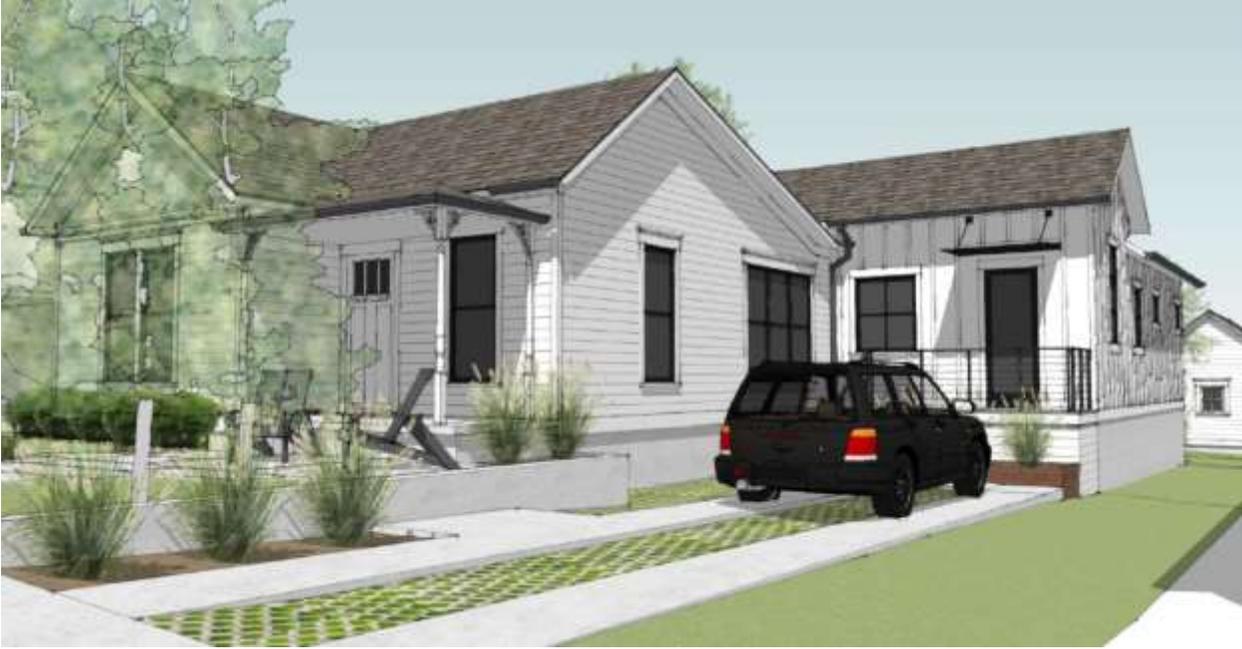
1016 Grant Avenue – Southwest (proposed)

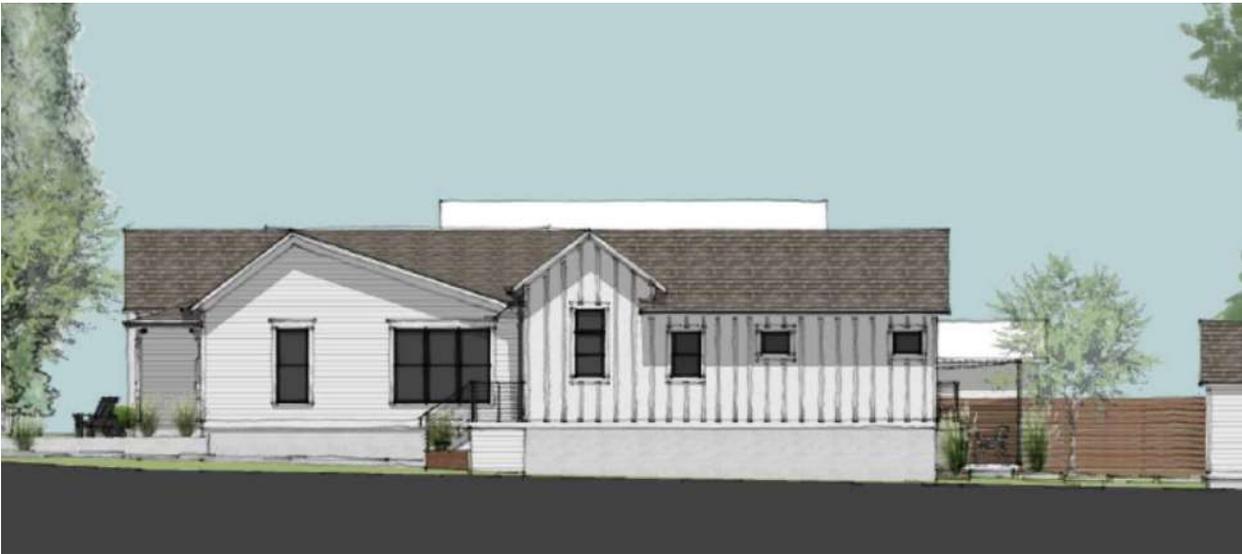
1016 Grant Avenue – South (proposed)

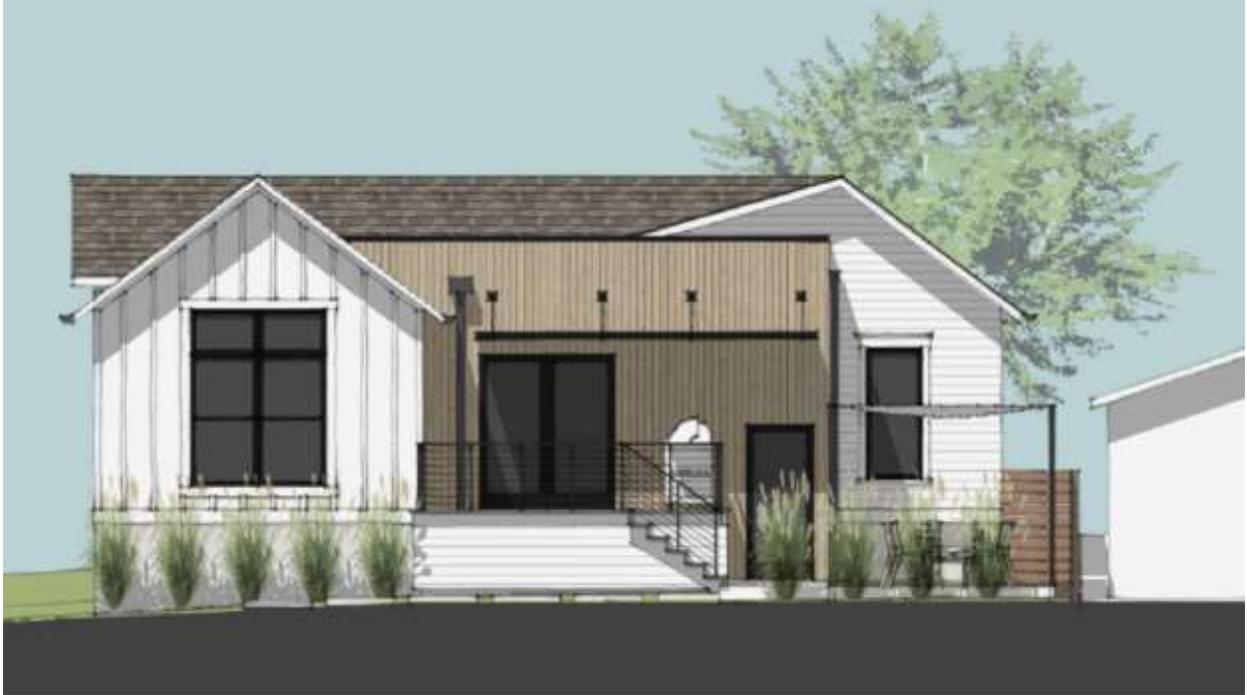
1016 Grant Avenue – East (proposed)

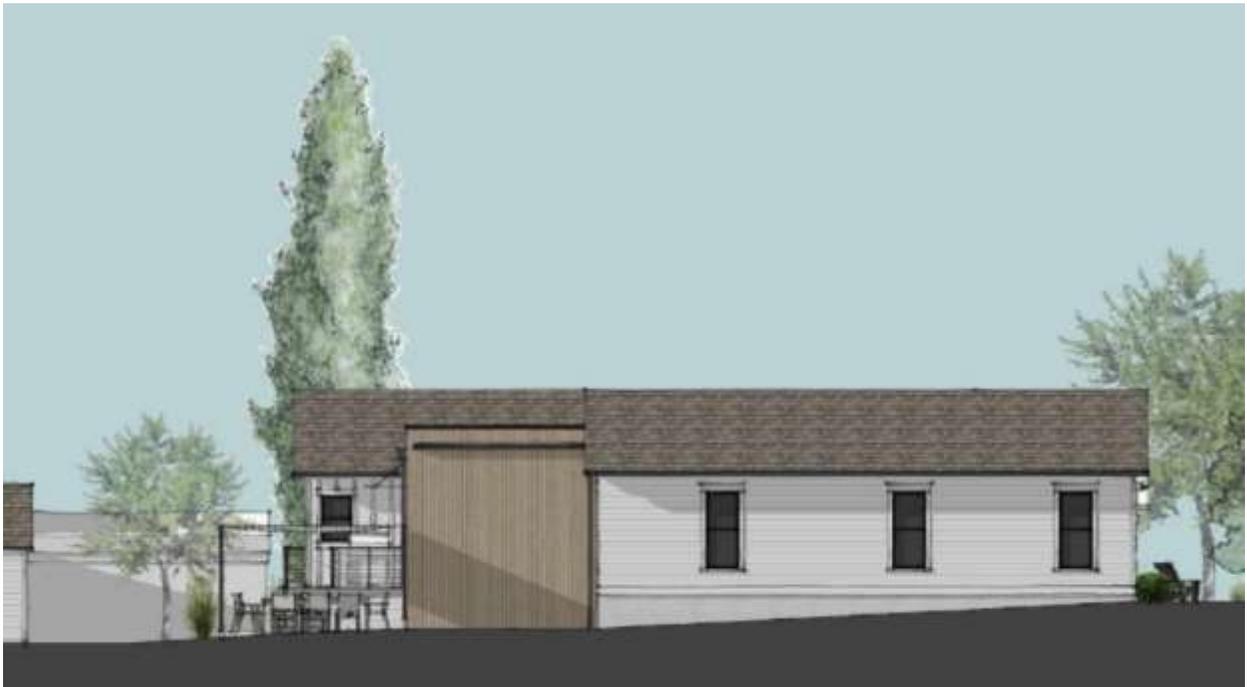
1016 Grant Avenue – North (proposed)

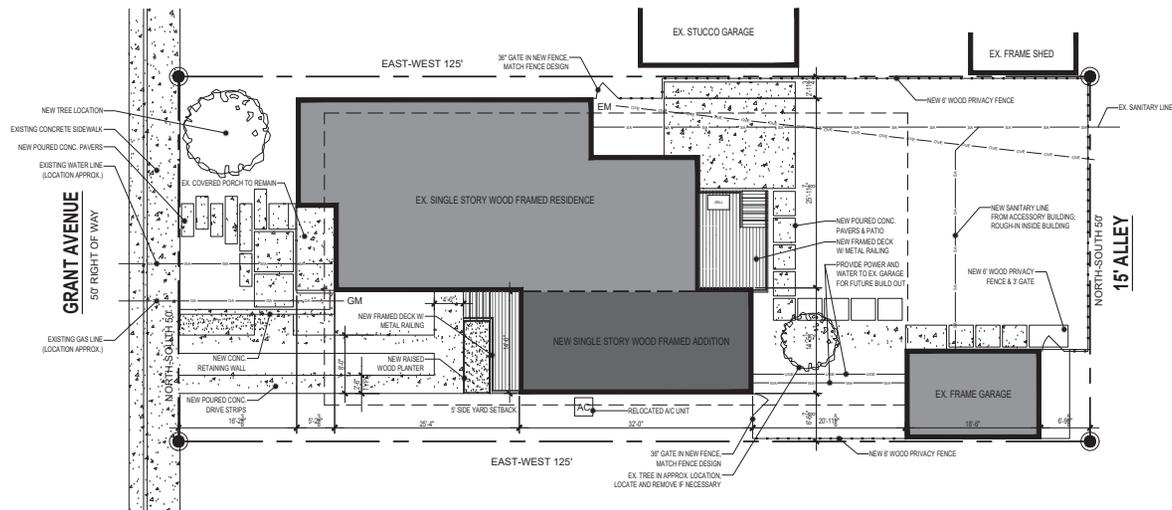
1
G0.1 SITE PLAN
SCALE: 1/8" = 1'-0"

NOTE: SURFACE WATER SHALL DRAIN AWAY FROM THE HOUSE AT ALL POINTS. DIRECT DRAIN WATER TO THE STREET OR TO AN APPROVED DRAINAGE COURSE. NOT ONTO NEIGHBORING PROPERTIES.

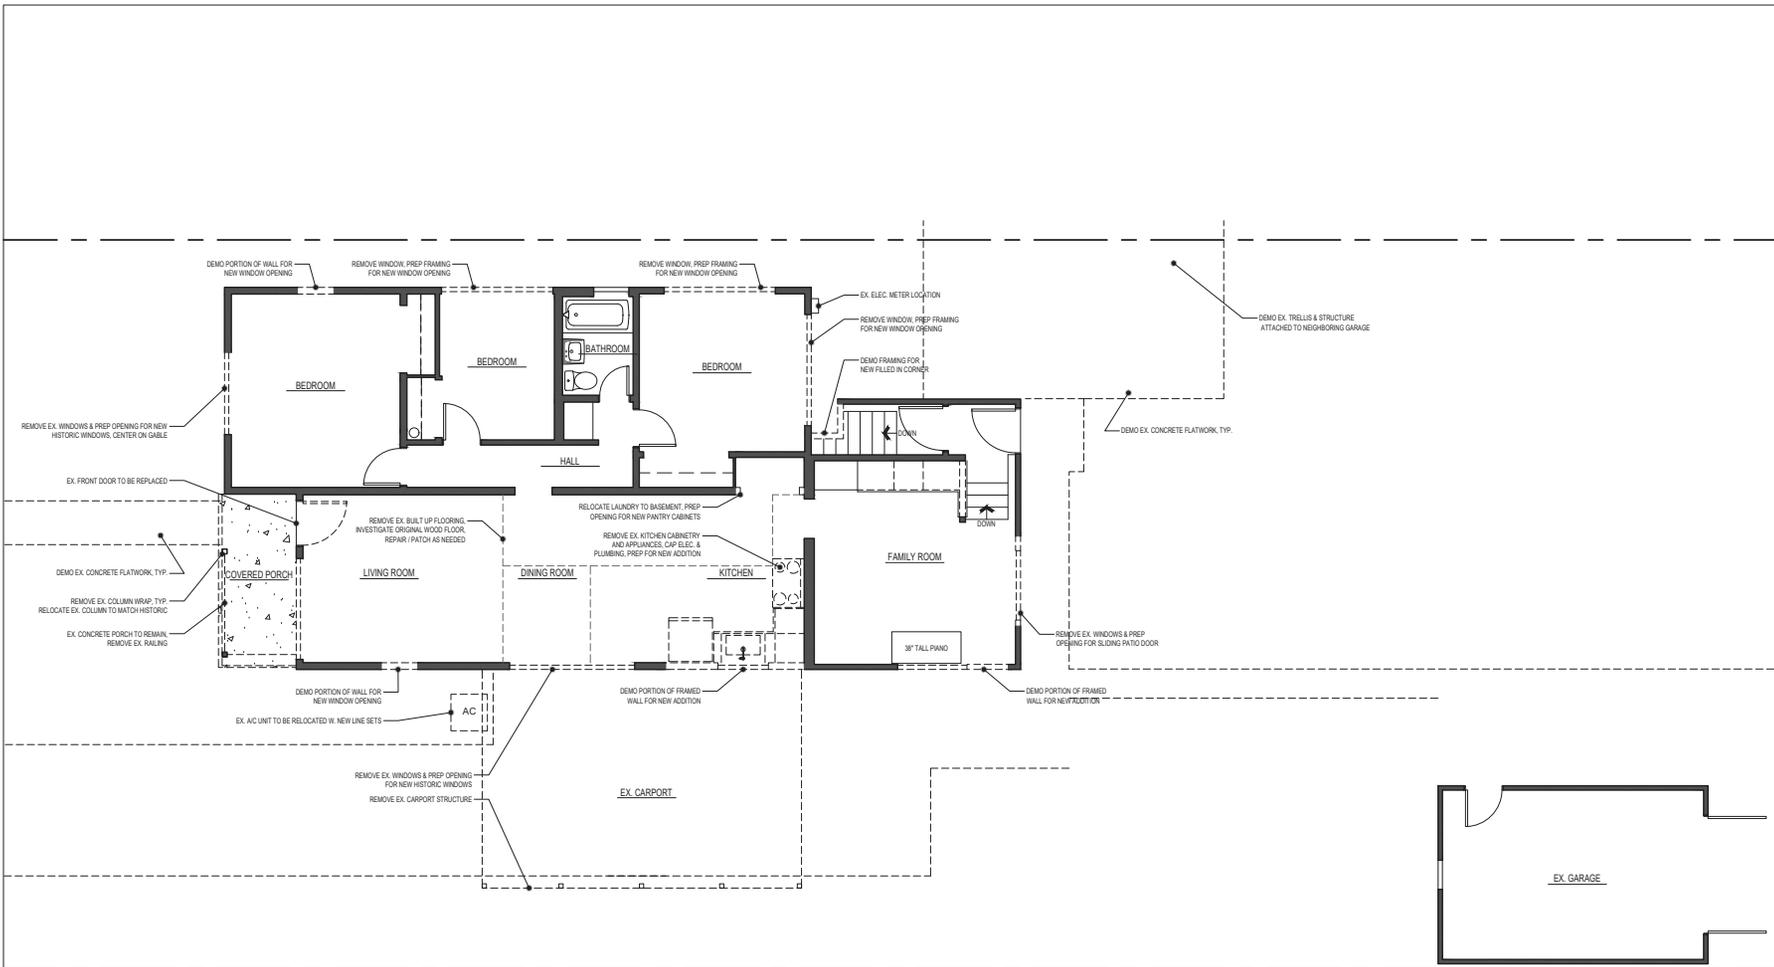
1
A1.0

DEMOLITION PLAN
SCALE 1/4" = 1'-0"

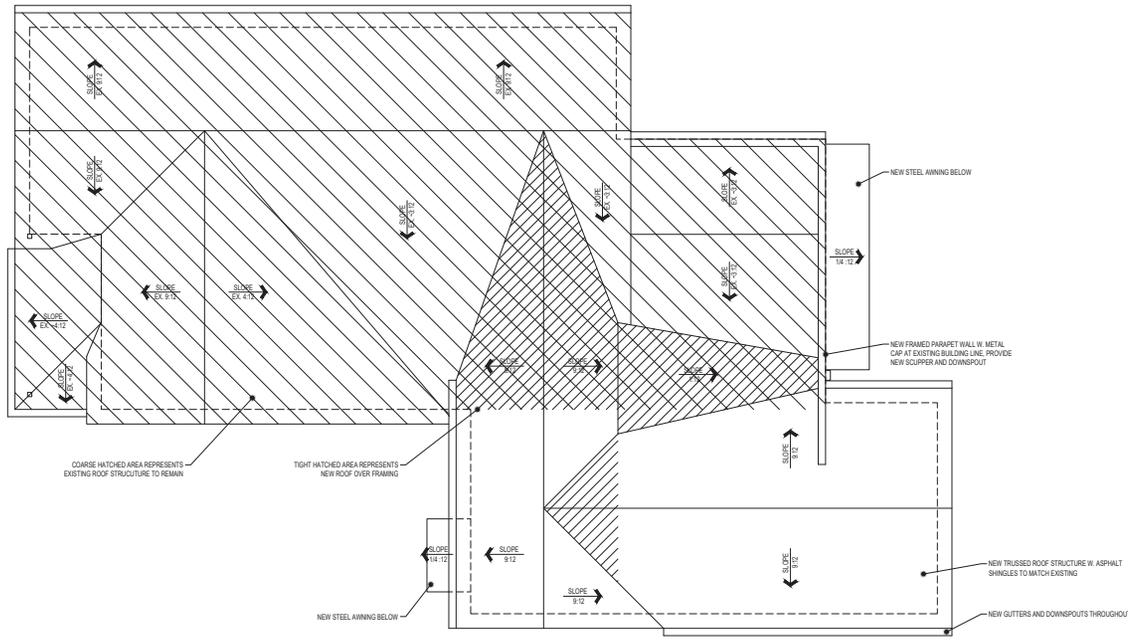
COARSE HATCHED AREA REPRESENTS EXISTING ROOF STRUCTURE TO REMAIN

TIGHT HATCHED AREA REPRESENTS NEW ROOF OVER FRAMING

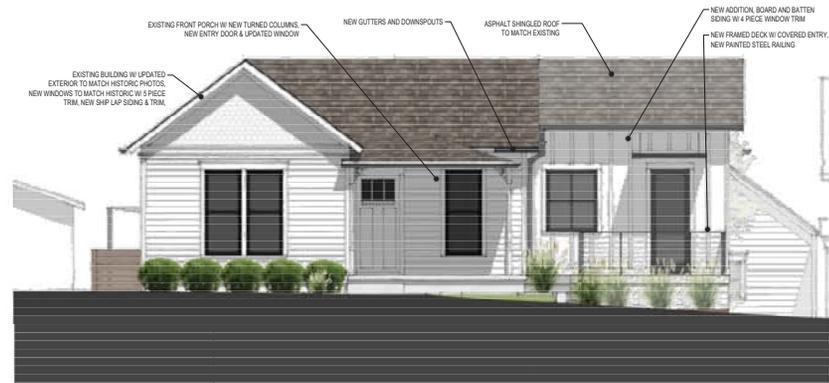
1
A2.1 WEST ELEVATION
SCALE: 1/4" = 1'-0"
