**Historic Preservation Commission
Agenda
June 15, 2020
6:30 pm**

PROJECT INFORMATION:
ADDRESS: 925 Jefferson Avenue
LEGAL DESCRIPTION: Lots 6-7, Block 11, Jefferson Place
DATE OF CONSTRUCTION: 1891

REQUEST: A request to Landmark 925 Jefferson Avenue and a request for an Alteration Certificate and Preservation and Restoration Grant at 925 Jefferson Avenue.

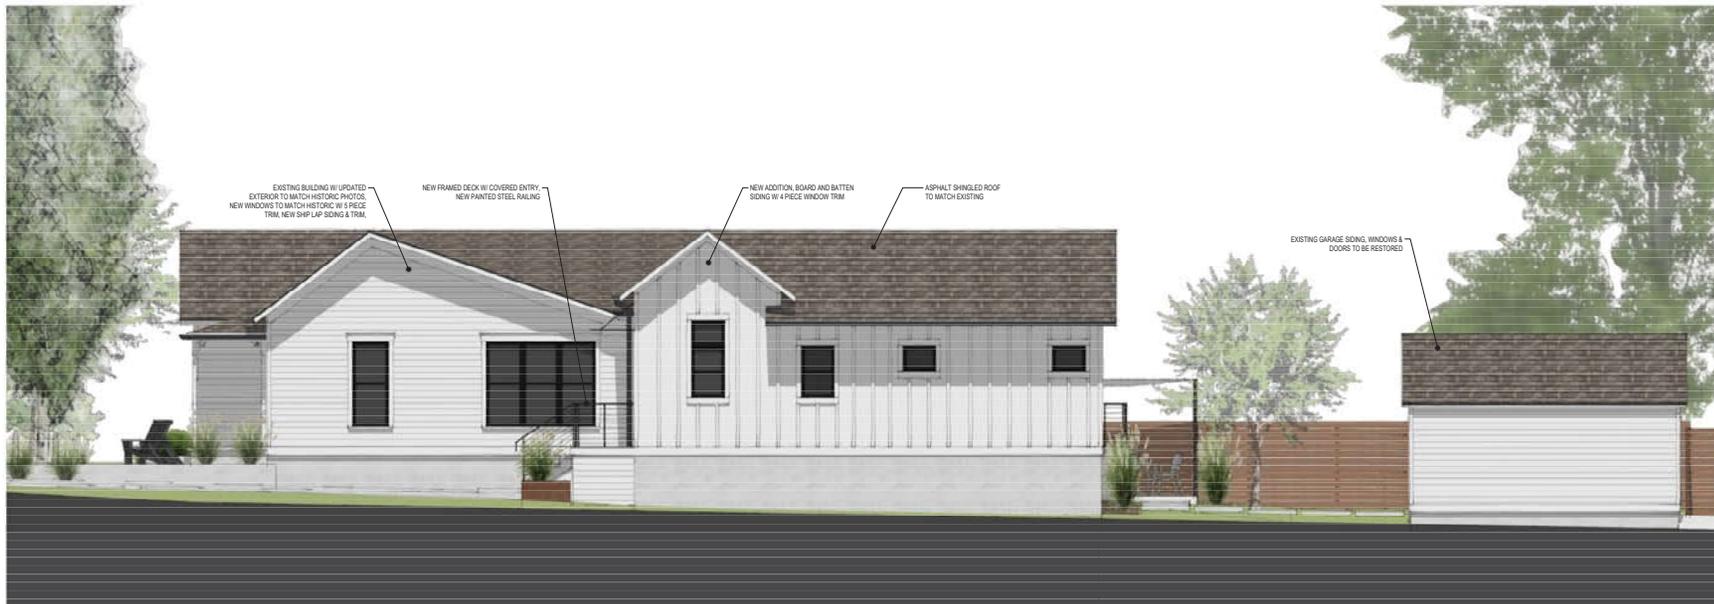
2
A2.1 SOUTH ELEVATION
SCALE: 1/4" = 1'-0"

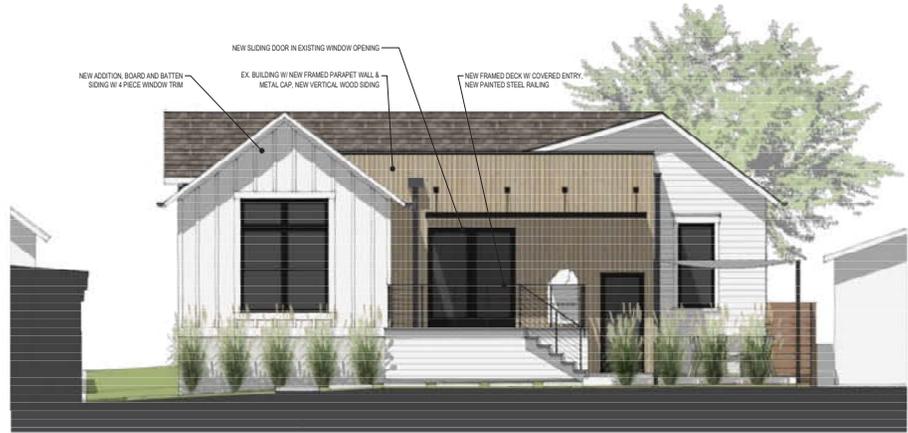
1 EAST ELEVATION
SCALE: 1/4" = 1'-0"

- NEW ADDITION, BOARD AND BATTEN SIDING W/ 4 PIECE WINDOW TRIM
- NEW SLIDING DOOR IN EXISTING WINDOW OPENING
- EX. BUILDING W/ NEW FRAMED PARAPET WALL & METAL CAP, NEW VERTICAL WOOD SIDING
- NEW FRAMED DECK W/ COVERED ENTRY NEW PAINTED STEEL RAILING

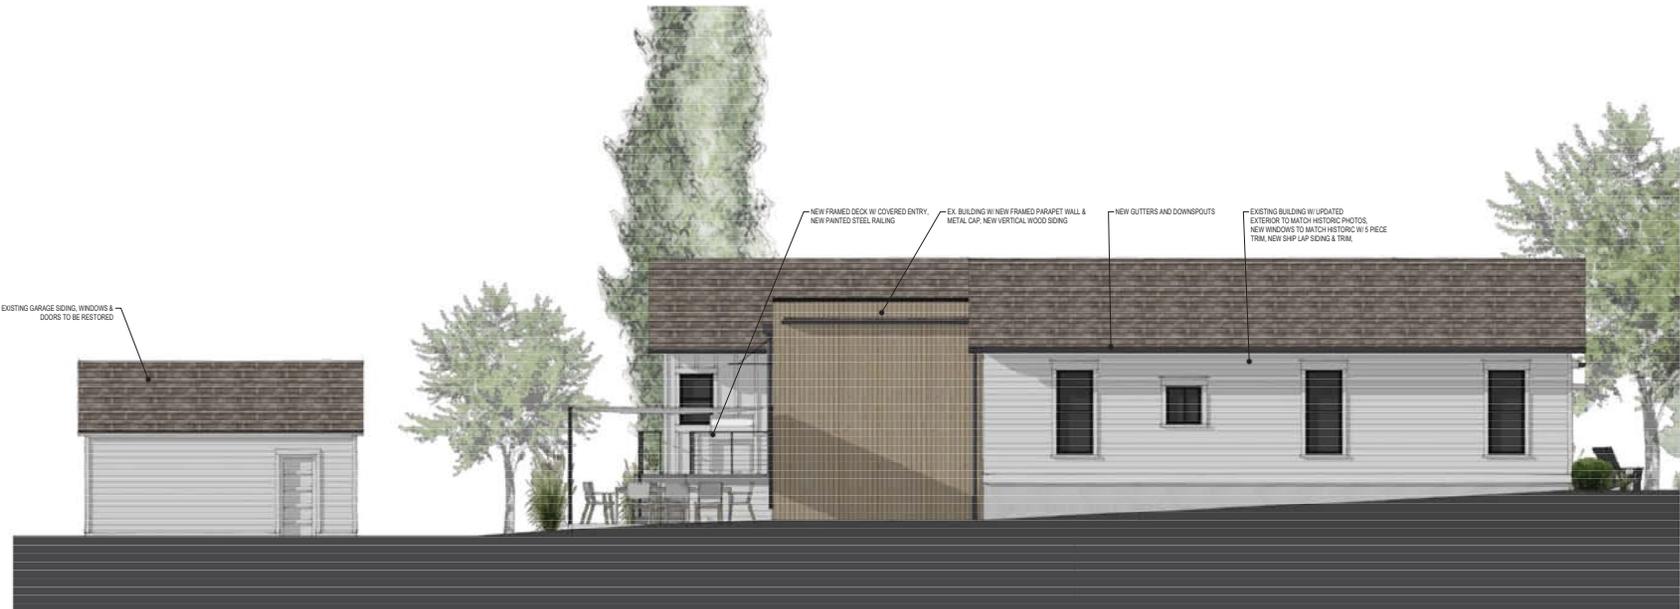
2 NORTH ELEVATION
SCALE: 1/4" = 1'-0"

- EXISTING GARAGE SIDING, WINDOWS & DOORS TO BE RESTORED
- NEW FRAMED DECK W/ COVERED ENTRY, NEW PAINTED STEEL RAILING
- EX. BUILDING W/ NEW FRAMED PARAPET WALL & METAL CAP, NEW VERTICAL WOOD SIDING
- NEW GUTTERS AND DOWNSPOUTS
- EXISTING BUILDING W/ UPDATED EXTERIOR TO MATCH HISTORIC PHOTOS, NEW WINDOWS TO MATCH HISTORIC W/ 5 PIECE TRIM, NEW CAP LAP SIDING & TRIM

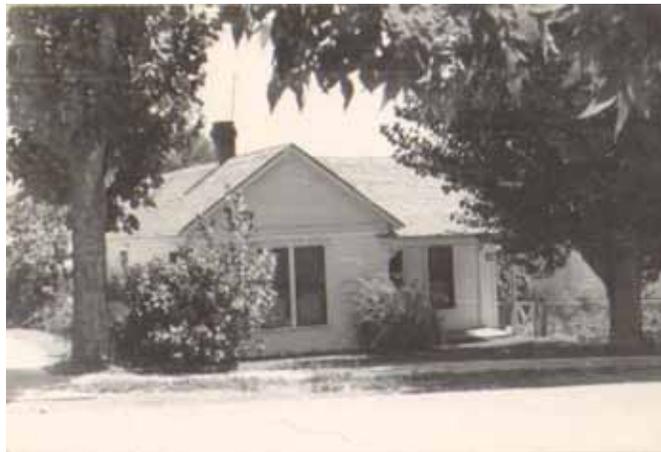
Image attached to the front of the
1948 Boulder County Assessor Card
showing the front (west) elevation
Courtesy of the Louisville Historical Museum

The covered front porch rests on a raised, poured concrete deck on top of a concrete foundation. The concrete is not original and was added between 1948 and 1956. Prior to 1956, there was a lower wood porch that can be seen in the 1948 Boulder County Assessor photo.

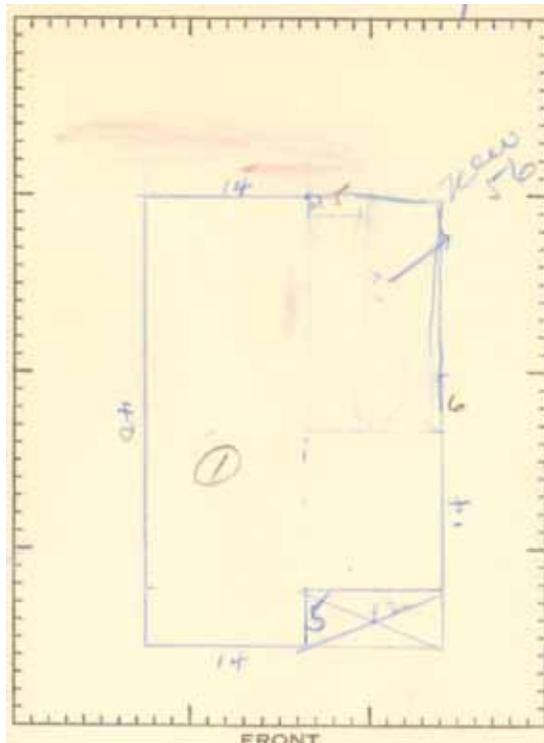
Ground Plan Sketch on the back of
1948 Boulder County Assessor Card
Courtesy of the Louisville Historical Museum

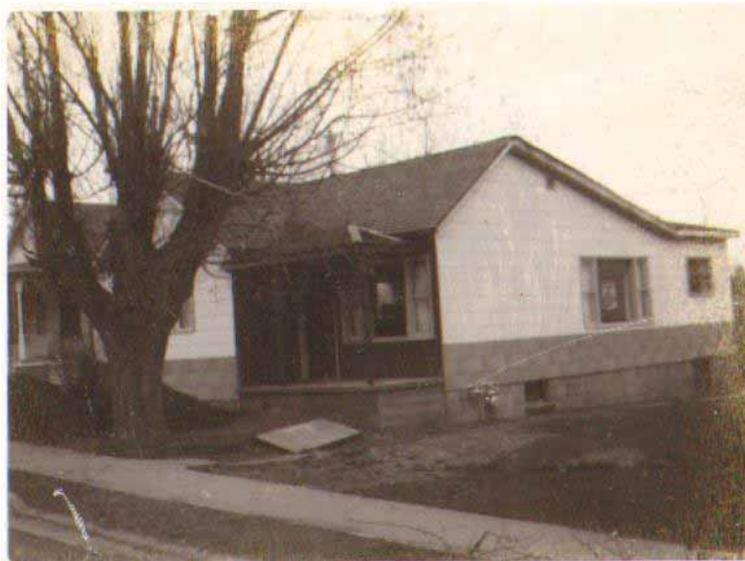
Image attached to the front of the
1956 Boulder County Assessor Card
showing the house from the southwest
Courtesy of the
Louisville Historical Museum

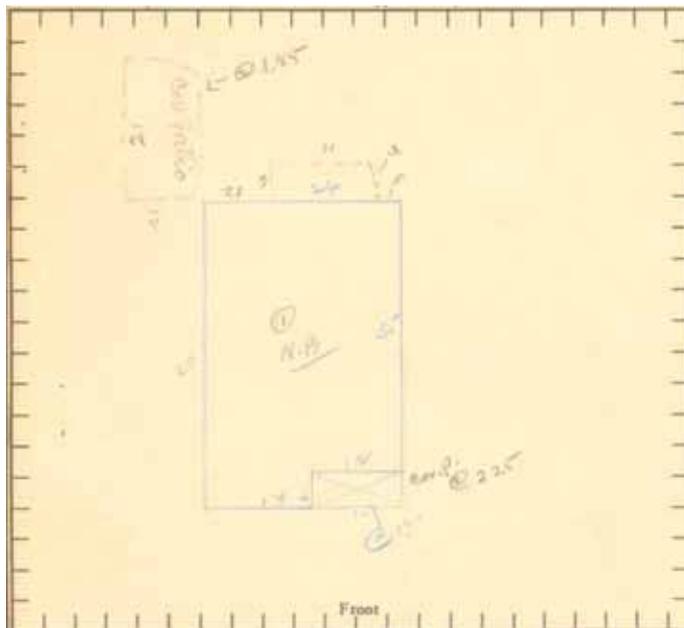
Ground Plan Sketch on front of
1956 Boulder County Assessor Card
Courtesy of the Louisville Historical Museum

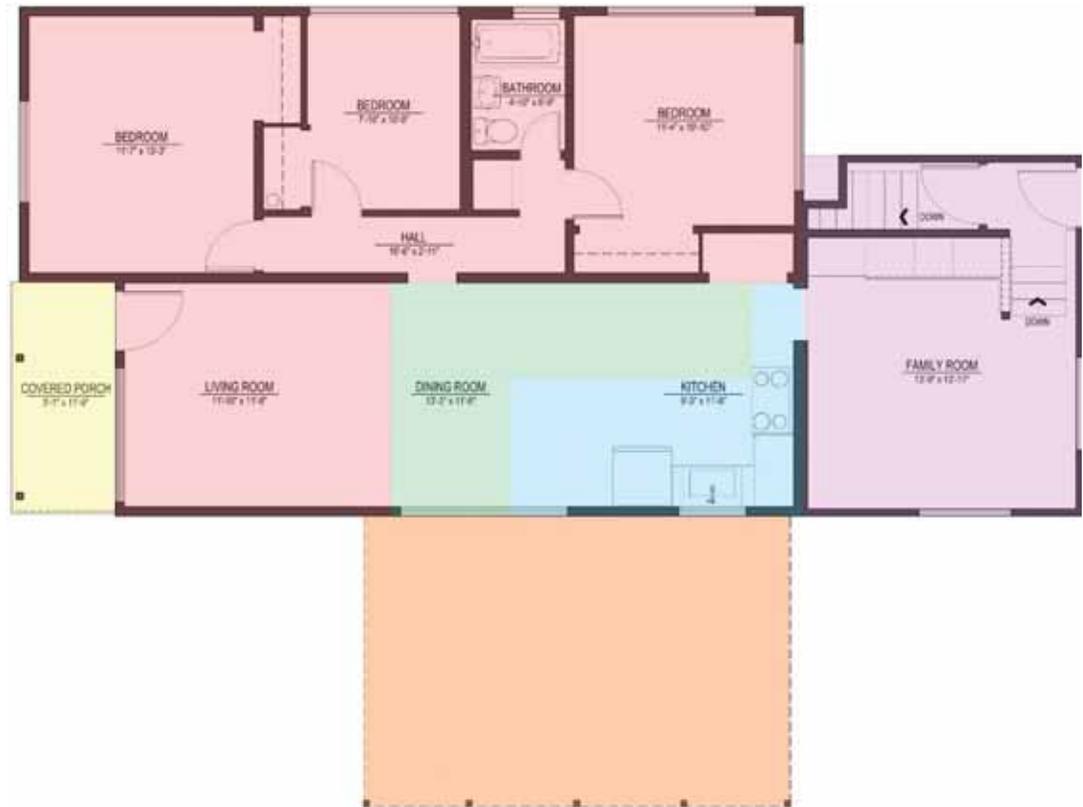
The footprint of the house, as observed, is shown below:

The footprint of the original house is shown in red as determined by observations made in the basement. The front covered porch (shown in yellow) was also original but was rebuilt between 1948 and 1956 at the same size to the original footprint, but with a concrete foundation and deck. The other shaded regions are subsequent additions. The green area was originally an uncovered deck that was later enclosed, along with the blue area, sometime between 1948 and 1956. The purple area was added at some point after 1956 as well as the carport to the south, shown in orange.

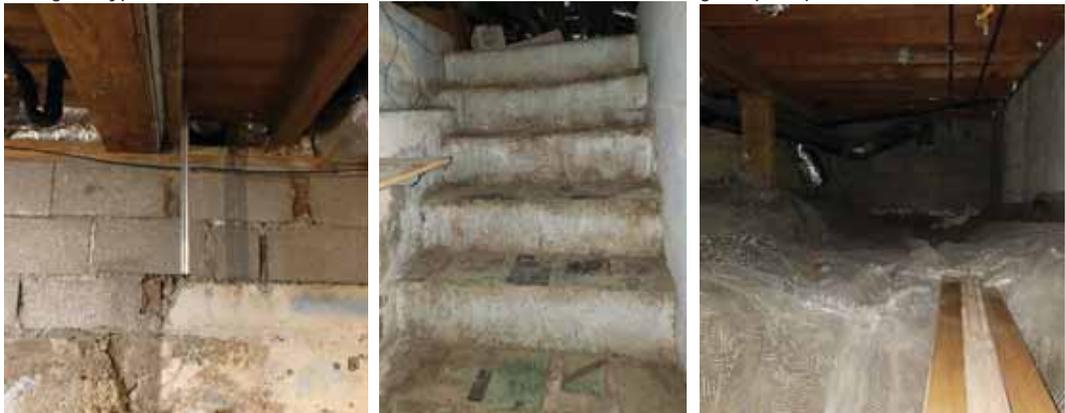
We have no other foundation recommendations at this time. There are no signs of major foundation distress. The owner may continue to monitor the building and contact us with any future problems. The owner is to note that the current foundation is not suitable for a second story and significant structural modifications to the foundation would be required to support additional loading from a remodel or addition. When monitoring the foundation, the owner is to check for foundation distress at the joint between masonry and concrete. This change in type of foundation wall material is a common location of damage or poor performance.

The existing foundation consists of CMU and Brick with poured concrete directly below. The concrete was used to extend the depth of an original crawl space and allow for a basement/cellar. This is not typical of foundation extensions which usually occur inside the original perimeter foundation. In addition, the CMU and Brick are also not original to the house. Typically houses of this type and age were supported by Brick or Stone shallow foundations.

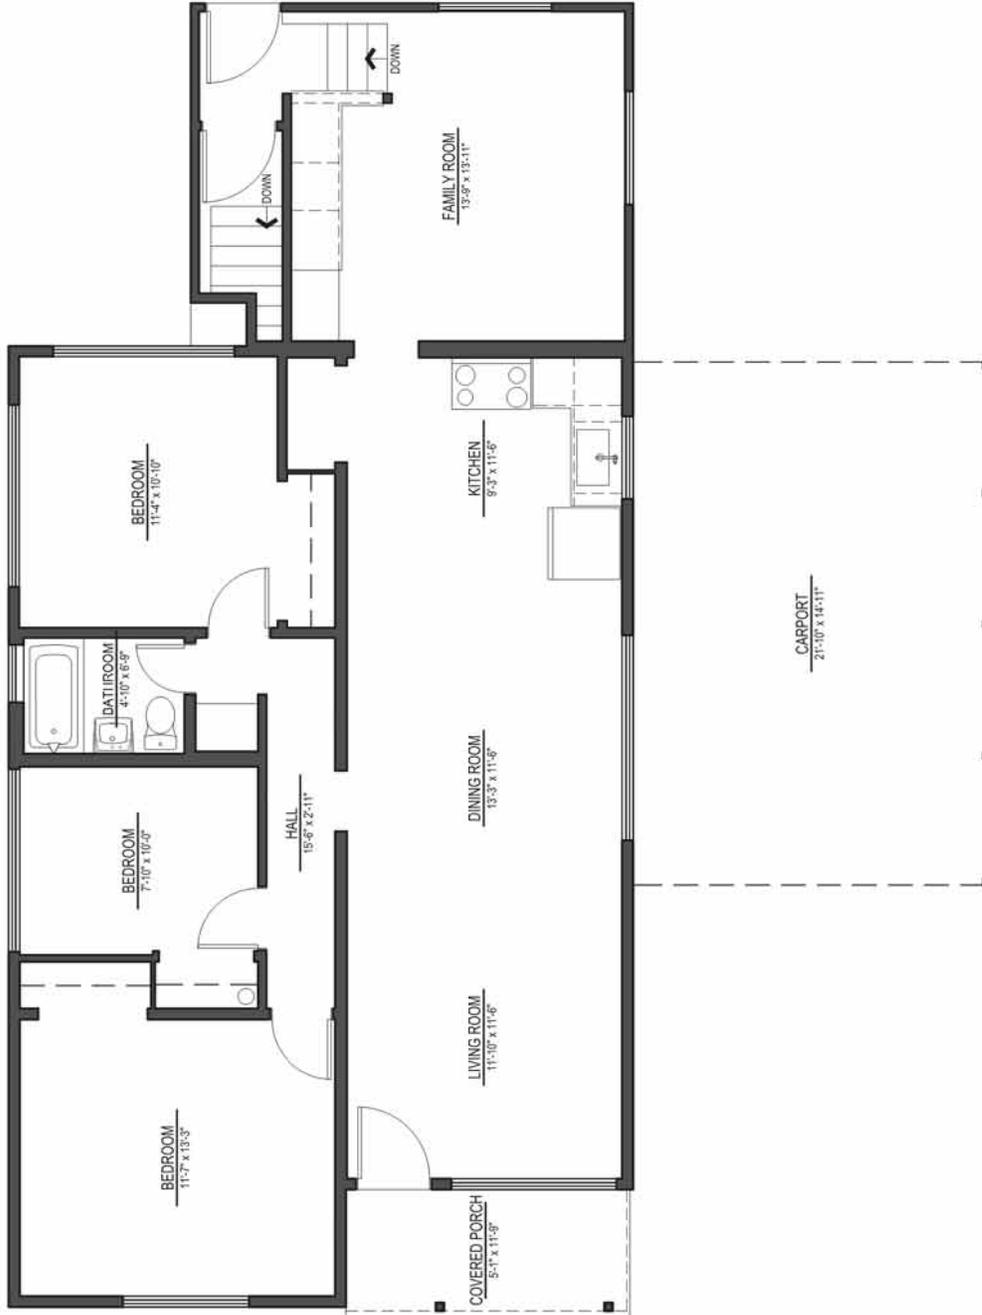
1
A1.1
EXISTING FLOOR PLAN
SCALE: 1/8" = 1'-0"

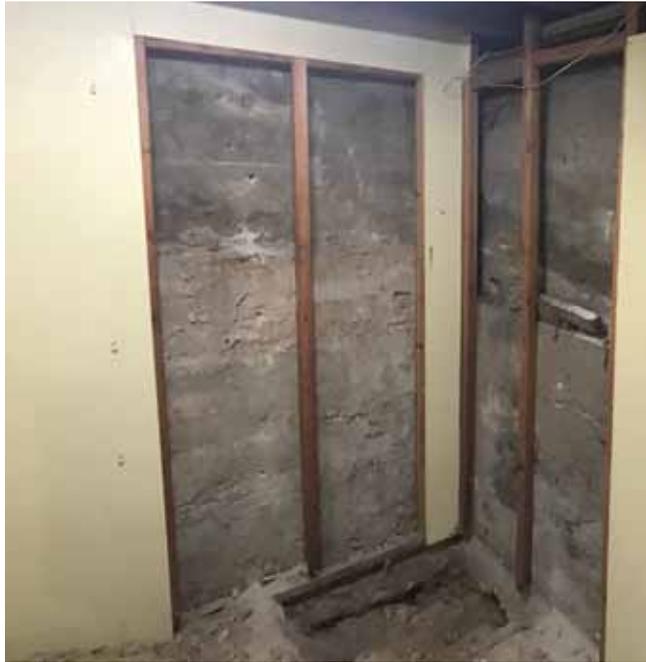
The concrete foundations walls have a cold joint between the two visible layers. A cold joint is an area of discontinuity between layers of concrete due to one layer hardening before the next layer is poured. The discontinuity between layers does not allow the second, wet layer to properly bind with the first, now hardened layer. Problems can arise if moisture gets into the cold joint to cause cracking or erosion in the walls themselves as the water freezes and thaws or water damage in the basement due to seepage through the cold joint. In addition, cold joints are compromised in strength. They are susceptible to shearing at the discontinuity under tension.

Due to the existence of the cold joint, the foundation is in moderate condition with some visible cracking and is incapable of supporting a second story. The dug-out, dirt crawlspace is un-retained in areas. Many of the posts below the central support beam in the

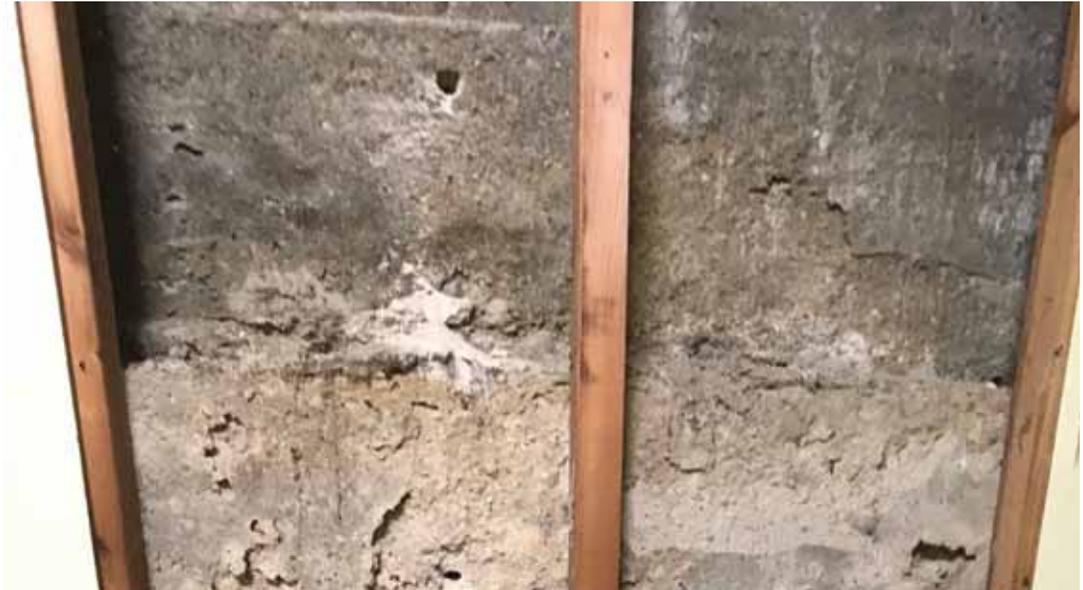
The dirt crawlspace is partially dugout to provide access. It appears the the soil was originally held back by concrete retaining walls. However, most of the retaining walls have been removed. The visible foundation walls in the crawlspace consist of a 33" concrete wall supported by a 6" bottom layer of rock on soil.

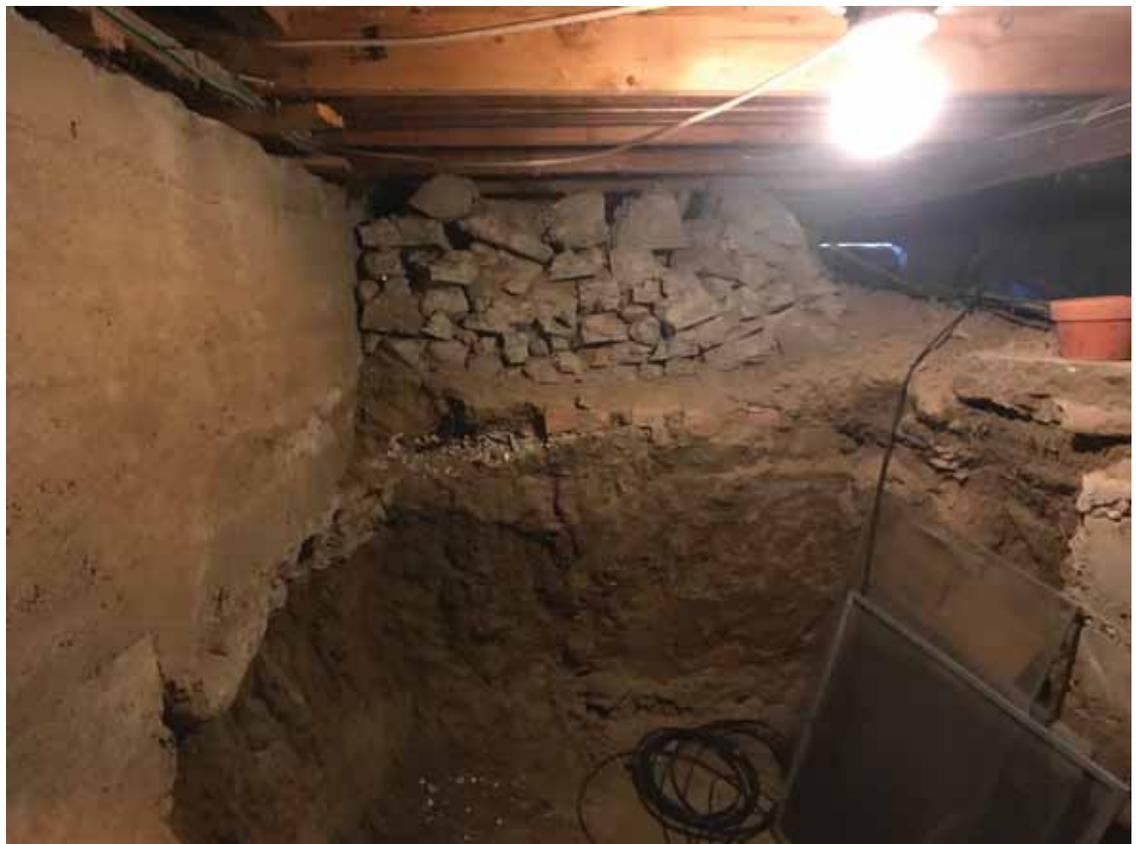
In the crawlspace, several small footings with wood column supports exist below the central wood support beam.

Some of these supports bear directly on soil while others bear on cut-out cement slabs. There is no vapor barrier installed over the exposed dirt floor of the crawlspace. A wood sill plate supports the main floor at the existing foundation walls but is not connected to the top of the foundation wall.

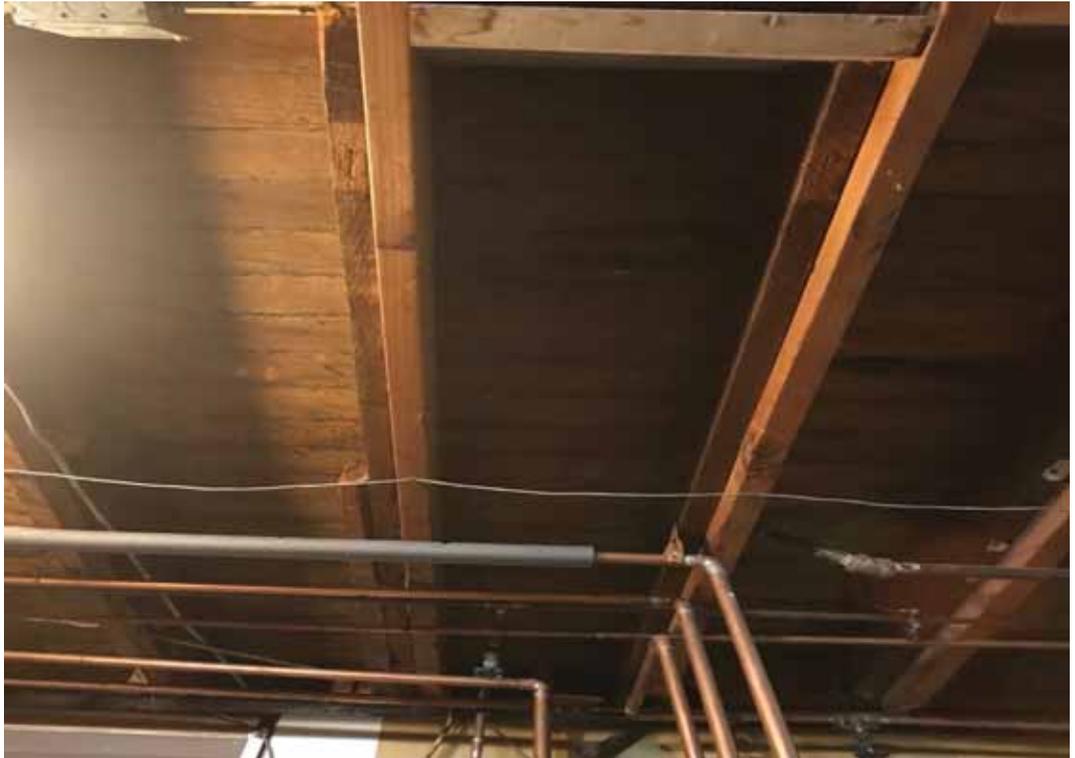
In the circa 1040's addition, floor construction consists of 2x6 joists on 16" O.C. The floor structure in the crawlspace under the addition is further supported by a 4x6 mid-span beam with intermittent, wood columns. The floor structure is also uninsulated.

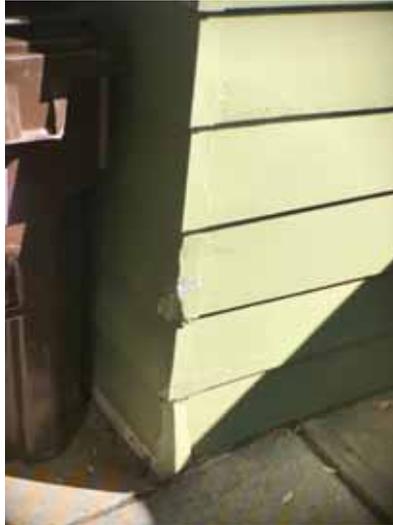
Exterior Walls

The wall framing was not visible for this study. Based on the thickness of the walls, it is likely a 2x4 stud wall with studs at regular intervals. The walls of the circa 1900's building may be original to the structure although this cannot be known for certain without taking the walls down to the studs. The exterior walls are clad in painted, redwood lapsiding with an 8" exposed face.

Due to the inability to observe wall framing, it isn't possible to evaluate the condition of the walls. The exterior siding is in good condition overall although there are a few boards near grade with rot. In addition, paint bubbles are forming on the west elevation due to sun exposure. Finally, corner flashing is damaged in some areas.

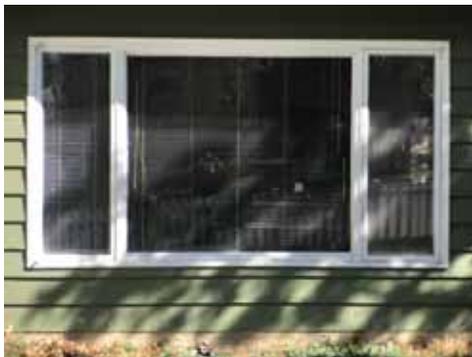
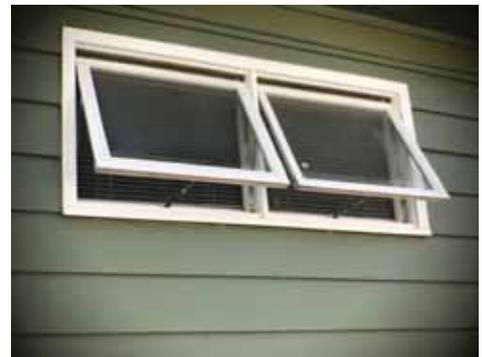
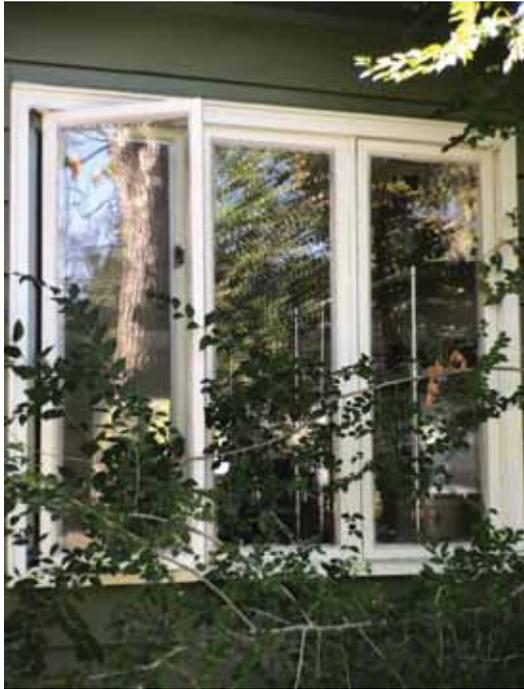
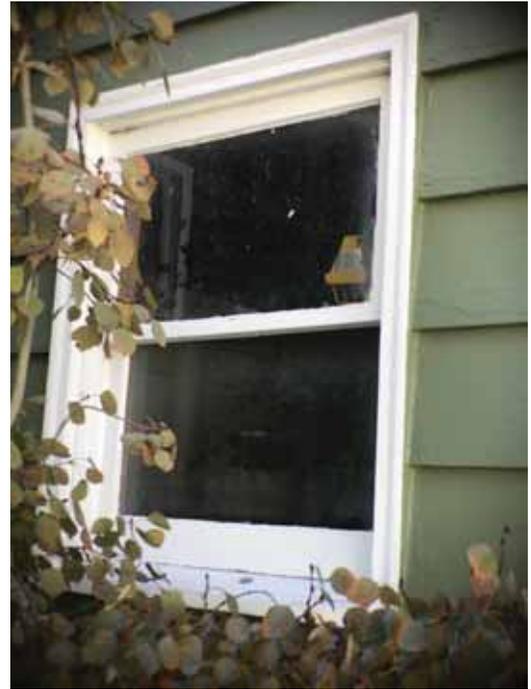
Exterior Windows

The windows at 1200 Jefferson Ave. are wood framed with single pane glass. There are a variety of window types. On the west elevation, the structure has a single picture window flanked by two casement windows. The north elevation has two double awning windows that are operable and one double-hung window on the garage. On the east elevation, there is one double casement window, a fixed pane window flanked by two casement windows, a single awning window and a double awning window. These windows all appear to be operable.

The south elevation has a single picture window flanked by two casements windows off the patio and a double casement window. It is unlikely that any of the windows are original to the 1900 coal miner's cabin but it appears from photographic evidence that all windows may be original to the 1948 addition.

The glazing compound, the putty that holds the window glass in position and functions to seal out weather, is cracked in many areas. In addition, some windows are inoperable.

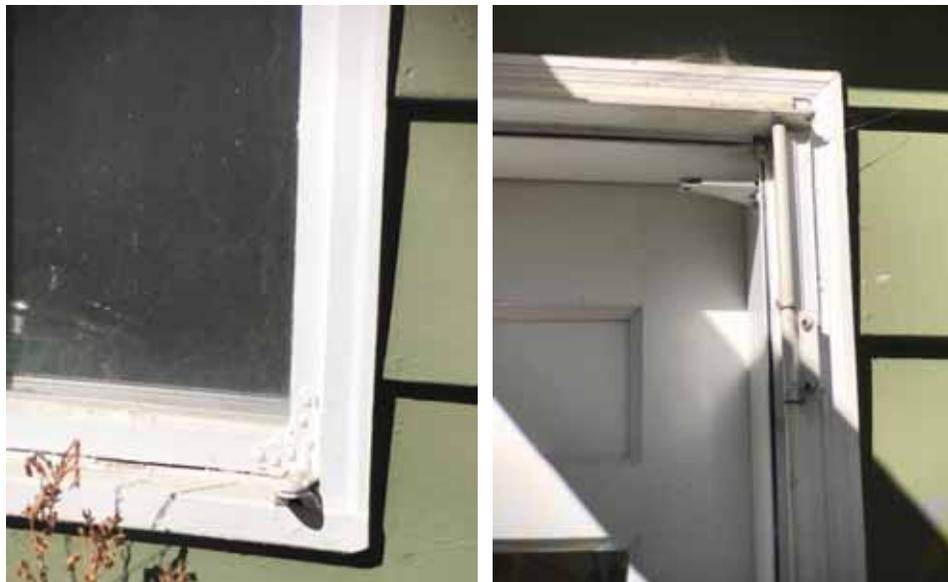
Window and Door Trim:

The windows and doors are simply trimmed out in painted, 1x picture-frame style wood trim. Overall, the trim is in average condition except for the trim to the right of the garage door which is broken at the base.

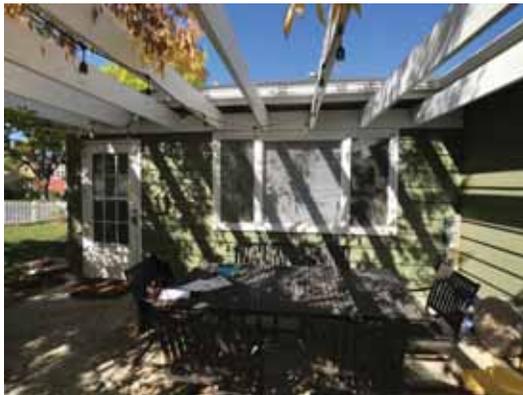
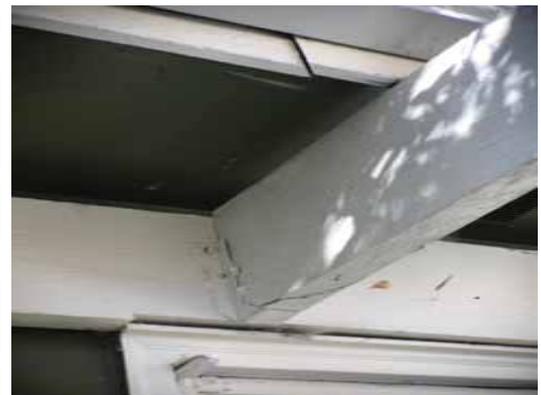
Porches:

1200 Jefferson has a simple concrete patio covered with a painted wood pergola along the south elevation. The pergola appears to be newer construction and is in good condition although there are a few cracked boards.

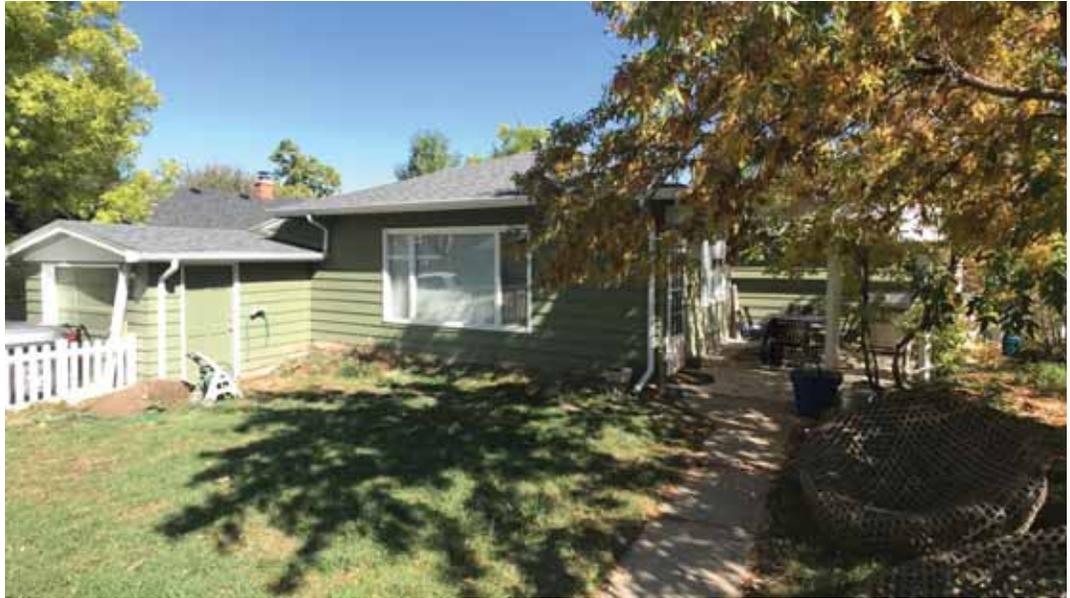
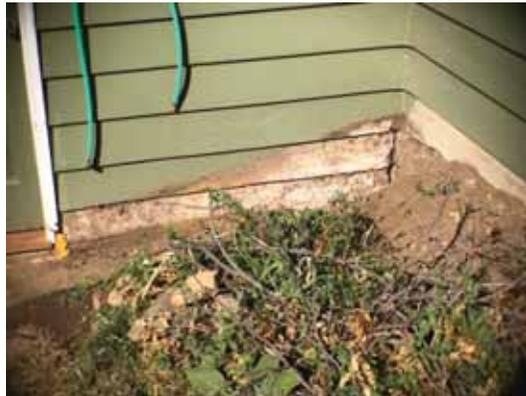
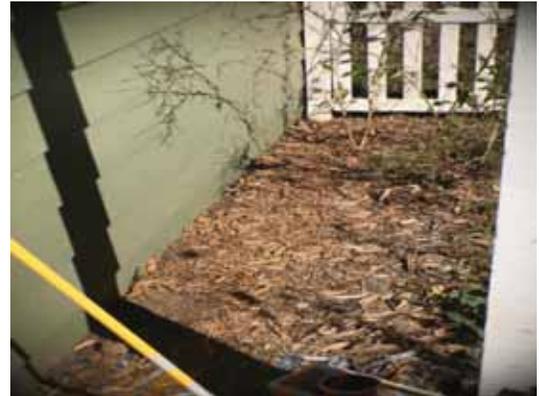
The site grades toward the house at the southwest corner and along the south elevation. This results in water draining towards the house and carrying dirt and debris along with it. The siding is covered by dirt in areas and is deteriorating. The siding has been covered in a concrete parge in areas in an effort to protect it. Water needs to be moved away from the foundation of the structure in order to prevent further deterioration of the foundation and seepage of water into the basement.

1. Regrade around the house to create positive drainage away from the foundation.
2. Consider installing a swale at the southwest corner of the property as a landscape feature to direct water around the south and west sides of the house.
3. Remove dirt and debris from areas where it is directly touching the siding. Dirt should only be in contact with concrete foundation.

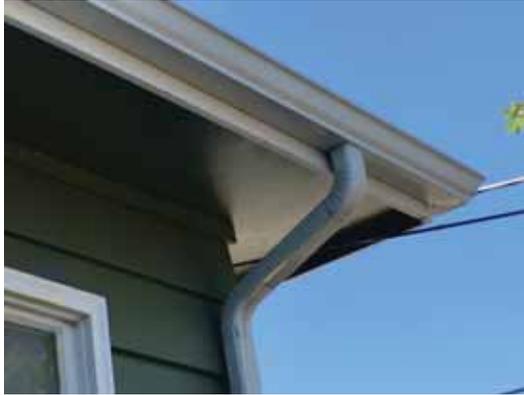
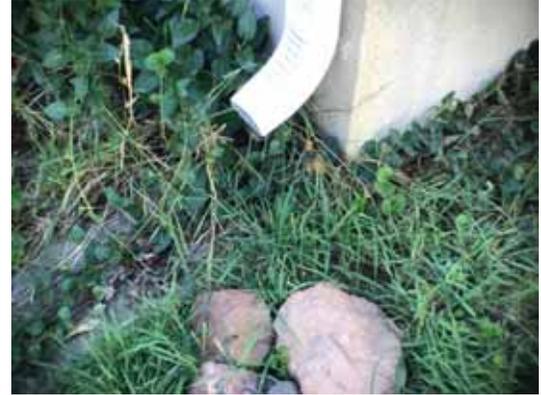
Gutters & Downspouts:

Gutters are a painted, standard 4" K-style metal and are located along the entire roofline of the home and along the south elevation of the garage. Gutters appear to be in good condition.

The 2x3 downspouts are a standard, painted metal and appear to be in good condition. Downspouts are located at all corners of the home except for the NW and NE corners of the garage. A few downspouts have extenders while others do not. Where the downspouts drain close to the building, the risk of water infiltration at the foundation is greatly increased.

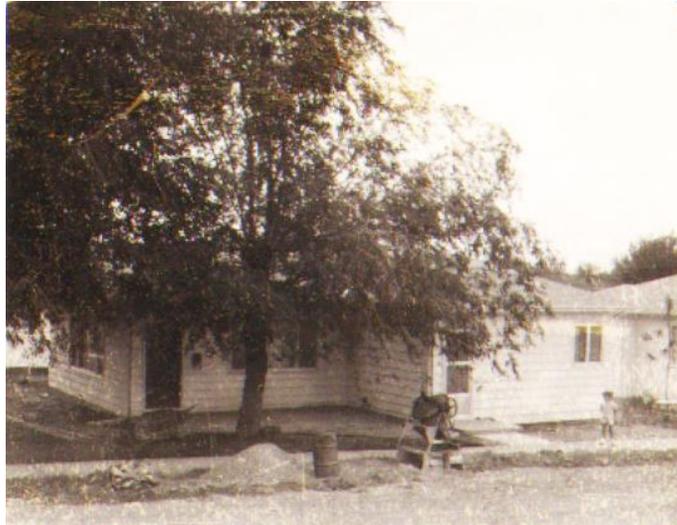
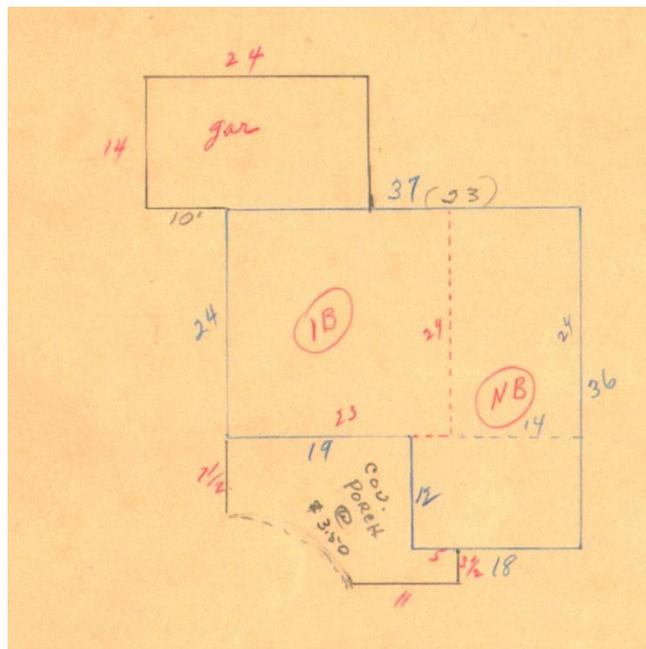
The following photo of the house and a ground layout sketch are from the Boulder County Assessor card that is dated 1958, with additional pencil markings added to the sketch in 1961.

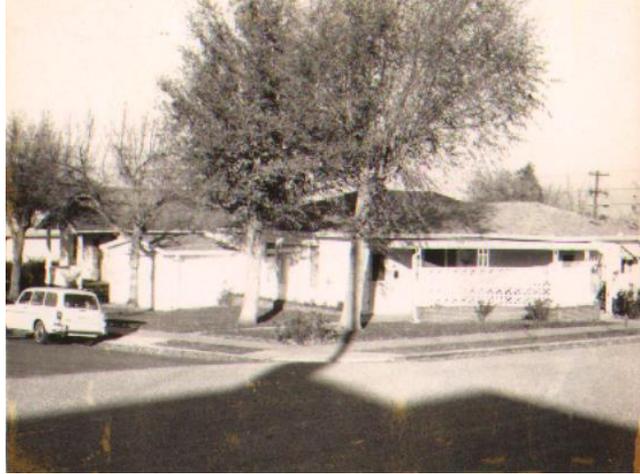
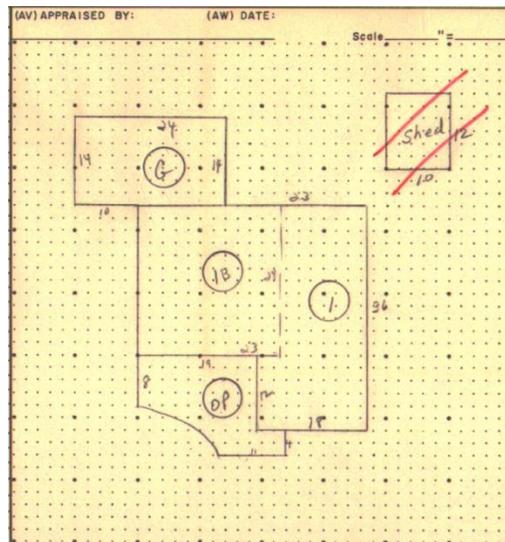
The following photo of the house and a ground layout sketch are from the Boulder County Assessor card that is dated 1977.
